Lessons Learned from Dike Failures in Recent Decades

ABSTRACT: *The paper describes five different dike failures that occurred in recent decades. The case histories were located on different rivers and involved different loading conditions. The observed failure mechanisms involved erosion and stability problems. The types of erosion observed were both internal erosion due to extreme groundwater flow and external erosion caused by the river flow and wave action. The case involving instability was caused by uplift, i.e., increased hydraulic head led to a sharp reduction in maximum shear strength between subsoil layers. Two cases demonstrate the importance of dike management and maintenance. Despite the variations in the loading conditions and failure mechanisms, all the cases show that the strength of a dike depends not only on the material used to build the dike but also on the strength of the subsoil.*

Lessons Learned from Dike Failures in Recent Decades. International Journal of Geoenvironment Case histories, Vol.4, Issue 3, p.203-229. doi: 10.4417/IJGCH-04-03-04

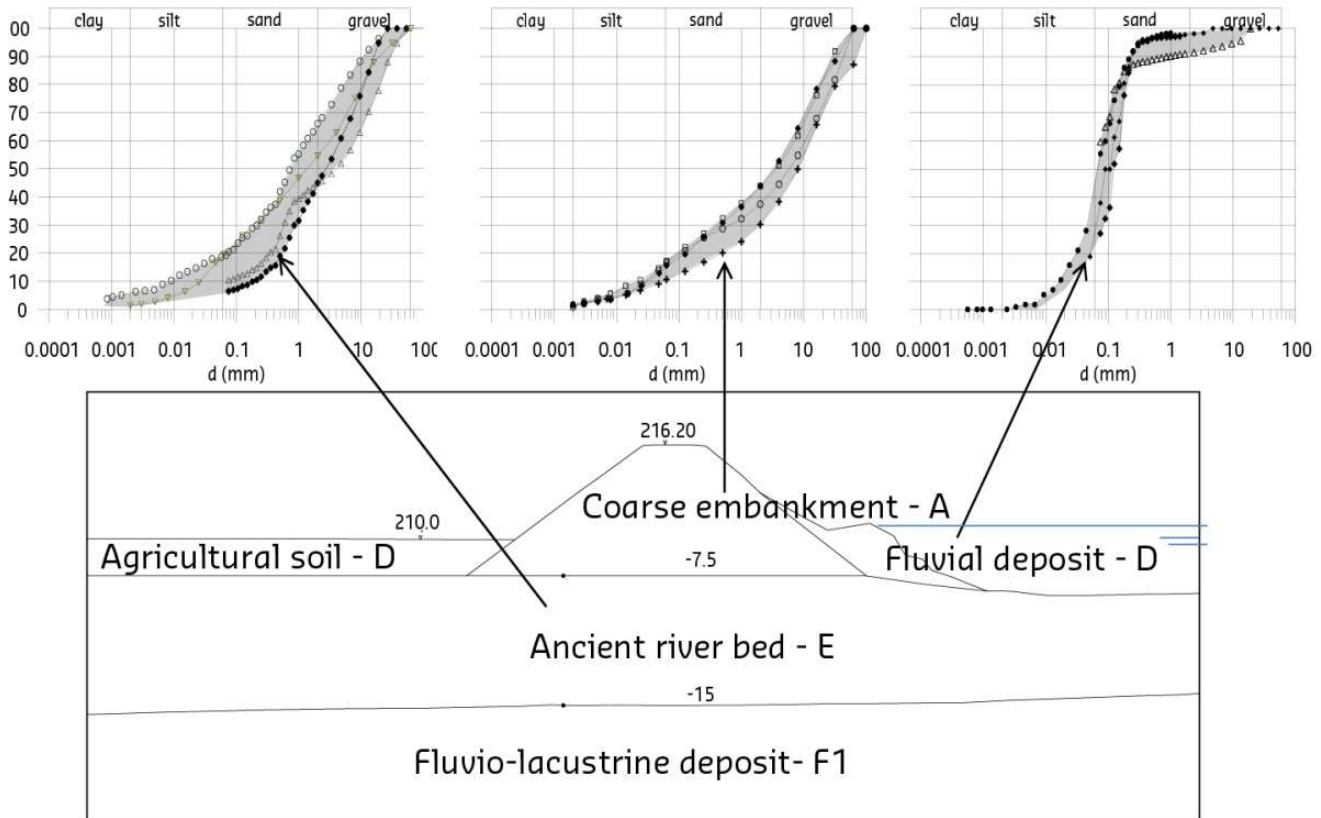
Figure 21. Soil profile for the cross-section representative of the dike segment in Laag breached in 1981 (chainage 124.620 km)

The cross-section at chainage 124.620 km was selected to analyze the hydro-mechanical response of the embankment (Figure 21). Figure 22 shows the longitudinal soil profile that includes the segment of the dike in St Florian affected by instability in 1981 (scarp of about 50 cm). The cross-section at chainage 122.248 km was selected to analyze the hydro-mechanical response of the embankment (Figure 23).

The grain-size distribution for the different soil types is shown in Figures 21 and 23, and Table 2. The soil types include:

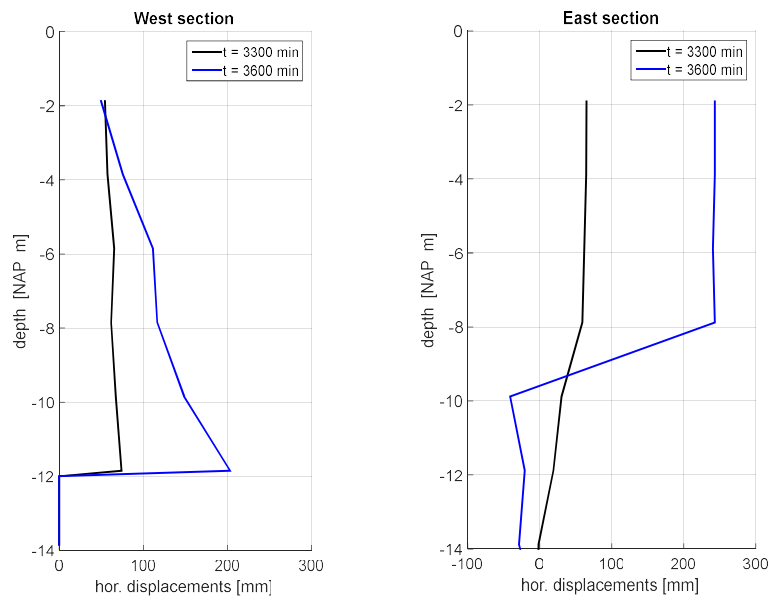
Figure 33. Horizontal displacement at the toe (both polder-side west respectively east of the central section as shown in Figure 27a)

Figure 33 shows the horizontal displacements measured at the toe in the eastern and western sections at $t = 3300$ min (55 h) and $t = 3600$ min (60 hours). Note that there was no inclinometer in the central section. The maximum displacement was found at the transition between the Pleistocene and Holocene layers, which was not at the same depth in both sections. Figure 34 shows the development of the maximum displacement for both sections. In the western section, horizontal displacements started to develop as soon as infiltration began. At approximately $t = 1500$ min, infiltration was suspended temporarily and no further deformation was observed until $t = 2500$ min, when infiltration resumed. Soon after, horizontal displacement developed in the eastern section as well. Infiltration was suspended for a second time, and horizontal displacement stopped again. Soon after infiltration resumed, displacement accelerated until the dike failed at $t = 3450$ min (57.5 hours) after the start of the test.
