Lessons Learned from Dike Failures in Recent Decades

ABSTRACT: *The paper describes five different dike failures that occurred in recent decades. The case histories were located on different rivers and involved different loading conditions. The observed failure mechanisms involved erosion and stability problems. The types of erosion observed were both internal erosion due to extreme groundwater flow and external erosion caused by the river flow and wave action. The case involving instability was caused by uplift, i.e., increased hydraulic head led to a sharp reduction in maximum shear strength between subsoil layers. Two cases demonstrate the importance of dike management and maintenance. Despite the variations in the loading conditions and failure mechanisms, all the cases show that the strength of a dike depends not only on the material used to build the dike but also on the strength of the subsoil.*

Lessons Learned from Dike Failures in Recent Decades. International Journal of Geoenvironment Case histories, Vol.4, Issue 3, p.203-229. doi: 10.4417/IJGCH-04-03-04

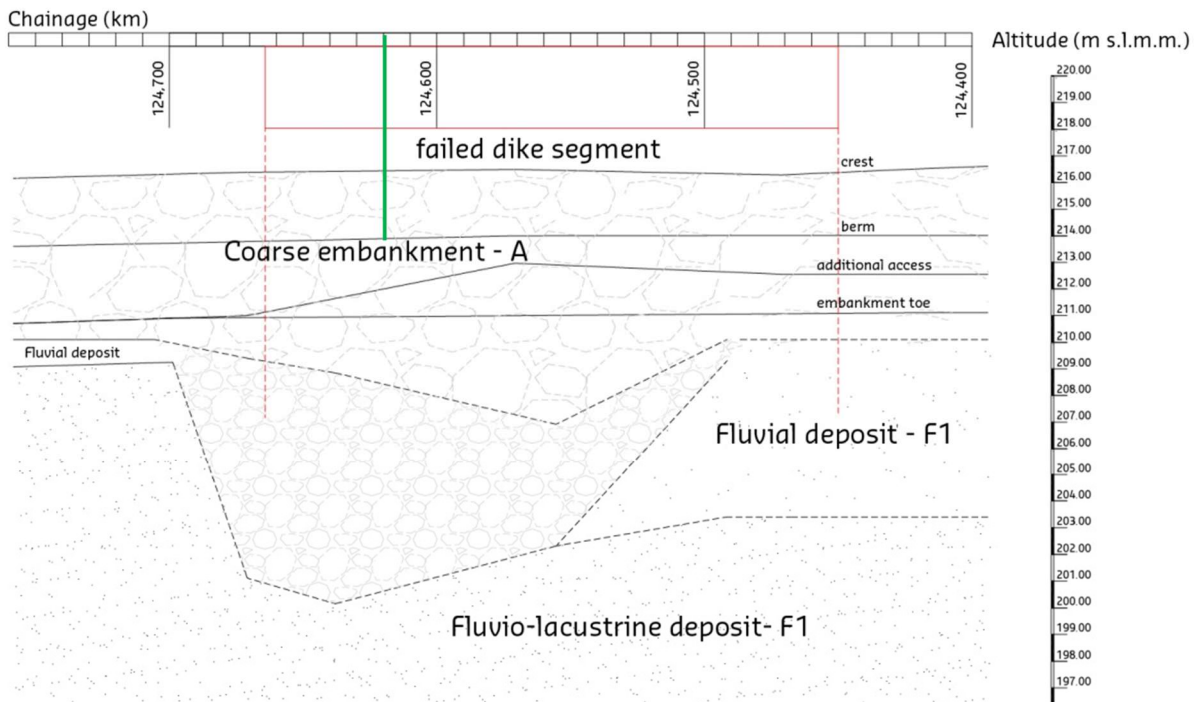
Figure 20. Longitudinal soil profile of the dike segment in Laag that includes the section breached in 1981. The location of the representative cross-section is indicated by the green line.

Figure 20 shows the longitudinal soil profile that includes the segment of the dike in Laag breached in 1981 and then reconstructed after 1981. The dip in the interface between the coarse-grained embankment and the ancient river bed is attributable to the excavation of the ancient river bed material after the dike was breached. During the flood, the embankment was patrolled frequently (a few times a day) and no evidence of sand boiling was detected. It is not possible to exclude that

sand boiling was occurring between one visual inspection and another. However, it would appear that failure was mainly caused by underseepage rather than erosion triggered by uplift pressures at the landside toe of the embankment.

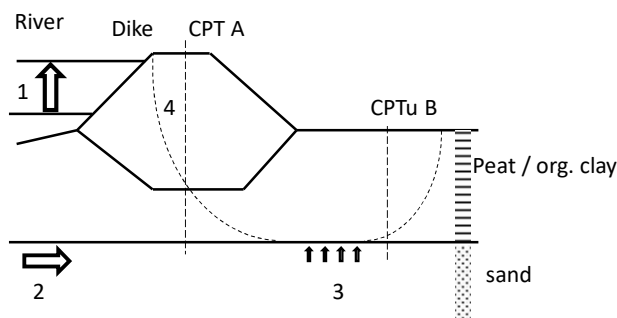
A typical failure mechanism for dikes in this area is loss of stability due to uplift of the soft soil layers at the toe. Figure 28 explains the failure mechanism. There is a hydraulic connection between the river and the Pleistocene sand layer. A rise in the river level (1) results in an increase in the hydraulic head in the Pleistocene sand layers (2) until the pore pressure equals the weight of the Holocene layers on top (3). The shear strength at the transition between the Holocene clay and peat layers on the one hand and the Pleistocene sand deposit on the other is drastically reduced, creating the conditions for a long, deep, slip plane (4). The uplift phenomenon is described in further detail by Cooling & Marsland (1953), Marsland (1961), Bauduin et al. (1989) and Van (2001). Observations of stability loss due to uplift are scarce and it was decided to study the uplift phenomenon at the Bergambacht test site.

Figure 28. Impression of the uplift failure mechanism, 1: river level rise, 2: hydraulic connection to sand layer, 3: pore pressure rise until uplift top layer, 4: failure plane.

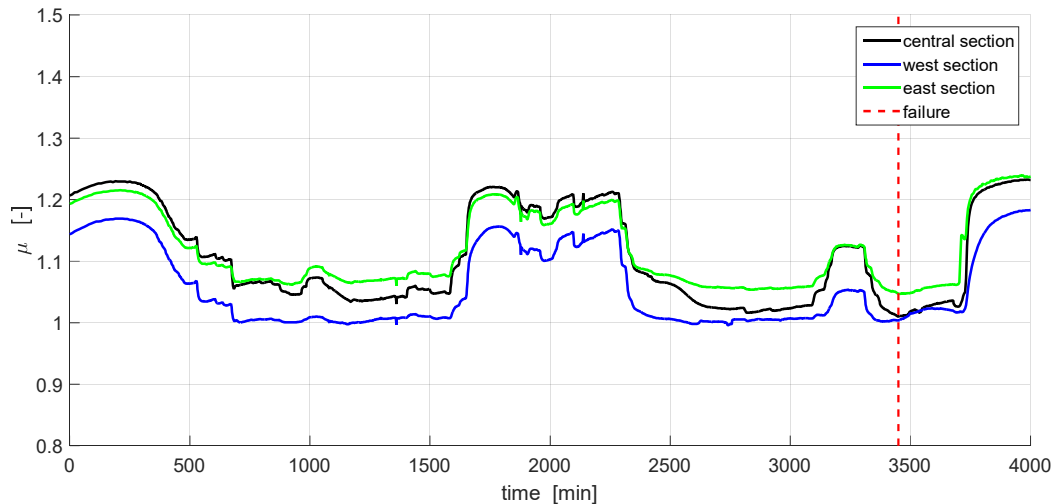
Figure 37. Ratio of total overburden pressure to pore pressure, μ , during the test

To check on the uplift conditions during the test, the ratio, μ , of the weight of the Holocene layer to pore pressure in the Pleistocene sand layer was determined for each of the transducers in the Pleistocene sand layer. Figure 37 shows the ratio, μ , during the test for the transducers placed at 46 m from the crest of the dike in the central, eastern and western sections. Initially, $\mu = 1.2$. When infiltration began, this value reduced, as expected. Due to differences in the subsoil layer, μ varied for the different sections, with the lowest value in the western section, where the value remained approximately 1. In the central and eastern sections, μ seemed to reduce slightly during the test. This corresponds to the slight increase in infiltration pressure during the test, as shown in Figure 35. The value did not drop significantly below 1.0. This could be explained by the pumping capacity, which does not allow for any further increase in pore pressure in the sand layer at the toe of the dike. It can also be hypothesized that when the pore pressure in the sand layer starts to exceed the weight of the clay and peat layers above it, a gap is created which is filled with pore water from the sand layer until a new equilibrium is attained. When pumping capacity is further increased, the gap may be widened, maintaining the equilibrium in vertical forces. In this hypothesis, $\mu = 1.0$ could be a physical boundary that will have prevented any further decline in the μ value in the western section during the test. It should be noted that, at larger distances from the dike, the Pleistocene hydraulic head decreased, causing an increase in μ . Close to the dike, μ is affected by the weight of the dike body.
