Geotechnical Observations of Dams Failed During the 2015 Historic Flooding in South Carolina

ABSTRACT: *This paper presents a description of post-flood reconnaissance and geotechnical investigation of four earthen dams that were breached or damaged following an extreme flooding event in South Carolina in 2015. As a result of unprecedented rainfall and flooding that occurred during a five-day period at the beginning of October in 2015, a total of 51 earthen dams failed and nearly 200 were damaged. Many of these dams failed due to overtopping that led to a breach of the dam. Among the four dams investigated, full breach was observed at three dams; two of which were overtopped, and one was not. The fourth dam was not breached but was severely damaged. For each of these dams, the paper documents background information, pre-flood conditions, post-flood field observations and measurements, and laboratory testing results of collected soil samples. Impacts of vegetation on the dams and the effects of dam failure on critical infrastructure are also presented. The detailed descriptions and geotechnical investigations of the dam failures presented herein serve as case histories that can be u

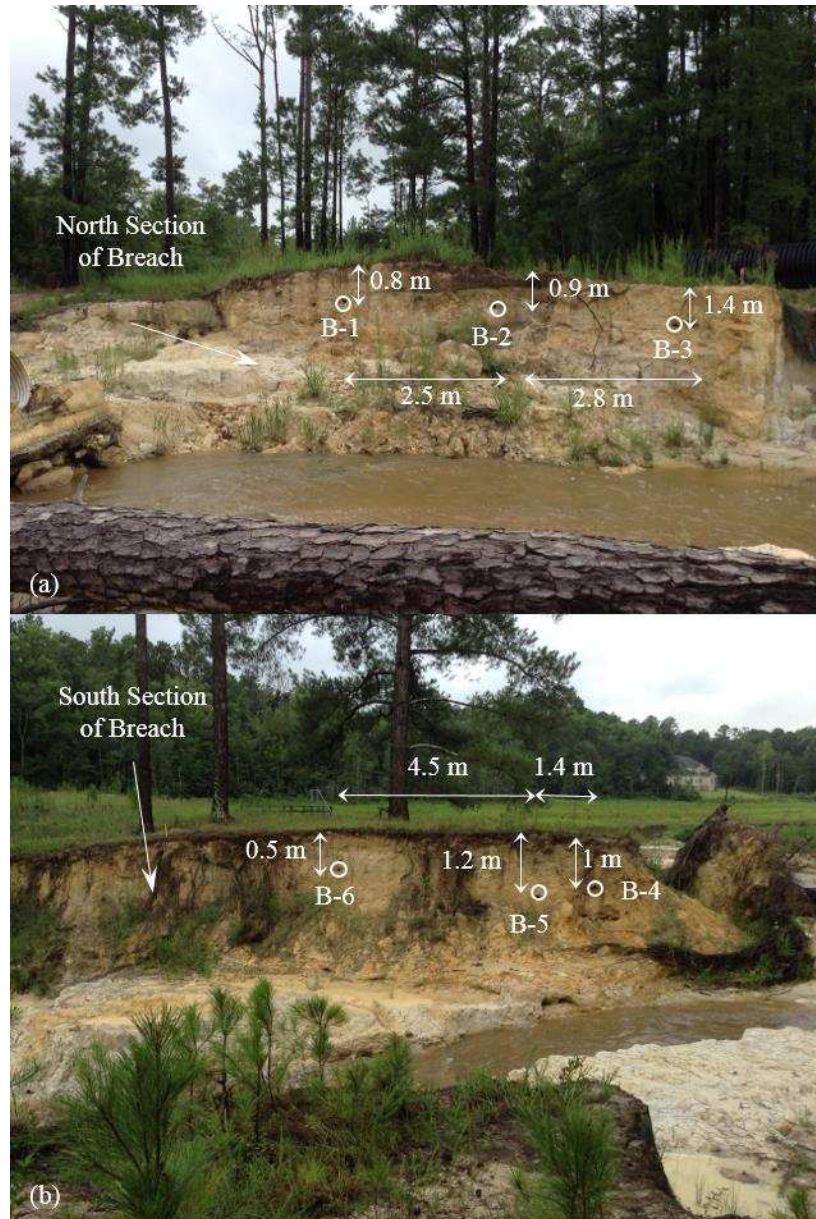
Laboratory testing results from soil samples collected at six locations from the breach section of Dam B are presented in Table 2. The sampling locations were selected to acquire soils representative of the full cross-section of the dam. Figure 17 shows the sampling locations viewed from the crest of the dam. The locations relative to the spillway, Congress Road, and the dam length, are also shown in Figure 12. Soils collected from the north and south sides of the breach are different. Samples B-1 and B-3 collected from the north side of the breach are classified as low to high plasticity clays and silts (MH and CH, and ML and CL, respectively), while the remaining soil samples were classified as silty or clayey sands (SM or SC). It is possible that because samples B-1 and B-3 were obtained from the north end of Dam B, there were natural materials scattered among the dam fill, or two different material types were used in the construction of the dam. In either case, there was no evidence of a dam core. Based on the results of samples taken closer to the middle section of the dam (B-4, B-5, and B-6), the dam material is mostly clayey sand with low plasticity fines. The fines content ranges from 15% to 49%. The erosion rate, based on the characteristics of the soils in this dam, is moderately rapid (Wan and Fell 2004). The presence of roots through the dam may result in significant increments of the erosion rate.

Figure 17. Sampling locations for Dam B, (a) north wall of breach section (north view from crest), and (b) south wall of breach section (south view from crest).
