# Geotechnical Observations of Dams Failed During the 2015 Historic Flooding in South Carolina

**ABSTRACT:** This paper presents a description of post-flood reconnaissance and geotechnical investigation of four earthen dams that were breached or damaged following an extreme flooding event in South Carolina in 2015. As a result of unprecedented rainfall and flooding that occurred during a five-day period at the beginning of October in 2015, a total of 51 earthen dams failed and nearly 200 were damaged. Many of these dams failed due to overtopping that led to a breach of the dam. Among the four dams investigated, full breach was observed at three dams; two of which were overtopped, and one was not. The fourth dam was not breached but was severely damaged. For each of these dams, the paper documents background information, pre-flood conditions, post-flood field observations and measurements, and laboratory testing results of collected soil samples. Impacts of vegetation on the dams and the effects of dam failure on critical infrastructure are also presented. The detailed descriptions and geotechnical investigations of the dam failures presented herein serve as case histories that can

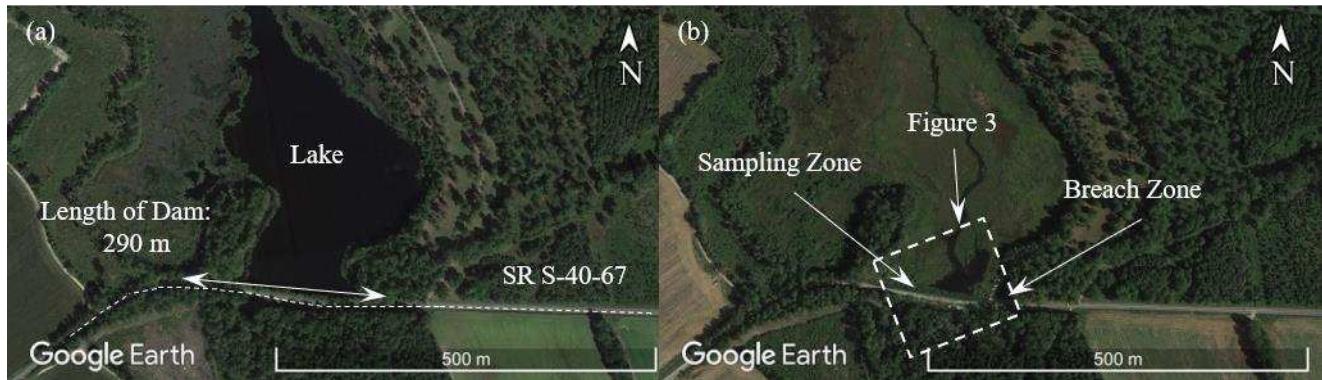
Dam A is located 28 km southeast from downtown Columbia, South Carolina. The dam was constructed around 1932 (USACE 2016). Satellite imagery of the dam before and after failure are shown in Figure 2. The crest width was measured to be 16 m, and the upstream side slope was measured to be 30°. The downstream side slope was completely washed out and could not be measured. According to USACE (2016), the height of the dam is 4 m, which is defined as the vertical distance from the lowest point on the crest to the lowest point in the original streambed. The original length of the dam is approximately 290 m. A two-lane roadway that is 16 m wide (including shoulders) runs along the crest of the dam. The dam impounds a lake with a surface area of about 0.06 km<sup>2</sup> under normal storage conditions (USACE 2016). The dam allows normal and maximum storage capacities of 178,000 m<sup>3</sup> and 400,000 m<sup>3</sup>, respectively. SCDHEC (2016) considers this dam to be a low-

Figure 2. Dam A (a) before and (b) after failure (Google Earth, accessed on April 8, 2018).

Damage to this dam includes a complete breach and a large zone of surface erosion separate from the breach, as shown in Figure 3. The breach is located near to the east end of the dam. The breach extended approximately 50 m of the total 290 m length of the dam, and nearly 7,300 m<sup>3</sup> of material, including soil and pavement, were washed out (see Figure 6). In the breach zone, several trees on the upstream side slope tipped over the road in the direction of water flow (see Figures 6 and 8), which provides some evidence of overtopping. In the surface erosion zone, the soil erosion along the downstream side slope extended over 60 m parallel to and 20 m perpendicular to the road, as shown in Figures 3, 5b and 7b. As shown in Figure 7a, part of the asphalt shoulder and roadway collapsed above the zone of surface erosion.

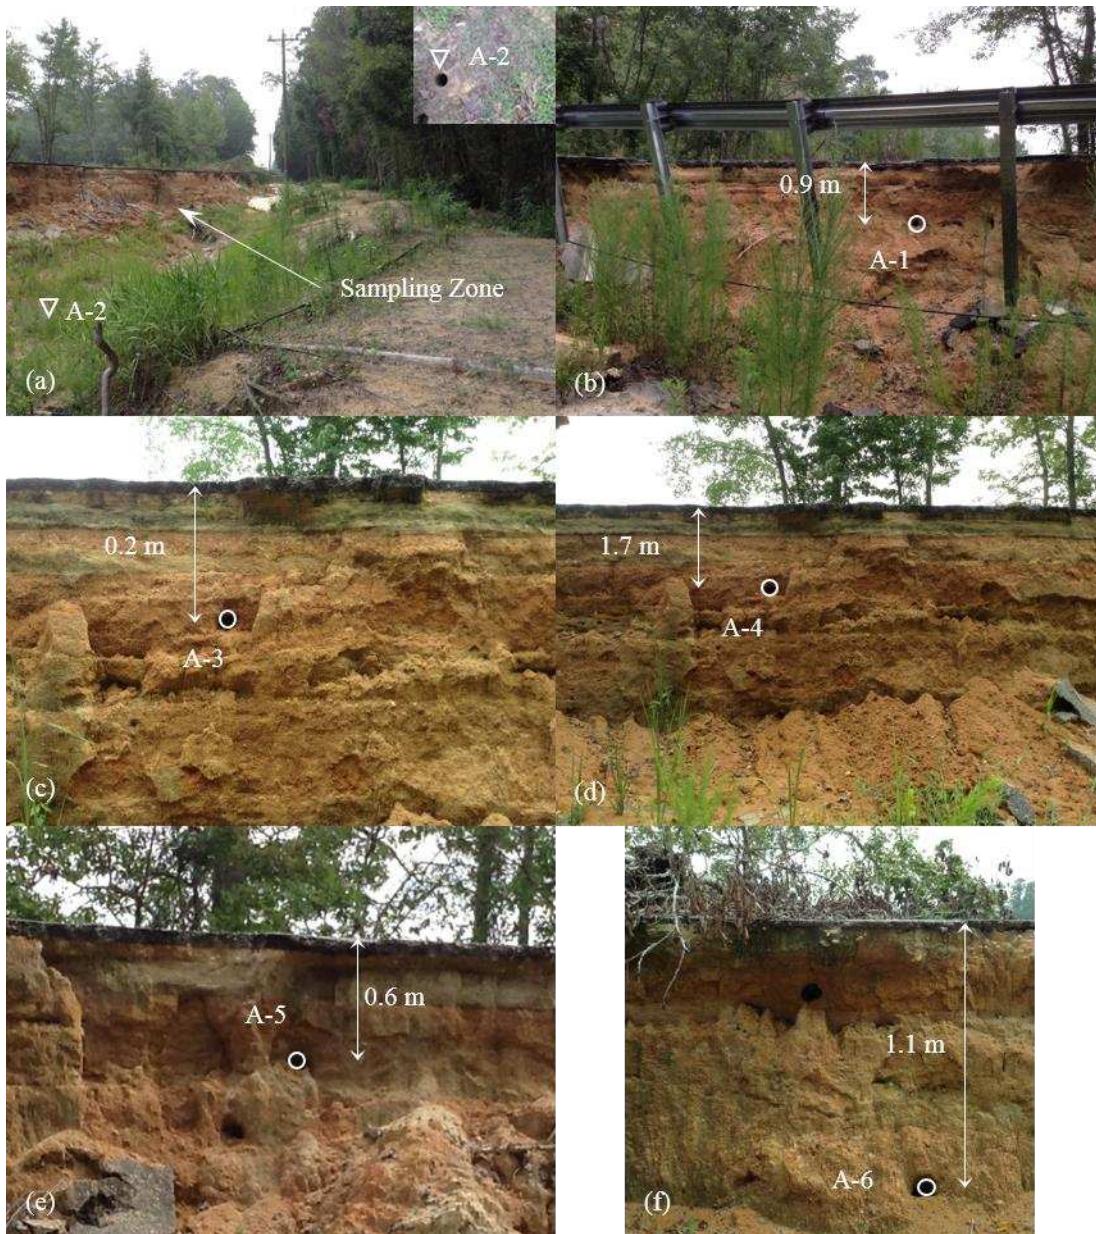
Laboratory testing results from soil samples collected at six locations from the downstream side slope of the dam are presented in Table 1. Approximately half of the road lane collapsed due to slope failure; therefore, the samples were collected relatively close to the center of the embankment. The samples were obtained in the area where surface erosion and slope failure occurred except for sample A-2, which was obtained from the foundation soil. The distance from the crest of the dam to the sample locations is presented in Figure 9, and the sampling depth for each hole is presented in Table 1. The distance of sampling locations relative to the breach zone are shown in Figure 3. The dam materials are mostly silty to clayey sands with 23% to 42% low plasticity fines. The foundation soil (A-2) at a depth of approximately 56-81 cm also appears to be silty sand. Based on these test results and the visual field observations of the soils along the length of the exposed embankment, the dam material appears to be relatively consistent (SM or SC) with no definable core. The coefficient of permeability is low to very low ( $10^{-4}$  to  $10^{-6}$  cm/s). Based on the soil characteristics in Dam A, internal erosion would occur moderately to extremely rapidly in the presence of cracks or hydraulic fractures (Wan and Fell 2004).

Figure 9. Sampling locations in Dam A: a) east view from downstream side, and b), c), d), e) and f) north view from downstream side (V: vertical sample, O: horizontal sample).

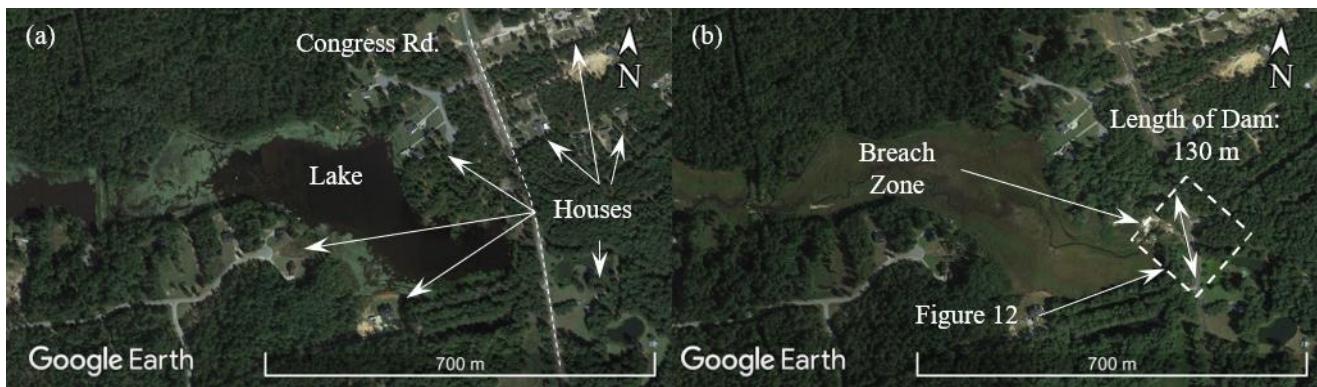
Dam B is located 27 km east of downtown Columbia, South Carolina. The dam was constructed in 1960 (USACE 2016). Satellite imagery of the dam before and after failure are shown in Figure 10. The crest width of the dam was measured to be 6 m and the upstream side slope was measured to be  $23^\circ$ . The downstream side-slope was not measured due to slope failure caused by surface erosion. According to USACE (2016), the height of the dam is 4.3 m, and the original length of the dam is approximately 130 m. The dam impounds a lake with surface area of  $0.08 \text{ km}^2$  under normal storage conditions. The normal and maximum storage capacities are 89,000 and 166,000  $\text{m}^3$ , respectively. SCDHEC (2016) considers this dam to be a significant-hazard potential structure (C2). Several houses are located on the upstream and downstream sides of the dam (see Figure 10a). The dam is located west of Congress Road, a two-lane road located 40 m downstream of the dam. Pictures of the breached section of the dam, looking toward Congress Road are shown in Figure 11. The dam breach washed out both lanes of Congress Road and damaged the bridge supporting the road, as shown in Figures 12 and 13.

Figure 10. Dam B (a) before and (b) after failure (Google Earth, accessed on April 8, 2018).

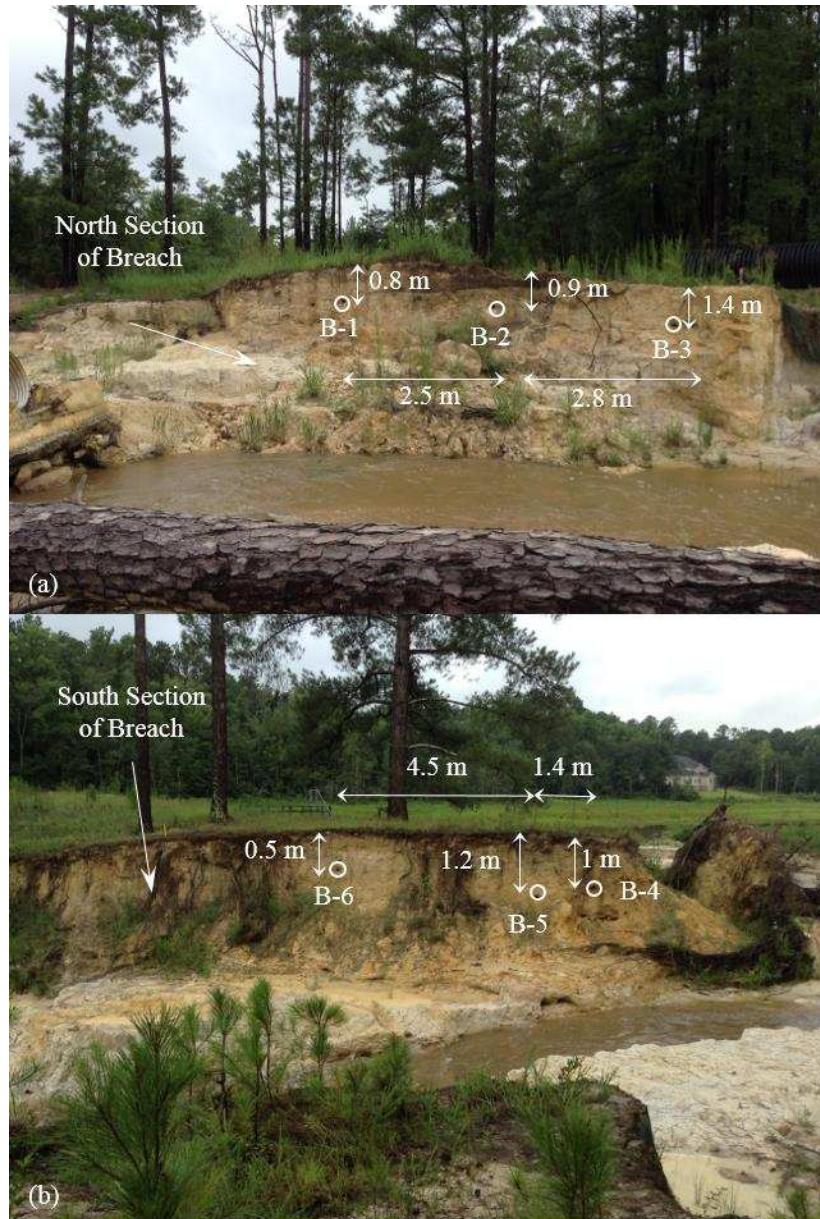
Laboratory testing results from soil samples collected at six locations from the breach section of Dam B are presented in Table 2. The sampling locations were selected to acquire soils representative of the full cross-section of the dam. Figure 17 shows the sampling locations viewed from the crest of the dam. The locations relative to the spillway, Congress Road, and the dam length, are also shown in Figure 12. Soils collected from the north and south sides of the breach are different. Samples B-1 and B-3 collected from the north side of the breach are classified as low to high plasticity clays and silts (MH and CH, and ML and CL, respectively), while the remaining soil samples were classified as silty or clayey sands (SM or SC). It is possible that because samples B-1 and B-3 were obtained from the north end of Dam B, there were natural materials scattered among the dam fill, or two different material types were used in the construction of the dam. In either case, there was no evidence of a dam core. Based on the results of samples taken closer to the middle section of the dam (B-4, B-5, and B-6), the dam material is mostly clayey sand with low plasticity fines. The fines content ranges from 15% to 49 %. The erosion rate, based on the characteristics of the soils in this dam, is moderately rapid (Wan and Fell 2004). The presence of roots through the dam may result in significant increments of the erosion rate.

Figure 17. Sampling locations for Dam B, (a) north wall of breach section (north view from crest), and (b) south wall of breach section (south view from crest).

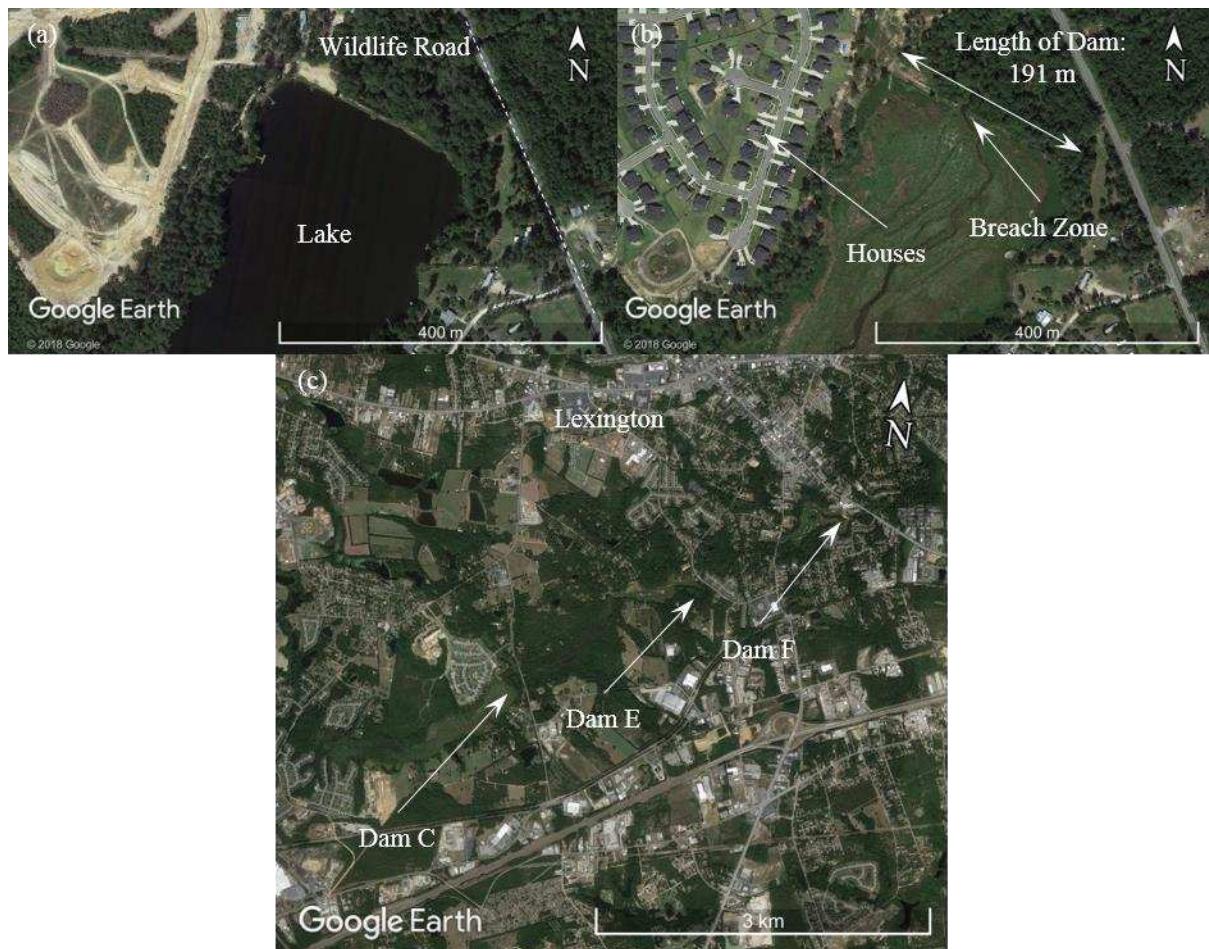
Dam C is located 21 km west from downtown Columbia, South Carolina. The dam was constructed in 1900 and is one of the oldest dams in South Carolina (USACE 2016). Satellite imagery of the dam, before and after the flood event, are shown in Figures 18a and 18b. The dam was built across a creek, nearly 4 km upstream of two pond dams (labeled Dam E and Dam F in Figure 18c). The crest width of the dam was measured to be 4 m and the upstream and downstream side slopes were measured to be  $32^\circ$  and  $35^\circ$ , respectively. According to USACE (2016), the height of the dam is 4 m, and the original length of the dam is approximately 191 m. The dam is located nearly 130 m southwest from a two-lane state road (labeled Wildlife Road in Figure 18), and close to a new subdivision located to the west of the dam. Dam C impounds a lake with an approximate surface area of  $0.26 \text{ km}^2$  under normal storage conditions, allowing a storage of approximately  $443,000 \text{ m}^3$ . SCDHEC (2016) considers this dam to be a significant-hazard potential structure (C2). Fortunately, the breach did not cause significant damage to Wildlife Road or the houses nearby.

Figure 18. Dam C (a) before and (b) after failure, (c) locations of Dams E and F downstream of Dam C (Google Earth, accessed on April 8, 2018).

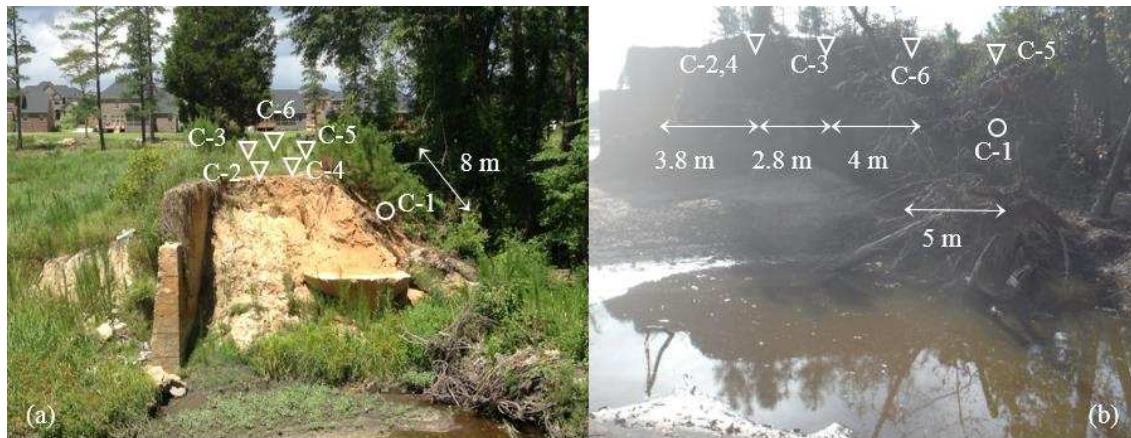
Laboratory testing results from soil samples collected at six locations from the crest and downstream side slope of Dam C are presented in Table 3. The sampling locations are presented in Figures 19 and 24. Dam fill materials are mainly clayey to silty sands with approximately 27% to 53% low plasticity fines. Based on the experimental results and field observations of the cross-section of the breach (see Figure 21), the dam fill materials are relatively consistent and a definable core was not observed. The erosion rate, based on the characteristics of the soils in this dam, is moderately to extremely rapid (Wan and Fell 2004).

Figure 24. Sampling locations for Dam C: a) northwest view from southeast section of breach, and b) southwest view from downstream (V: vertical sample, O: horizontal sample).

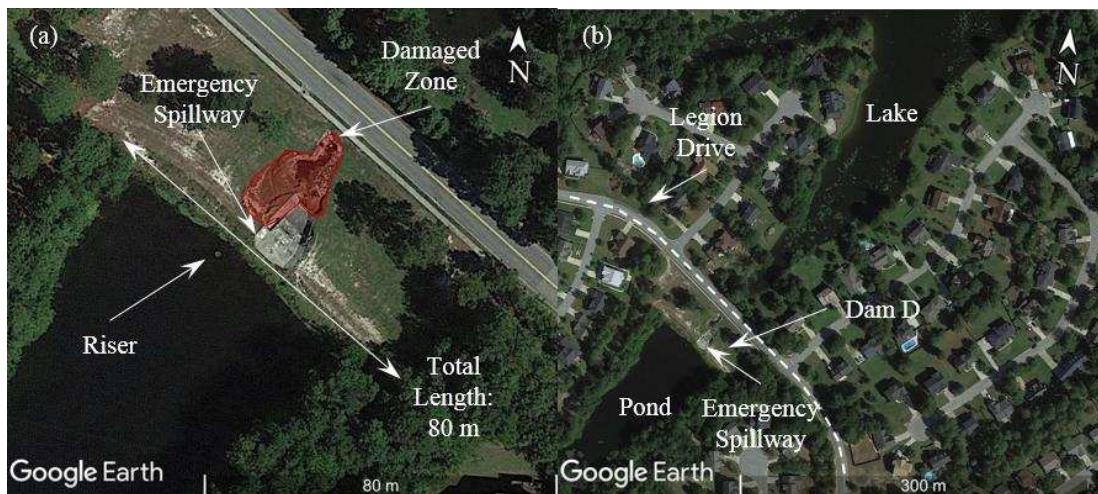
Dam D is located 22 km northeast from downtown Columbia, South Carolina. The dam is not regulated by SCDHEC and the year of construction is unknown. However, based on information provided by the owners, it is assumed to be at least 25 years old. The dam was constructed before the development of a nearby subdivision and has been used to maintain a recreational pond for neighboring communities. Satellite imagery of the dam is shown in Figure 25. Figure 26 presents photographs of the downstream side slope of the dam before and after the flood event. Sloughing in the downstream side-slope occurred before the flood event, as observed in Figure 26a, suggesting saturation of the soil near surface as a result of internal seepage. The crest width was measured to be 4 m, the height of the dam was measured to be 3.7 m, and the upstream and downstream side slopes were measured to be  $26^\circ$  and  $23^\circ$ , respectively. The length of the dam was measured to be 80 m. A two-lane road (labeled Legion Drive in Figure 25b) is located nearly 40 m east and runs parallel to the length of the dam. Many houses are located both upstream and downstream of the dam. Dam D is considered to be a small dam because it impounds a pond with an estimated surface area of  $6,900 \text{ m}^2$  and an estimated storage of nearly  $8,000 \text{ m}^3$  (ICOLD 2011). These values were estimated from satellite imagery via Google Earth (accessed on September 14, 2016) and information provided by the dam owners. As shown in Figure 25b, water is conducted from the impoundment towards a larger lake located downstream. Dam D was not breached during the 2015 flood event, but was severely damaged. No repairs have been made to date, and based on communication with the dam owners, it is likely that the dam will be removed due to high repair cost.

Figure 25. Aerial views of Dam D: a) geometry, draining structures, and damaged zone, and b) location relative to surrounding community (Google Earth, accessed on April 8, 2018).

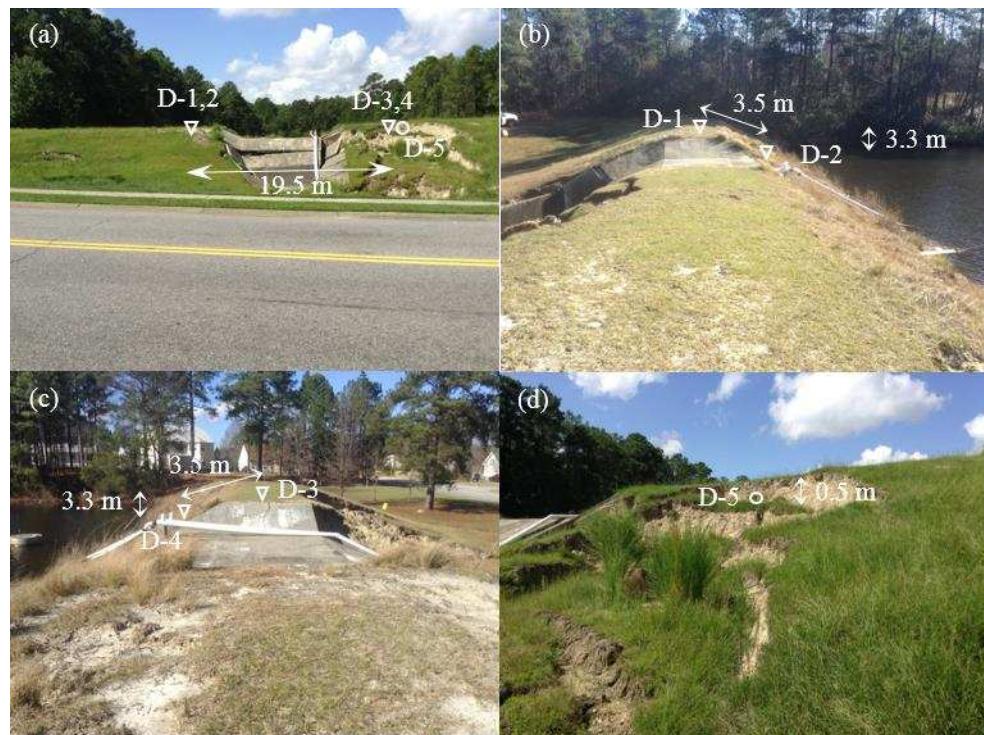
zone adjacent to the emergency spillway. Even though sample location D-5 is expected to be closer to the core of the dam (see Figure 31), pre-failure information provided by the dam owner indicates that Dam D does not have a definable core. In fact, the dam fill materials were consistent across all five sampling locations (primarily silty sands, SM, with little to no plasticity). Test results show that these soils have low to very low permeability ( $10^{-4}$  to  $10^{-6}$  cm/s). The erosion rate, based on the characteristics of the soils in this dam, is extremely rapid (Wan and Fell 2004).

Figure 31. Sampling locations in Dam D: a) southwest view from Legion Drive, b) southeast view from the crest, c) northwest view from the crest, and d) southwest view from downstream side slope near the sliding zone ( $\nabla$ : vertical sample,  $\bullet$ : horizontal sample).
