Geotechnical Effects of Hurricane Harvey in the Houston, Beaumont, and Port Arthur Areas

ABSTRACT: The Geotechnical Extreme Events Reconnaissance (GEER) Association deployed multiple teams of engineers from academia and practicing firms to the coast of Texas in late August and early September 2017 following Hurricane Harvey. This report summarizes the observations and data from the GEER team that focused primarily on the inland effects of Hurricane Harvey in the Houston area with some observations in the Port Arthur / Beaumont area east of Houston. Rain, not storm surge or wind, caused the observed damage in Houston, Beaumont, and Port Arthur by overwhelming stormwater management facilities and creating high flows and flooding in and near area waterways. The major Houston-area flood structures, Addicks and Barker Dams, performed well from a geotechnical perspective. Observed damages included shallow slides along levees, severe erosion along riverways, isolated road and culvert erosion and uplift, and area-wide flood effects in low and poorly drained neighborhoods.

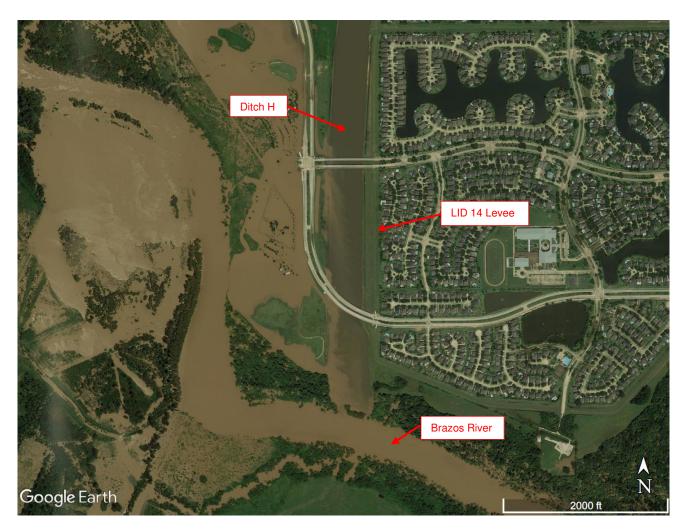
The team made observations of slope slides at two large drainage ditches in Fort Bend County: Ditch H and the Flat Bank Diversion Channel. The ditches serve as channels for drainage from and across the LIDs. Ditch H extends due north from the Brazos River, past LIDs 14, 2, and 17, and connects to the Bullhead Bayou and the Oyster Creek watershed in Sugar Land. Flat Bank Diversion Channel runs between Sienna Plantation LID North and LID 19 to connect Oyster Creek to Steep Bank Creek, which then connects to the Brazos River. Fig. 13 shows the locations of both ditches, and Fig. 17 shows a Google Earth aerial of Ditch H during the Harvey flooding.

Figure 17. A Google Earth image of LID # 14 and Ditch H and its connection to the Brazos River (August 30, 2017).
