Geotechnical Effects of Hurricane Harvey in the Houston, Beaumont, and Port Arthur Areas

ABSTRACT: *The Geotechnical Extreme Events Reconnaissance (GEER) Association deployed multiple teams of engineers from academia and practicing firms to the coast of Texas in late August and early September 2017 following Hurricane Harvey. This report summarizes the observations and data from the GEER team that focused primarily on the inland effects of Hurricane Harvey in the Houston area with some observations in the Port Arthur / Beaumont area east of Houston. Rain, not storm surge or wind, caused the observed damage in Houston, Beaumont, and Port Arthur by overwhelming stormwater management facilities and creating high flows and flooding in and near area waterways. The major Houston-area flood structures, Addicks and Barker Dams, performed well from a geotechnical perspective. Observed damages included shallow slides along levees, severe erosion along riverways, isolated road and culvert erosion and uplift, and area-wide flood effects in low and poorly drained neighborhoods.*

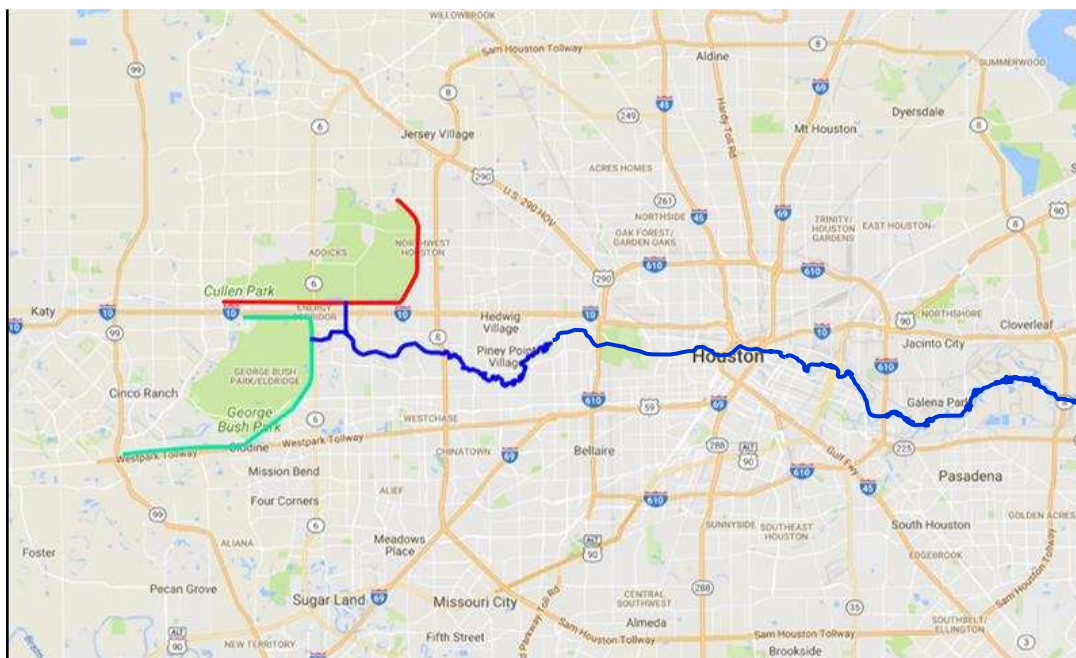
Figure 4. Addicks (red) and Barker (green) Dams and their feed into the Buffalo Bayou (blue) (Google Maps).

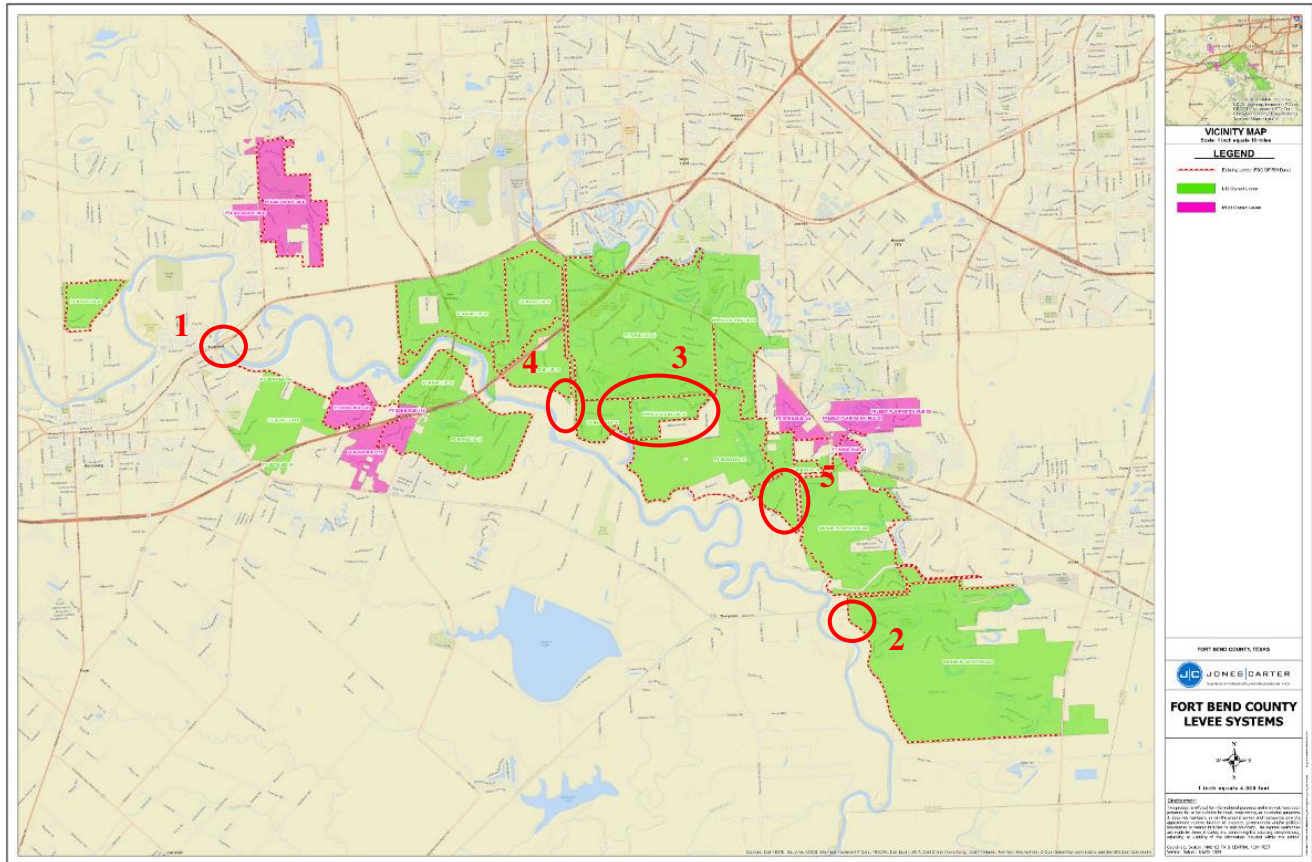
Figure 13. Fort Bend County Levee Systems. See following list for names of labelled systems. Existing levees are shown as red-dashed lines, LIDs in green, and MUDs in purple (from Jones|Carter), 1 – Richmond, Texas, USGS gauge on the Brazos River, 2 – Sienna Plantation Levee Improvement District levee surficial slough, 3 – First Colony LID 2, 4 – Ditch H, 5 – Flat Bank Diversion Channel

During the Hurricane Harvey flooding, the USGS stream gauge for the Brazos River at Richmond, Texas, (see Location 1 on Fig. 13) recorded a peak reading of 16.8 m (55.19 ft) corresponding to about 3,540 m³/s (125,000 cfs). The gauge also recorded a total of 64 cm (25 inches) of rain between August 25 and August 29, 2017. The previous high-water record at the gauge was 16.7 m (54.74 ft) on June 2, 2016 during the Memorial Day Flood.

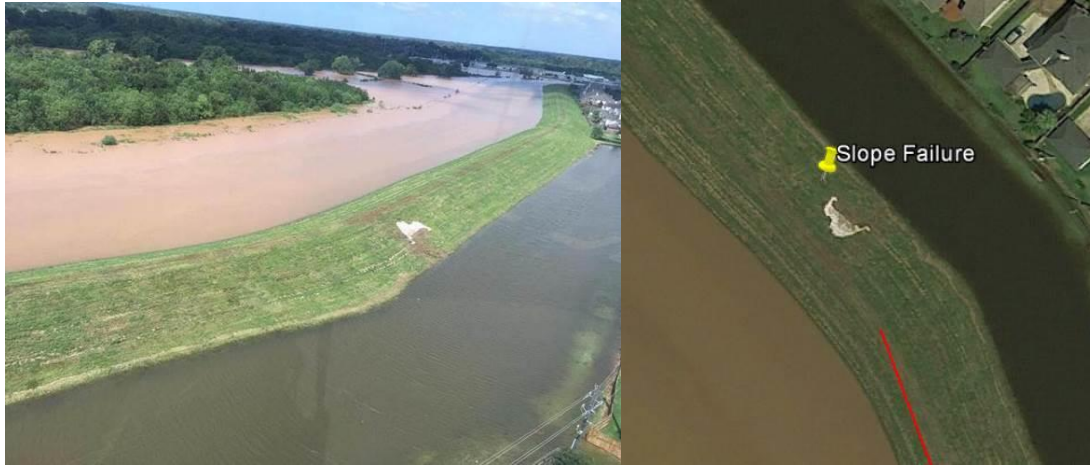
Overall, we understand that the Brazos River LID levees performed well, with no major failures, breaches, or overtopping. One incident of a surficial slide on the protected slope of a Sienna Plantation LID levee was reported and photographed by others as shown in Fig. 14 (see Location 2 on Fig. 13). The GEER team visited the First Colony LID 2 (see Location 3 on Fig. 13) and two of the drainage ditches that serve the LIDs (see Locations 4 and 5 on Fig. 13). Despite the good levee performance, flooding occurred within several LIDs due to the issues with storm water removal from the protected side behind the levees to the river side. Some LIDs were even completely cut off due to water surrounding the entirety of the LID.

Figure 14. Aerial photo (right) and Google Earth (left), August 30, 2017, 29.491844° N, 95.541017° W.

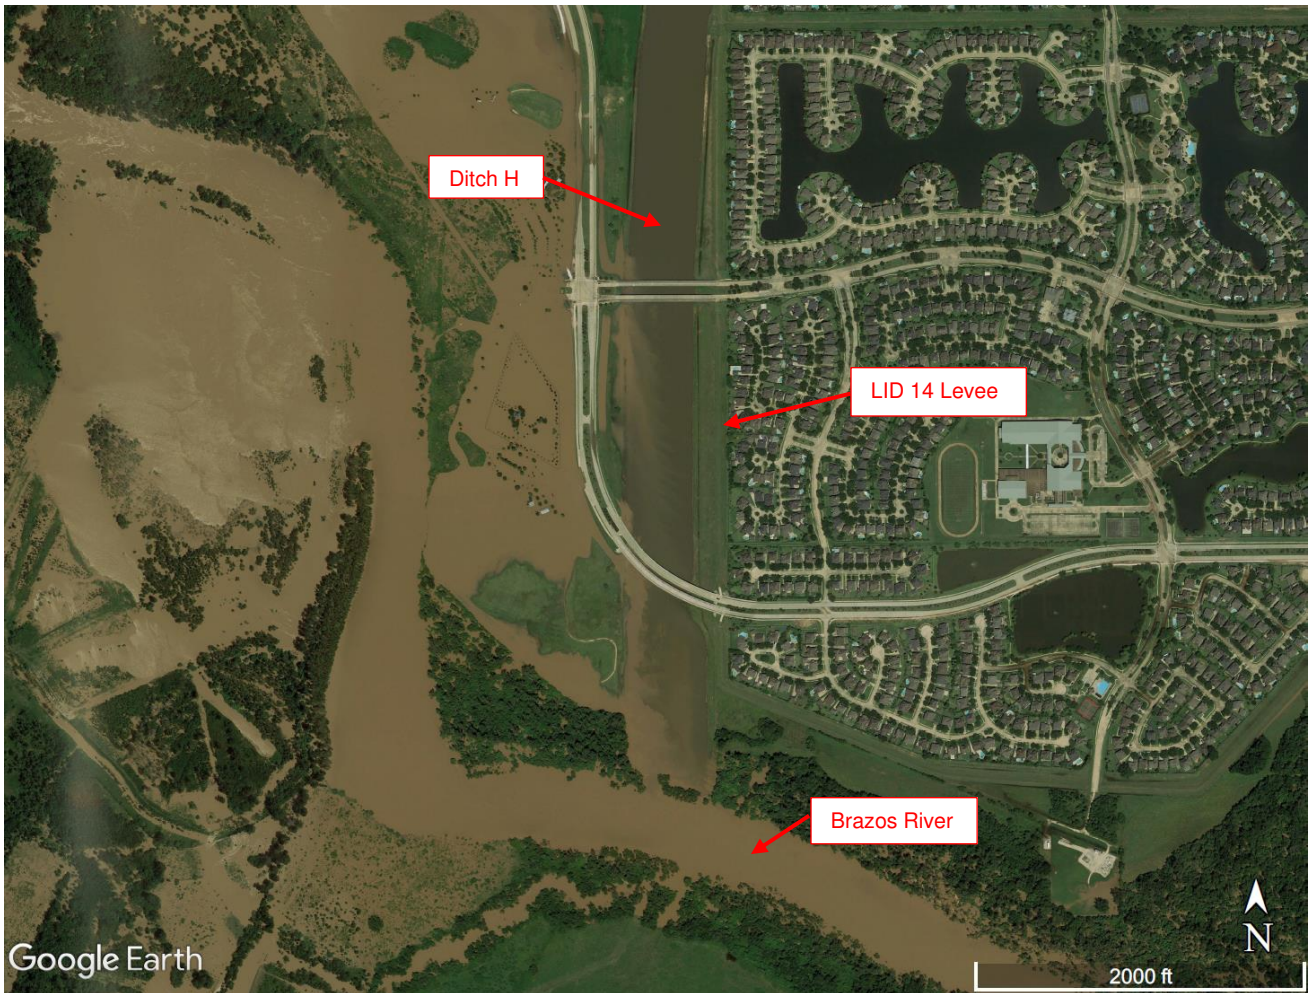
The team made observations of slope slides at two large drainage ditches in Fort Bend County: Ditch H and the Flat Bank Diversion Channel. The ditches serve as channels for drainage from and across the LIDs. Ditch H extends due north from the Brazos River, past LIDs 14, 2, and 17, and connects to the Bullhead Bayou and the Oyster Creek watershed in Sugar Land. Flat Bank Diversion Channel runs between Sienna Plantation LID North and LID 19 to connect Oyster Creek to Steep Bank Creek, which then connects to the Brazos River. Fig. 13 shows the locations of both ditches, and Fig. 17 shows a Google Earth aerial of Ditch H during the Harvey flooding.

Figure 17. A Google Earth image of LID # 14 and Ditch H and its connection to the Brazos River (August 30, 2017).
