## Geotechnical Effects of Hurricane Harvey in the Houston, Beaumont, and Port Arthur Areas

**ABSTRACT:** *The Geotechnical Extreme Events Reconnaissance (GEER) Association deployed multiple teams of engineers from academia and practicing firms to the coast of Texas in late August and early September 2017 following Hurricane Harvey. This report summarizes the observations and data from the GEER team that focused primarily on the inland effects of Hurricane Harvey in the Houston area with some observations in the Port Arthur / Beaumont area east of Houston. Rain, not storm surge or wind, caused the observed damage in Houston, Beaumont, and Port Arthur by overwhelming stormwater management facilities and creating high flows and flooding in and near area waterways. The major Houston-area flood structures, Addicks and Barker Dams, performed well from a geotechnical perspective. Observed damages included shallow slides along levees, severe erosion along riverways, isolated road and culvert erosion and uplift, and area-wide flood effects in low and poorly drained neighborhoods.*

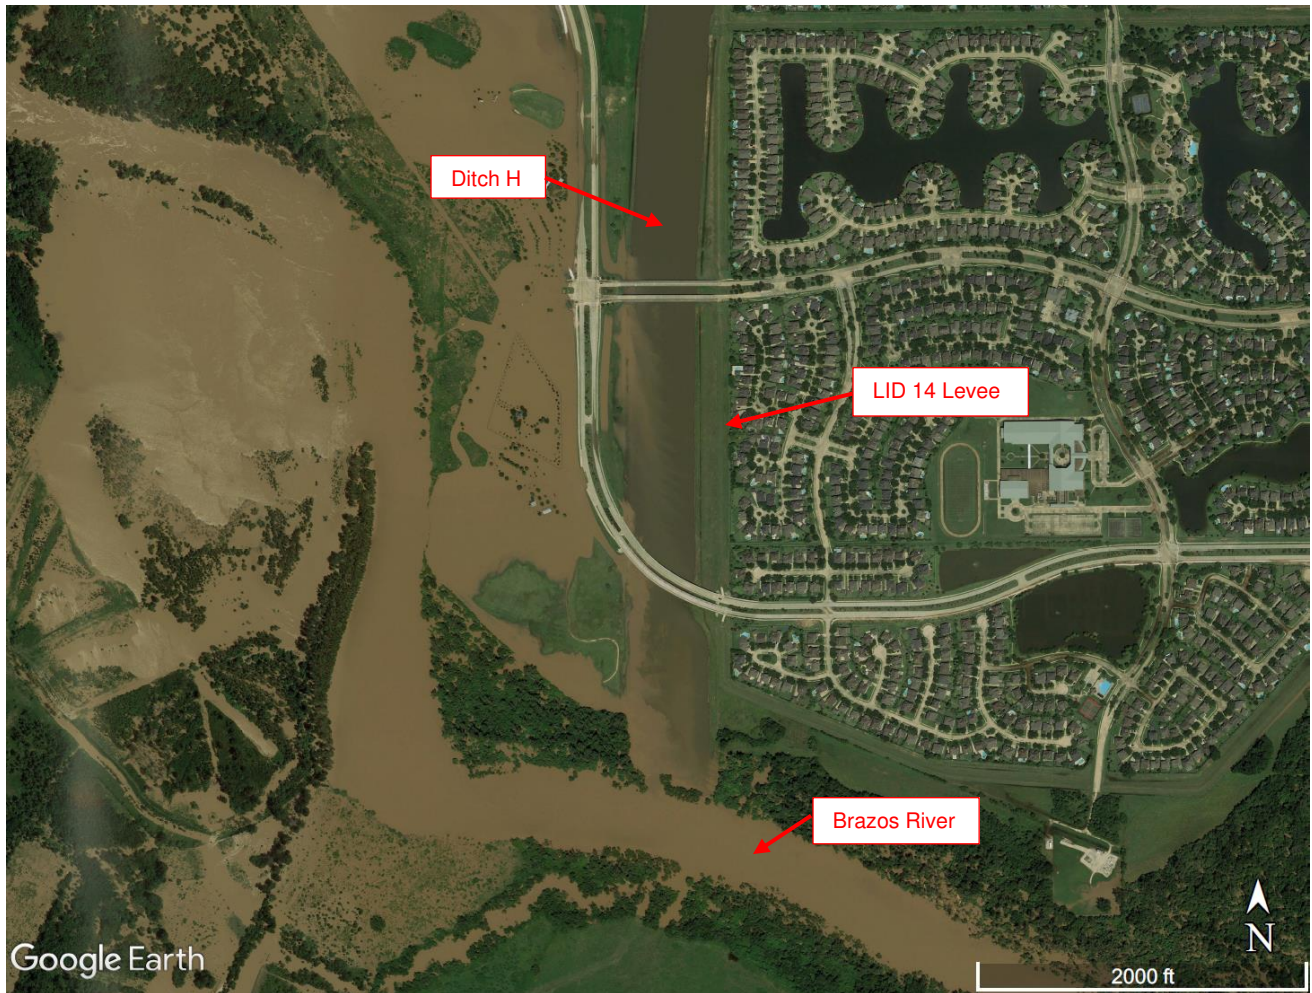
The team made observations of slope slides at two large drainage ditches in Fort Bend County: Ditch H and the Flat Bank Diversion Channel. The ditches serve as channels for drainage from and across the LIDs. Ditch H extends due north from the Brazos River, past LIDs 14, 2, and 17, and connects to the Bullhead Bayou and the Oyster Creek watershed in Sugar Land. Flat Bank Diversion Channel runs between Sienna Plantation LID North and LID 19 to connect Oyster Creek to Steep Bank Creek, which then connects to the Brazos River. Fig. 13 shows the locations of both ditches, and Fig. 17 shows a Google Earth aerial of Ditch H during the Harvey flooding.

Figure 17. A Google Earth image of LID # 14 and Ditch H and its connection to the Brazos River (August 30, 2017).
