Geotechnical Effects of Hurricane Harvey in the Houston, Beaumont, and Port Arthur Areas

ABSTRACT: *The Geotechnical Extreme Events Reconnaissance (GEER) Association deployed multiple teams of engineers from academia and practicing firms to the coast of Texas in late August and early September 2017 following Hurricane Harvey. This report summarizes the observations and data from the GEER team that focused primarily on the inland effects of Hurricane Harvey in the Houston area with some observations in the Port Arthur / Beaumont area east of Houston. Rain, not storm surge or wind, caused the observed damage in Houston, Beaumont, and Port Arthur by overwhelming stormwater management facilities and creating high flows and flooding in and near area waterways. The major Houston-area flood structures, Addicks and Barker Dams, performed well from a geotechnical perspective. Observed damages included shallow slides along levees, severe erosion along riverways, isolated road and culvert erosion and uplift, and area-wide flood effects in low and poorly drained neighborhoods.*

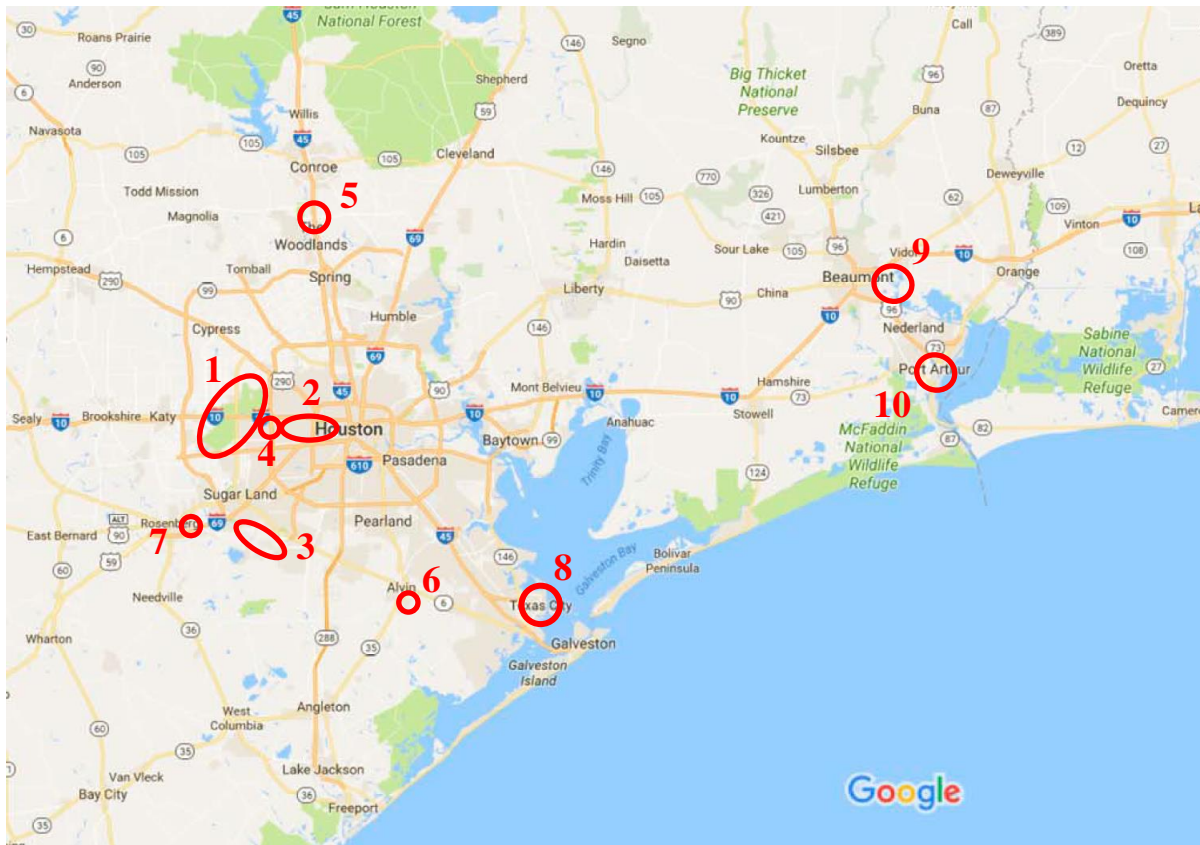
Figure 1. Observation Areas by GEER Hurricane Harvey Houston Team (see following list for site names). 1 – USACE Houston Flood Risk Management Dams – Barker and Addicks Dams, 2 – Buffalo Bayou, 3 – Brazos River Levees, 4 – Beltway 8 Underpass Slab, 5 – San Jacinto River Bridges, 6 – Mustang Bayou Bridge, 7 – FM 762 Road Culvert, 8 – Texas City Levees, 9 – Beaumont, 10 – Port Arthur

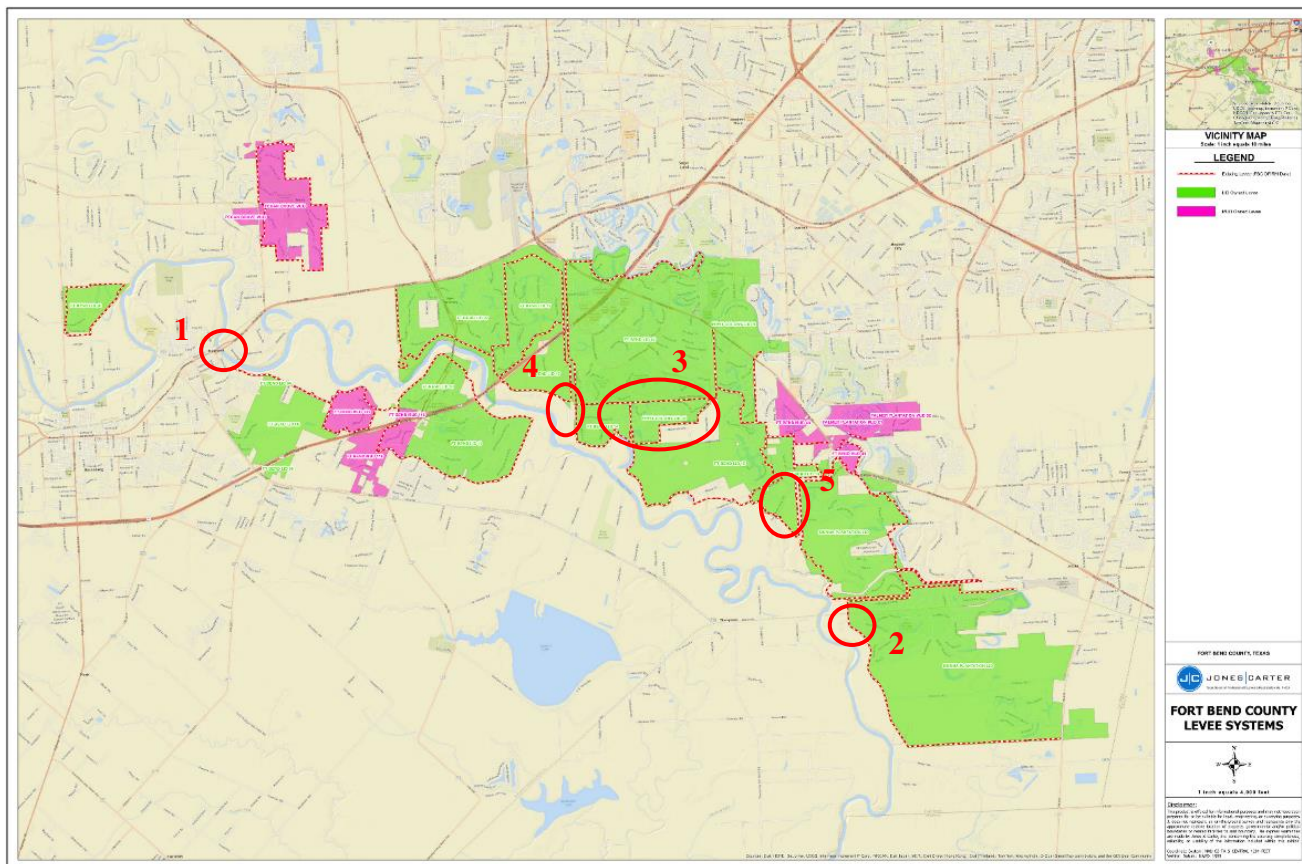
Figure 13. Fort Bend County Levee Systems. See following list for names of labelled systems. Existing levees are shown as red-dashed lines, LIDs in green, and MUDs in purple (from Jones|Carter), 1 – Richmond, Texas, USGS gauge on the Brazos River, 2 – Sienna Plantation Levee Improvement District levee surficial slough, 3 – First Colony LID 2, 4 – Ditch H, 5 – Flat Bank Diversion Channel

During the Hurricane Harvey flooding, the USGS stream gauge for the Brazos River at Richmond, Texas, (see Location 1 on Fig. 13) recorded a peak reading of 16.8 m (55.19 ft) corresponding to about 3,540 m³/s (125,000 cfs). The gauge also recorded a total of 64 cm (25 inches) of rain between August 25 and August 29, 2017. The previous high-water record at the gauge was 16.7 m (54.74 ft) on June 2, 2016 during the Memorial Day Flood.

Overall, we understand that the Brazos River LID levees performed well, with no major failures, breaches, or overtopping. One incident of a surficial slide on the protected slope of a Sienna Plantation LID levee was reported and photographed by others as shown in Fig. 14 (see Location 2 on Fig. 13). The GEER team visited the First Colony LID 2 (see Location 3 on Fig. 13) and two of the drainage ditches that serve the LIDs (see Locations 4 and 5 on Fig. 13). Despite the good levee performance, flooding occurred within several LIDs due to the issues with storm water removal from the protected side behind the levees to the river side. Some LIDs were even completely cut off due to water surrounding the entirety of the LID.

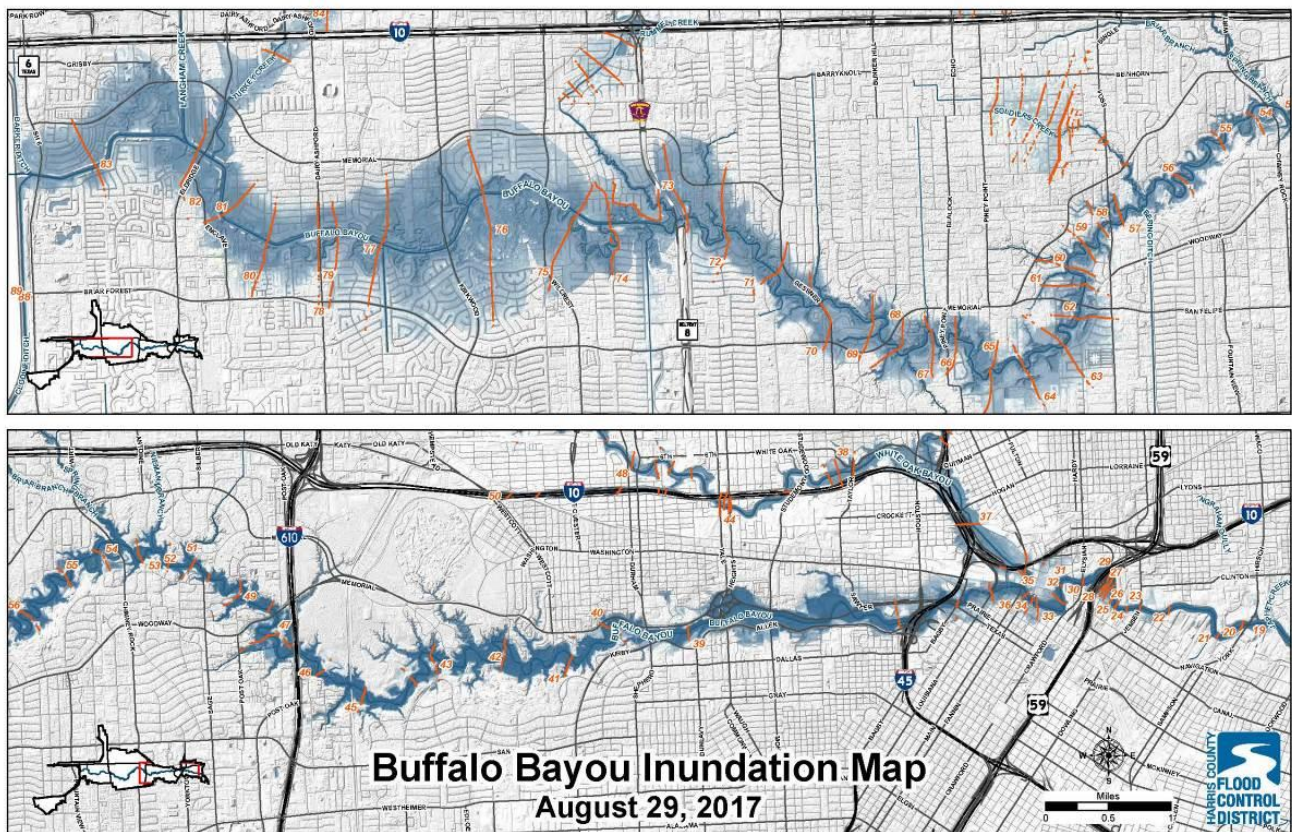
Figure 23. Buffalo Bayou inundation map (courtesy of Harris County Flood District).

Upon arrival of the GEER team at sites along Buffalo Bayou on September 9, 2017, the observed flows in the bayou were about $210 \text{ m}^3/\text{s}$ (7,300 cfs) at the USGS Addicks gauge. Flooding of residential areas had been largely reduced by September 9, though much of the former parks and trails along the bayou were still inundated with water. Signs of the previous flooding could be seen with river debris noted on bridge girder and railings (see Fig. 24). No critical geotechnical failures were noted along the observed portions of Buffalo Bayou, but scour areas and a slope failure were observed (see Figs. 25 and 26).
