Geotechnical Effects of Hurricane Harvey in the Houston, Beaumont, and Port Arthur Areas

ABSTRACT: The Geotechnical Extreme Events Reconnaissance (GEER) Association deployed multiple teams of engineers from academia and practicing firms to the coast of Texas in late August and early September 2017 following Hurricane Harvey. This report summarizes the observations and data from the GEER team that focused primarily on the inland effects of Hurricane Harvey in the Houston area with some observations in the Port Arthur / Beaumont area east of Houston. Rain, not storm surge or wind, caused the observed damage in Houston, Beaumont, and Port Arthur by overwhelming stormwater management facilities and creating high flows and flooding in and near area waterways. The major Houston-area flood structures, Addicks and Barker Dams, performed well from a geotechnical perspective. Observed damages included shallow slides along levees, severe erosion along riverways, isolated road and culvert erosion and uplift, and area-wide flood effects in low and poorly drained neighborhoods.

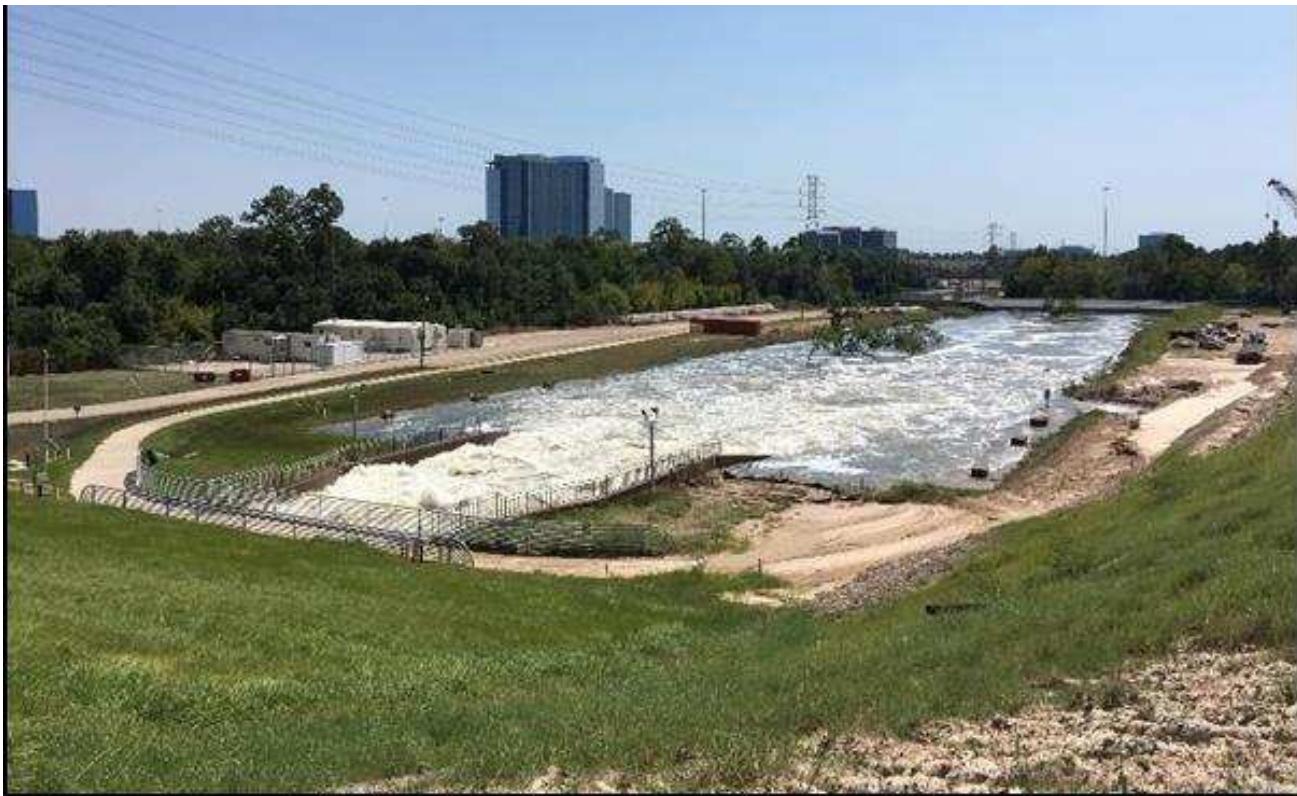
Figure 5. Addicks outlet releasing $\sim 170 \text{ m}^3/\text{s}$ ($\sim 6000 \text{ cfs}$) (September 9, 2017, 29.79026°N , 95.62378°W).

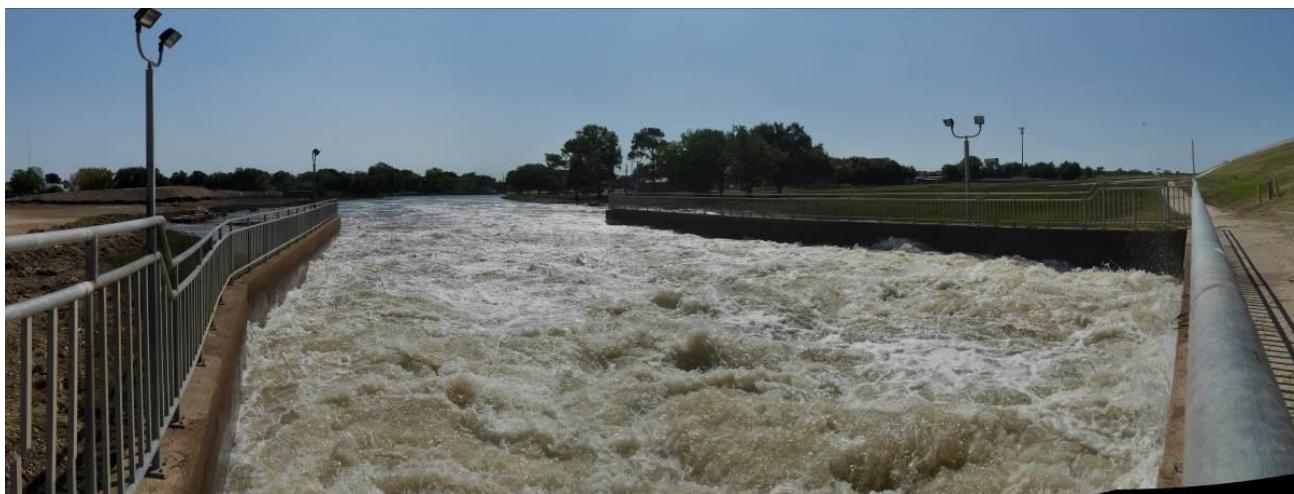
Figure 6. Barker outlet releasing $\sim 110 \text{ m}^3/\text{s}$ ($\sim 4000 \text{ cfs}$) (September 9, 2017, 29.76977°N , 95.64629°W).

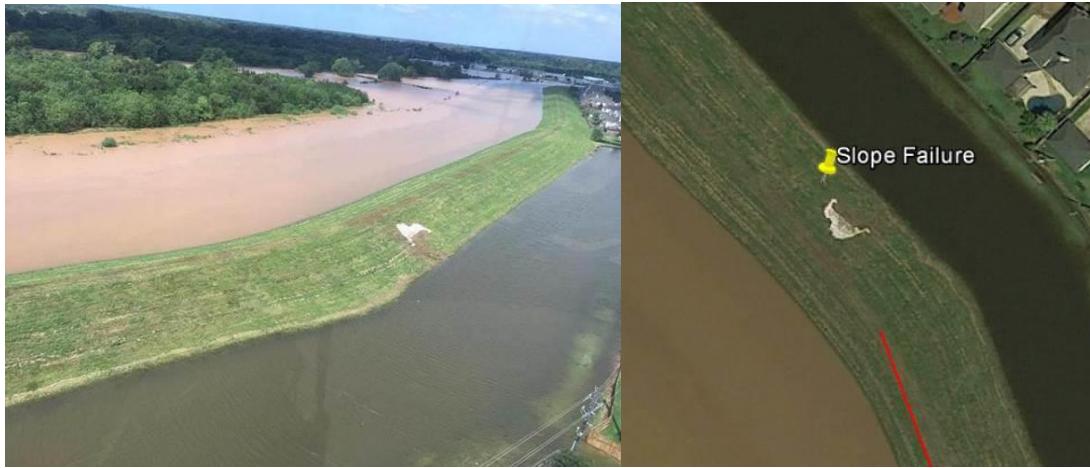
Overall, we understand that the Brazos River LID levees performed well, with no major failures, breaches, or overtopping. One incident of a surficial slide on the protected slope of a Sienna Plantation LID levee was reported and photographed by others as shown in Fig. 14 (see Location 2 on Fig. 13). The GEER team visited the First Colony LID 2 (see Location 3 on Fig. 13) and two of the drainage ditches that serve the LIDs (see Locations 4 and 5 on Fig. 13). Despite the good levee performance, flooding occurred within several LIDs due to the issues with storm water removal from the protected side behind the levees to the river side. Some LIDs were even completely cut off due to water surrounding the entirety of the LID.

Figure 14. Aerial photo (right) and Google Earth (left), August 30, 2017, 29.491844° N, 95.541017° W.

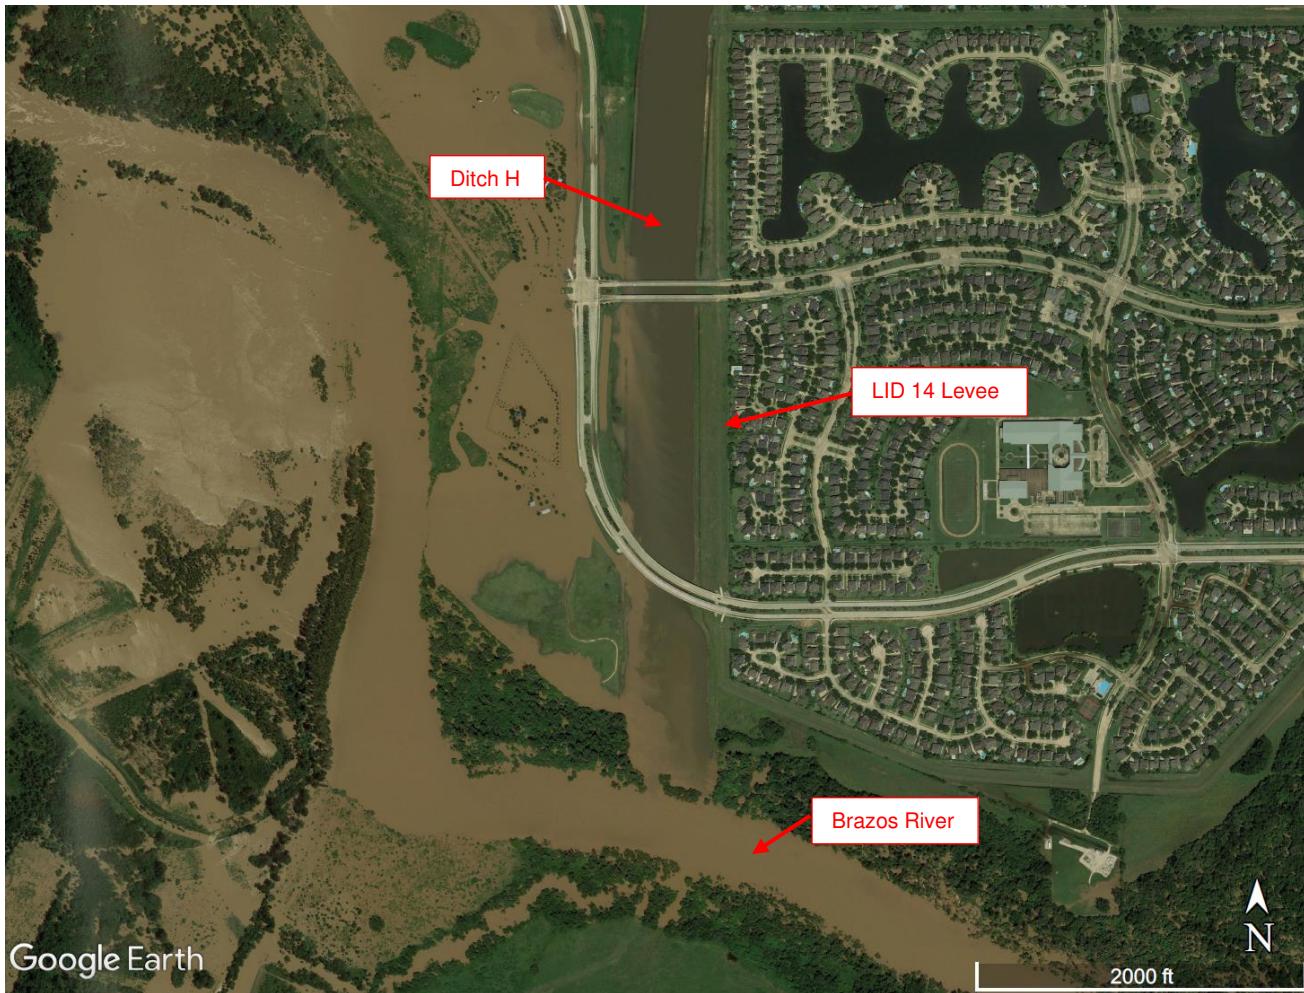
The team made observations of slope slides at two large drainage ditches in Fort Bend County: Ditch H and the Flat Bank Diversion Channel. The ditches serve as channels for drainage from and across the LIDs. Ditch H extends due north from the Brazos River, past LIDs 14, 2, and 17, and connects to the Bullhead Bayou and the Oyster Creek watershed in Sugar Land. Flat Bank Diversion Channel runs between Sienna Plantation LID North and LID 19 to connect Oyster Creek to Steep Bank Creek, which then connects to the Brazos River. Fig. 13 shows the locations of both ditches, and Fig. 17 shows a Google Earth aerial of Ditch H during the Harvey flooding.

Figure 17. A Google Earth image of LID # 14 and Ditch H and its connection to the Brazos River (August 30, 2017).

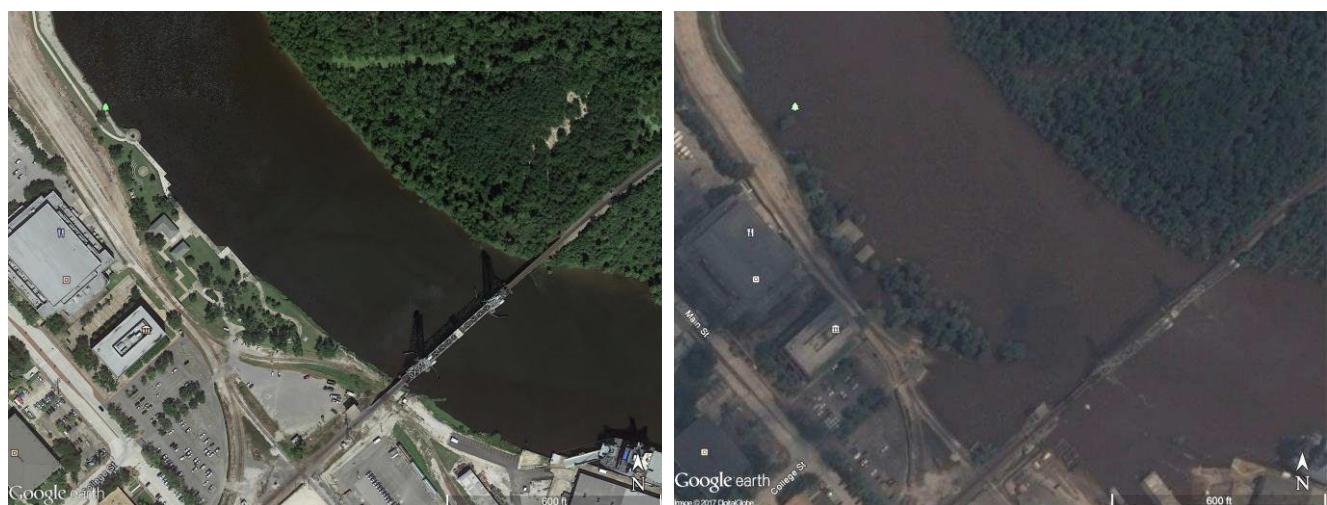
In Beaumont, the team observed significant erosion scour along the Neches River in the downtown area. Riverfront Park, behind City Hall and located on an outside bend of the river, was severely affected with the loss of shoreline and undercutting of many park features. Fig. 1 shows the location of Beaumont within the study area. Fig. 27 shows the location of Riverfront Park along the Neches River. Fig. 28 shows aerial / satellite images from Google Earth of Riverfront Park taken before the Harvey flooding (January 2015) and during the Harvey flooding (September 2015), respectively.

Figure 28. Aerial images of Beaumont Riverfront Park, January 2015 (left) and September 3, 2017 (right) (Google Earth).

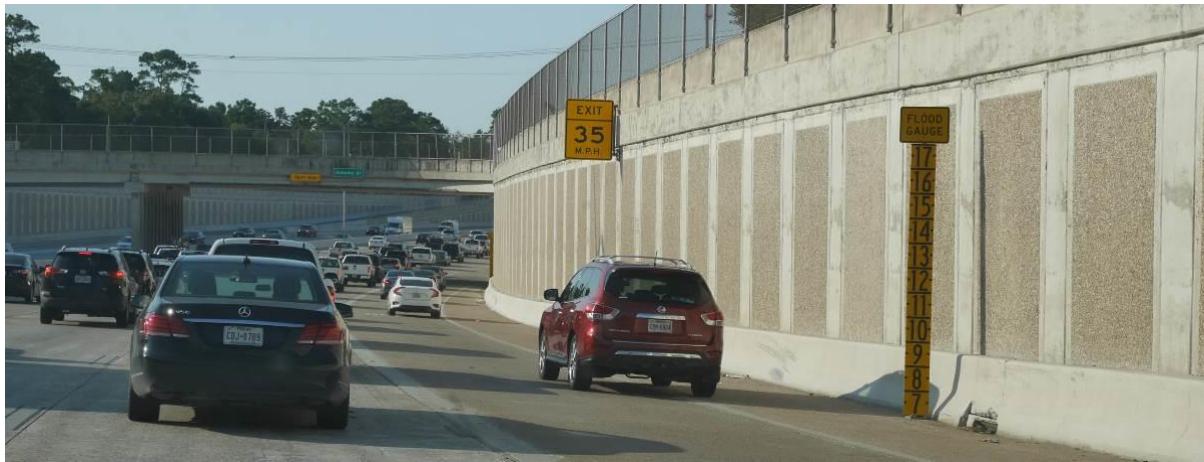
Flooding caused roadway damage to and closure of a major area artery at the underpass intersection of the Sam Houston Parkway / Beltway 8 and Boheme Drive (see Fig. 1 for location, 29.76736° N, 95.56210° W). The parkway is depressed at this intersection and floods often enough that flood depth sign gauges are posted along the road to warn motorists of the standing water depth (see Fig. 31).

Figure 31. Beltway 8 / Boheme Drive underpass and flood depth signs (September 11, 2017, 29.76694° N, 95.56139° W).

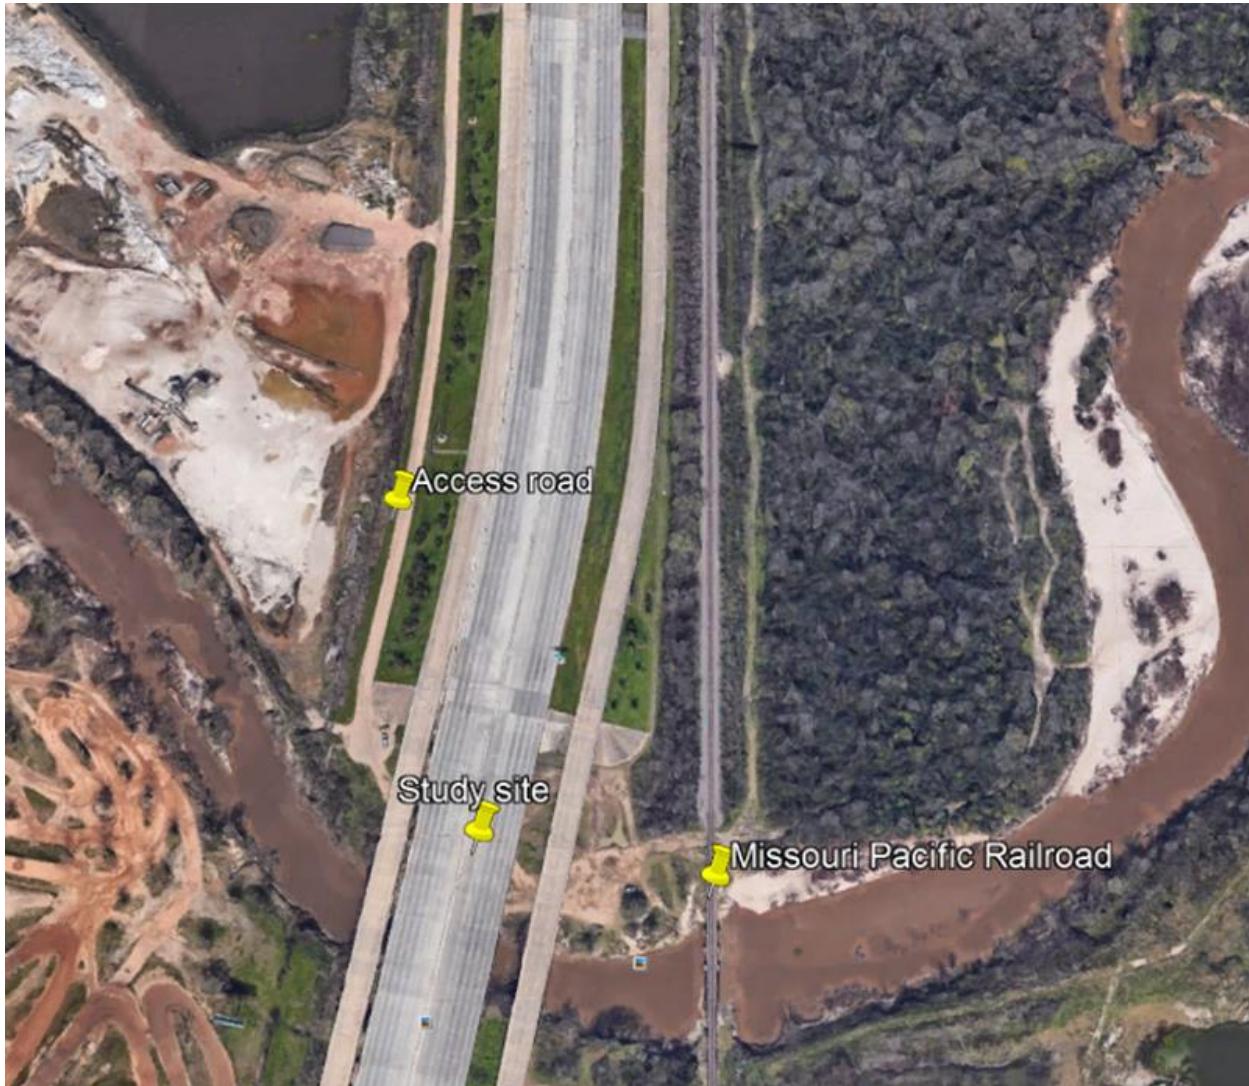
Figure 34. San Jacinto River Area observation locations (Google Earth image for April 2017, 30.24599° N, 95.45722° W).

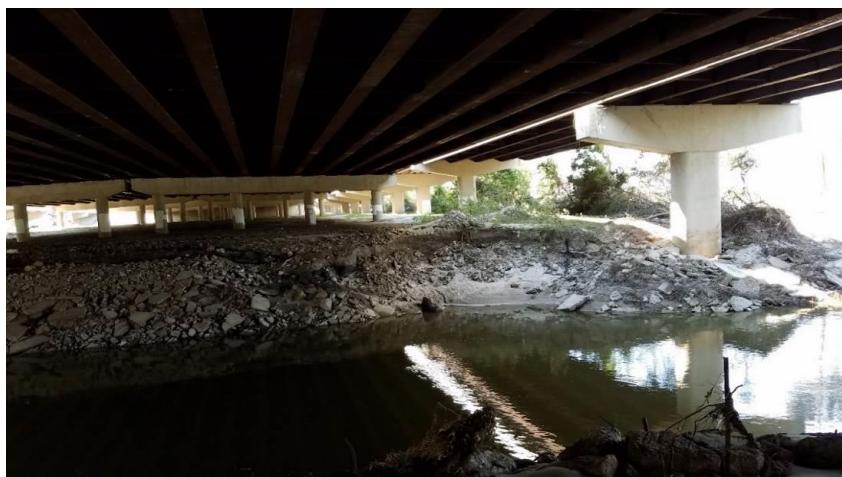
Figure 39. Riprap along south bank of San Jacinto River (September 11, 2017, Time 10:56 CDT, 30.24574° N, 95.45761° W).
