# Geotechnical Extreme Event Site Reconnaissance in Puerto Rico After The Passage of Hurricane Maria

Reference: Silva-Tulla F., and Pando M. A. (2020). Geotechnical Extreme Event Site Reconnaissance in Puerto Rico after the Passage of Hurricane Maria. International Journal of Geoengineering Case Histories, Volume 5, Issue 4, pp. 1-25, doi: 10.4417/IJGCH-05-04-01

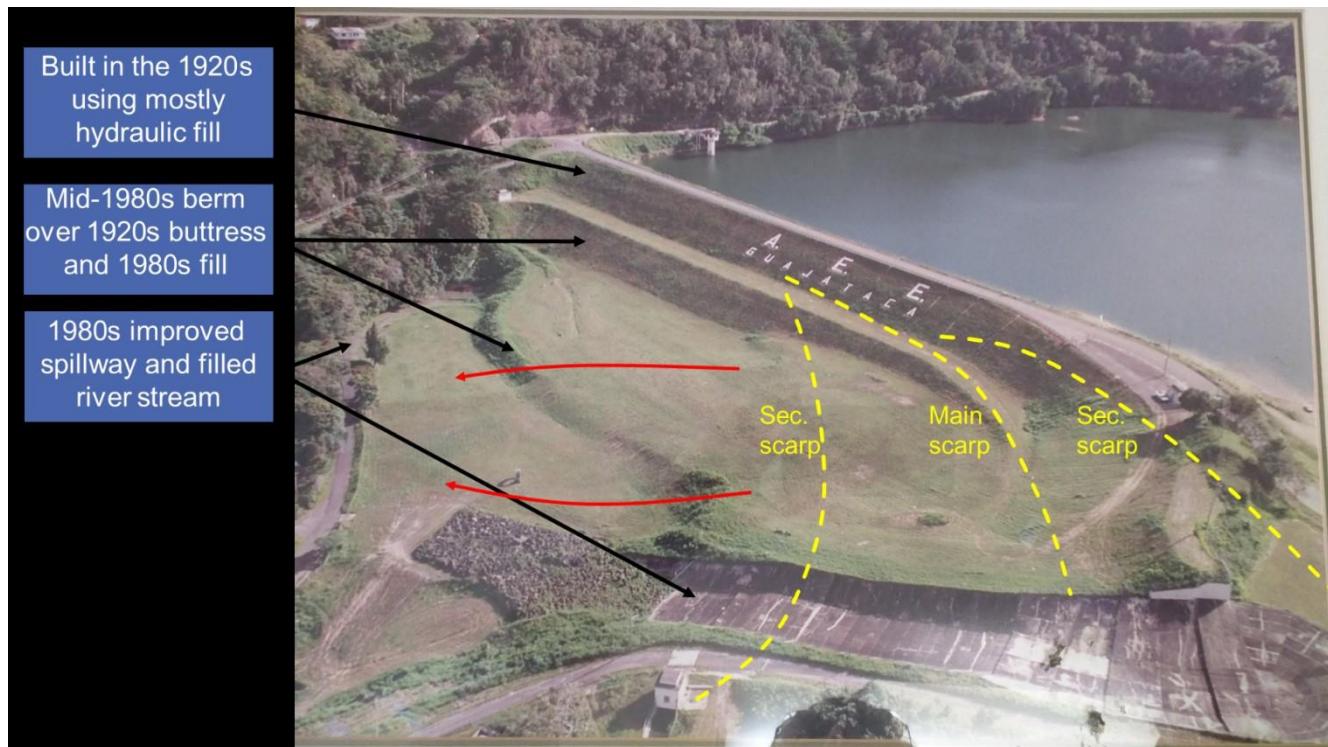
Note: Figure shows historical and landslide features remediated in the 1980s.

Figure 8. Photo of Guajataca Dam (Lat. +18.397895, Lon. -66.923725), taken a few decades before Hurricane Maria – exact date of photo unknown (adapted from Silva-Tulla et al., 2018).

The river is no longer visible in Figure 8, indicating that the photo was taken after completion of the 1980s improvements. Between 1992 and 1993, instrumentation consisting of seven inclinometers was installed (three along the crest, one over the buttress, and three downstream of the toe). Three of the four inclinometers installed on the buttress and downstream of the dam became inoperable within ten years of their installation due to excessive horizontal movements. Although these inclinometers were not completely sheared by 2002, we understand that they currently are. Movement was reported to our GEER team to have occurred at a depth of about 19 m (elevation 170 m), where a layer of green clay that slopes at an angle of about 4° exists. The appearance of piezometers in the field suggests they are contemporaneous with the slope indicators (i.e., installed in the early 1990s) (Silva-Tulla et al., 2018).

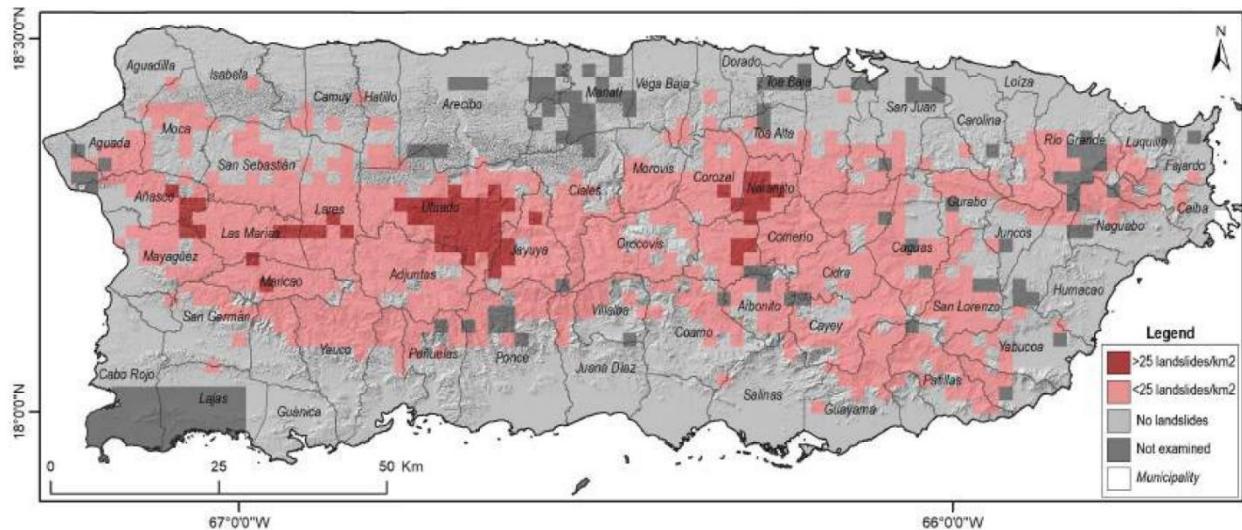
A rapid identification of landslide density across the island was performed by the USGS (Bessette-Kirton et al., 2017 and 2019) by examining post-hurricane satellite and aerial images (Figure 13). The map was generated analyzing FEMA and DigitalGlobe images collected between September 26 and October 8 in order to estimate the number of landslides inside 2 km x 2 km square cells. The authors warn of limitations of the study related to poor visibility associated with clouds, vegetation, and/or shadows. Further, the authors assumed that the majority of landslides detected were triggered by rainfall from Hurricane Maria, but the effects of antecedent rainfall from Hurricane Irma (September 6, 2017) and heavy rainfall reported in the days after Hurricane Maria may have also triggered landslides.

Figure 13. USGS map showing concentration of landslides attributed to Hurricane Maria (Bessette-Kirton et al., 2019).

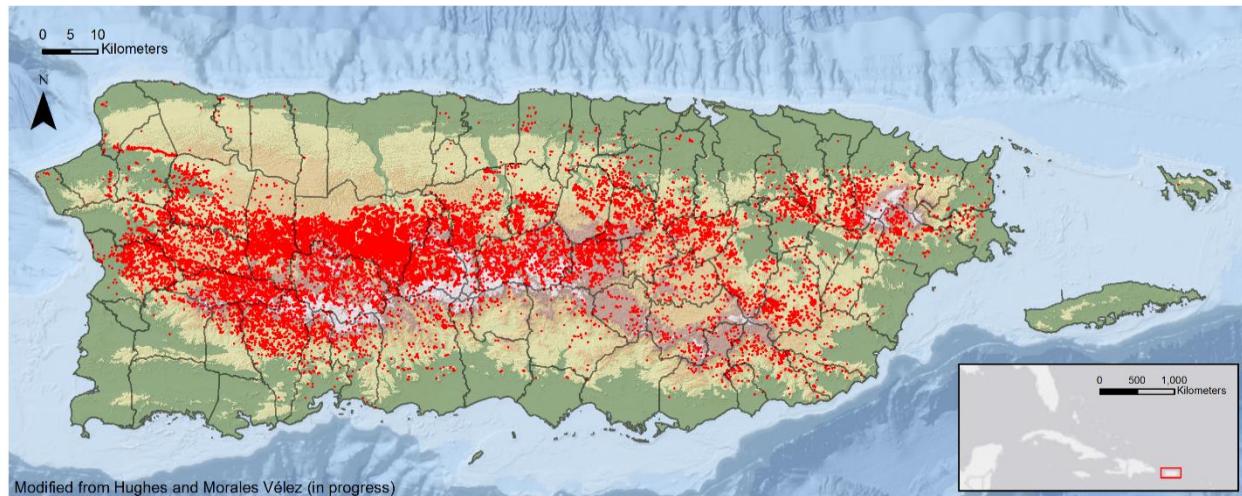
Despite these constraints, this map is useful in helping to identify the most critical areas of the island affected by landslides, and in aiding response and recovery efforts. The map in Figure 14 shows results of an ongoing investigation at UPRM by Hughes and Morales-Vélez (2017), in which more than 40,000 debris flow landslide sites have been identified across PR. Based on results from these two studies, the municipalities most severely impacted by landslides were Añasco, Mayagüez, Las Marías, Maricao, Lares, Utuado, Adjuntas, Jayuya, Ciales, and Orocovis. Three deaths were attributed directly to one of the landslides in the town of Utuado.

Figure 14. More than 40,000 debris flow sites (shown as red dots) identified across PR by Hughes & Morales-Vélez (2017).

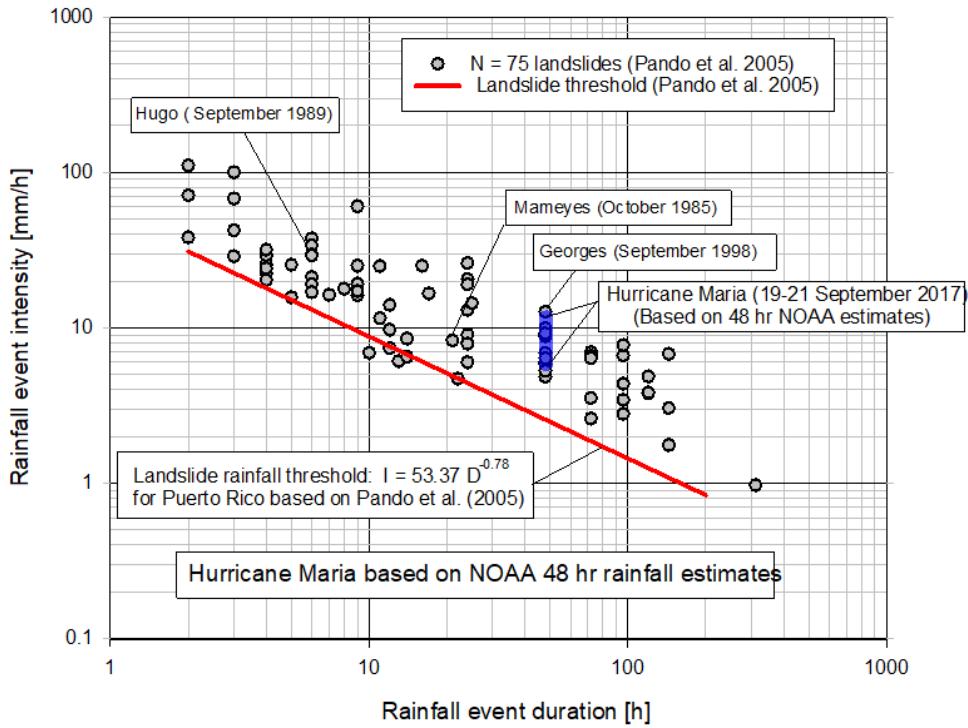
The passing of Hurricane Maria destroyed most rainfall gauges. However, rainfall estimates by NOAA and the National Weather Service for the period of 8:00 AM on September 19 to 8:00 AM on September 21 indicate rainfall ranging between 279 to 559 mm (11 to 22 in) for the municipalities most affected by landslides. For this 48-hour period, the average rainfall intensity would range approximately from about 5.8 to 11.6 mm/hr. Figure 15 shows this estimated range of rainfall intensity for Hurricane Maria, considering a 48-hour duration, together with a preliminary regional landslide rainfall threshold for Puerto Rico by Pando et al. (2005). The estimated rainfall intensity and duration for Hurricane Maria falls above this generalized regional landslide rainfall threshold, consistent with the many documented landslides recorded.

Figure 15. Estimated Hurricane Maria rainfall (blue line) and the Pando et al. (2005) rainfall-induced landslide threshold.

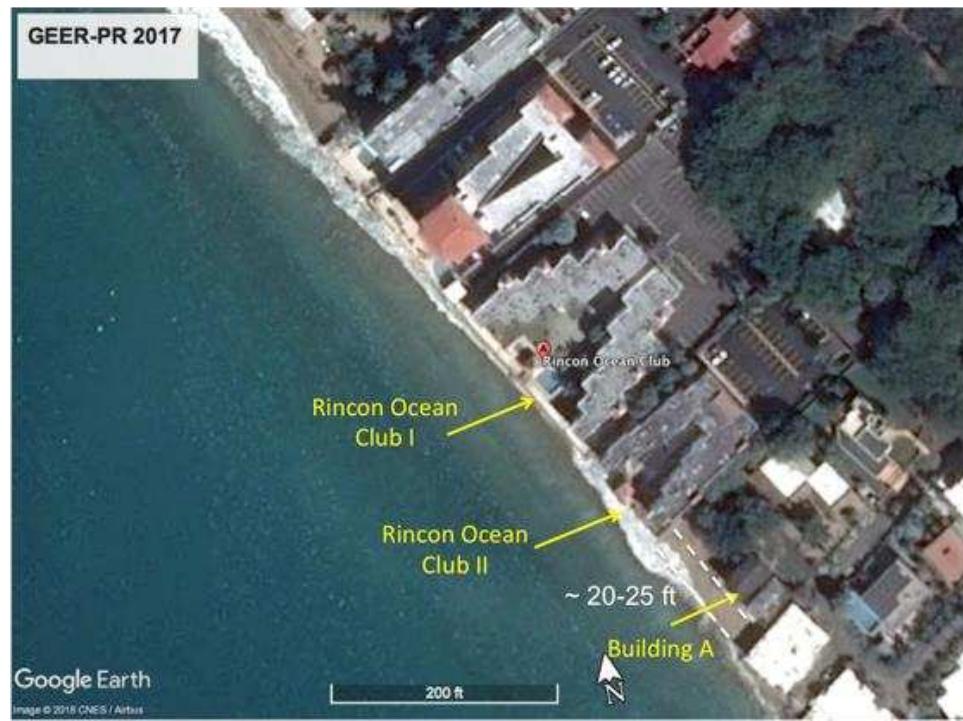
Site CE3, located within the Córcega Beach in the municipality of Rincón on the west coast of PR, showed damage at an oceanfront condominium complex consisting of two buildings (Rincón Ocean Club I and II) and a residence (Building A), as shown in the pre-storm aerial image in Figure 19. The beach width before Hurricane Maria at this site was about 6 to 9 m (20 to 30 ft).

The beachfront in the Córcega Beach area suffered extensive coastal scour. The approximately 6 to 9 m (20 to 30 ft) of beachfront shown in the pre-storm photo (Figure 19) was drastically reduced at the time of the site reconnaissance. The GEER Team did not observe sand washout deposits or shoreline erosion protection measures during the field reconnaissance of Site CE3. Unfortunately, there were no storm tide sensors available near Rincón to help assess tidal levels or the magnitude of wave action during this hurricane. However, NOAA (2017) reported highest water levels of 0.3 to 0.6 m (1 to 2 ft) above maximum higher high water (MHHW) for the northwest coastline of PR, where MHHW is defined as the average daily highest tide. This is consistent with a high-water elevation mark data recorded at USGS Stations (Silva-Tulla et al., 2018).

Figure 19. Pre-storm aerial image of coastal scour Site CE3 (Silva-Tulla et al., 2018).
