Geotechnical Extreme Event Site Reconnaissance in Puerto Rico After The Passage of Hurricane Maria

Reference: Silva-Tulla F., and Pando M. A. (2020). Geotechnical Extreme Event Site Reconnaissance in Puerto Rico after the Passage of Hurricane Maria. International Journal of Geoengineering Case Histories, Volume 5, Issue 4, pp. 1-25, doi: 10.4417/IJGCH-05-04-01

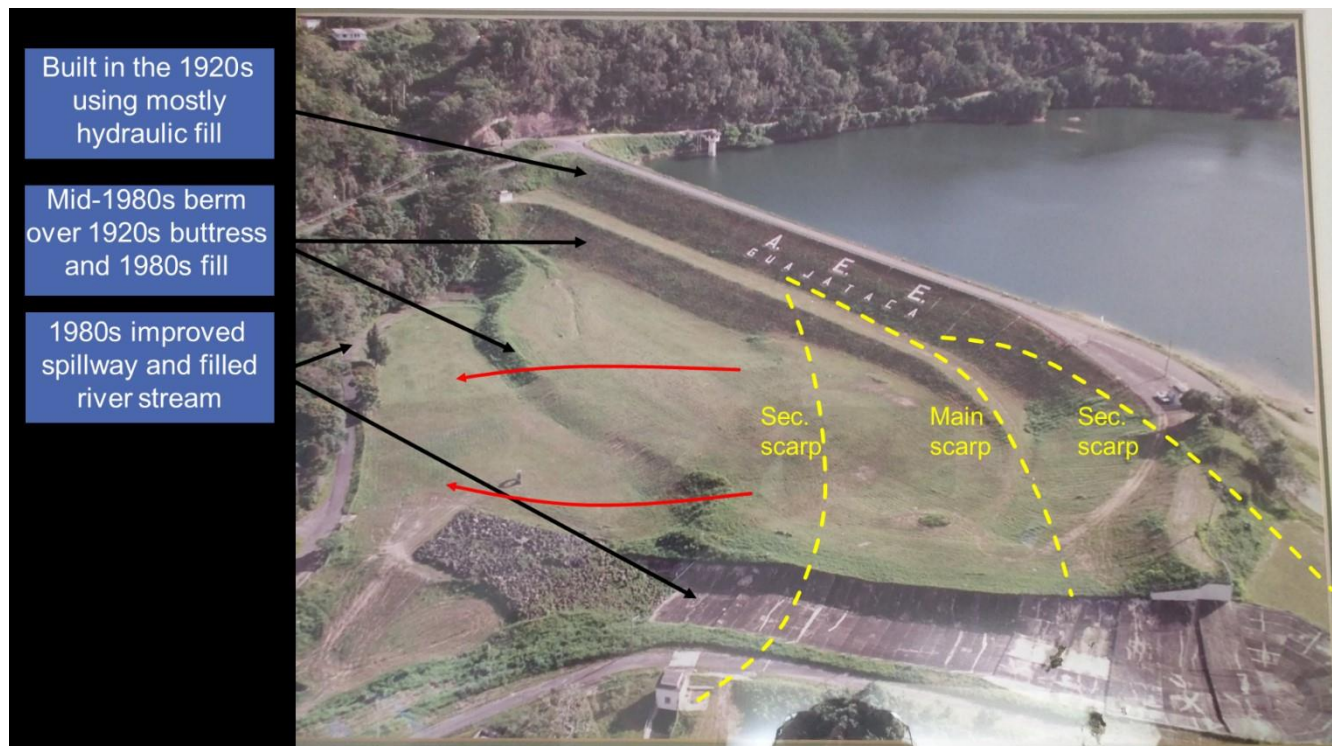
The GEER mission visited Guajataca Dam, where severe damage to the spillway and dam safety concerns prompted the evacuation of about 70,000 downstream residents. Figure 8 shows Guajataca Dam, an earthfill dam built in the 1920s, mostly by hydraulic fill methods, and modified in the 1980s. The dam has a maximum height of about 37 m (121 ft) and a crest 316 m (1,037 ft) long and 9.5 m (31.2 ft) wide, with a “puddle clay” core sloping at about 0.5 to 1 (horizontal to vertical [H:V]). Its upstream and downstream faces slope at ratios of 2:1 H:V or flatter. According to the National Inventory of Dams (USACE, 2016), Guajataca Dam was designed for and owned by the Puerto Rico Electric Power Authority. A detailed description of the history and construction of the dam can be found in USBR (2002).

Figure 8. Photo of Guajataca Dam (Lat. +18.397895, Lon. -66.923725), taken a few decades before Hurricane Maria – exact date of photo unknown (adapted from Silva-Tulla et al., 2018).

The river is no longer visible in Figure 8, indicating that the photo was taken after completion of the 1980s improvements. Between 1992 and 1993, instrumentation consisting of seven inclinometers was installed (three along the crest, one over the buttress, and three downstream of the toe). Three of the four inclinometers installed on the buttress and downstream of the dam became inoperable within ten years of their installation due to excessive horizontal movements. Although these inclinometers were not completely sheared by 2002, we understand that they currently are. Movement was reported to our GEER team to have occurred at a depth of about 19 m (elevation 170 m), where a layer of green clay that slopes at an angle of about 4° exists. The appearance of piezometers in the field suggests they are contemporaneous with the slope indicators (i.e., installed in the early 1990s) (Silva-Tulla et al., 2018).

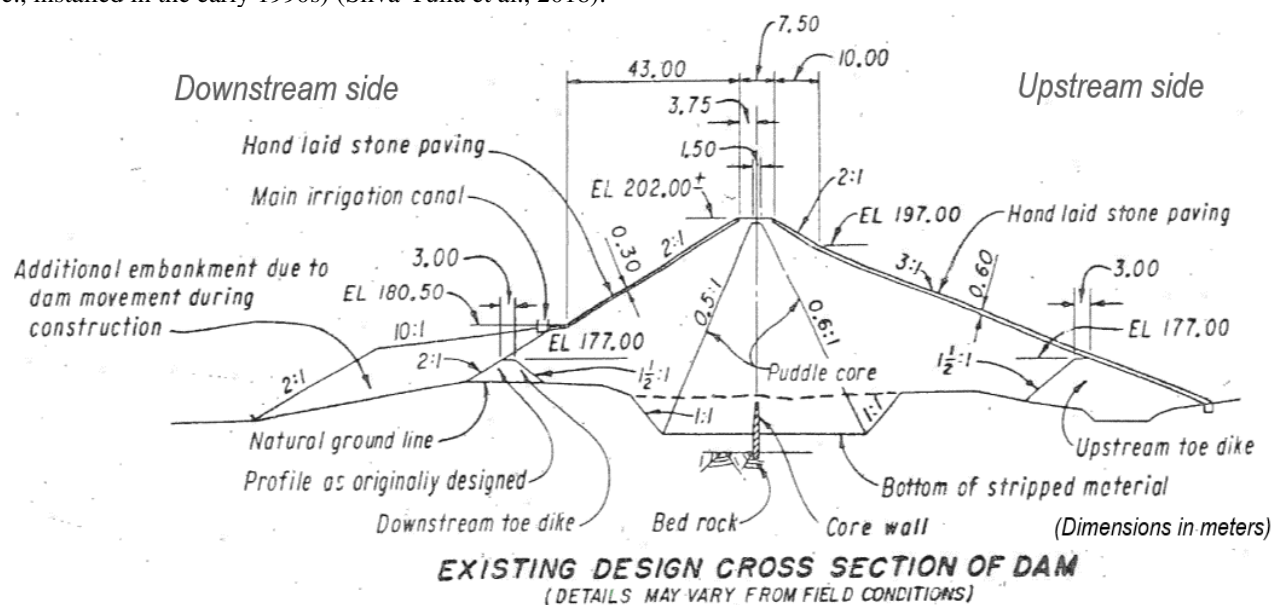
Figure 9 shows the cross section of Guajataca Dam, as reported by USBR (2002). Available records suggest that a large part of the dam consists of hydraulic fill, but its internal geometry and composition remain unclear. For example, the center of the dam is reported as a “puddle core”, but the USBR (2002) report suggests that the hydraulic fill process left the coarsest fill materials near the dam faces and the finest in the core area. The same report indicates that fill placement was changed to “dry” roller compaction in 1927 to address field observations of dam instability. Instability during the initial construction of the dam was reported in February 1927 as cracks, slippage, and other signs of movement, including bulging and settlement of the cofferdams. Reportedly, many locations showed movements on both the dam and the downstream natural ground; maximum movements included a 0.96 m (3.2 ft) downstream horizontal displacement and 1.44 m (4.7 ft) of vertical settlement.

Figure 9 shows the remedial berm constructed on the downstream side of the dam early in 1927 after the reservoir was drained, implemented to stabilize the ongoing sliding in the downstream direction. USBR (2002) also indicates that stabilization measures included the installation of numerous drain holes and replacing the fill placement technique to “dry” roller compaction. As construction of the dam proceeded, new movements of up to 35 cm (14 in) were reported on the upstream face and a heel was installed (location unknown). The USBR (2002) report indicates that in November 1927, as the dam was nearing completion, movements reported as “creep-type” were still observed. To enhance stability, fill was placed at the toe of the dam. The USBR (2002) report indicates that crest movements were measured during the years following the original dam’s completion. Movement varied from about 35 cm/yr (13.2 in/yr) between 1927 and 1929 to about 1 cm/yr (0.4 in/yr) between 1942 and 1951. In 1954, about 2,000 m³ of fill were added to the crest area to restore its original elevation.

In 1971, the USBR was requested to evaluate the dam; in 1977, it recommended various remedial measures, including rebuilding the crest and replacing part of the spillway. During an excavation near the toe of the spillway in 1981, movement of the spillway occurred. The excavation revealed a plastic layer with slickensides, and a subsequent investigation resulted in landslides being mapped under the spillway and dam. To increase the stability, the USBR recommended limiting the elevation of the downstream face berm (Figure 9) and filling or buttressing the river channel area. The work included the placement of a 2.44 m (8 ft) diameter pipeline, completed in 1984, to carry outlet flows.

Figure 9. Cross-section of Guajataca Dam from the 1920s (date of drawing is unknown; USBR, 2002).
