# Geotechnical Extreme Event Site Reconnaissance in Puerto Rico After The Passage of Hurricane Maria

ABSTRACT: The National Weather Service classified Hurricane Maria as a strong Category 4 Hurricane on the Saffir-Simpson hurricane wind scale at the time of its landfall in Yabucoa, Puerto Rico, U.S.A., on September 20, 2017. The immediate aftermath of Hurricane Maria was a devastated island with at least 64 people killed, severe infrastructure loss, a devastated electric power grid, and numerous geotechnical failures related to the intense rainfall and strong winds associated to this extreme event. This paper will summarize the event timeline and the geotechnical consequences of Maria's path across Puerto Rico. The impacts of Hurricane Maria on infrastructure and geomorphology are documented through the data and observations of the engineers and geologists that comprised the Geotechnical Extreme Events Reconnaissance (GEER) team. The main reconnaissance mission took place between October 25 and November 6, 2017, followed by a second field component involving terrestrial LiDAR surveys and UAV photogrammetry performed January 8 to 11, 2018.

Reference: Silva-Tulla F., and Pando M. A

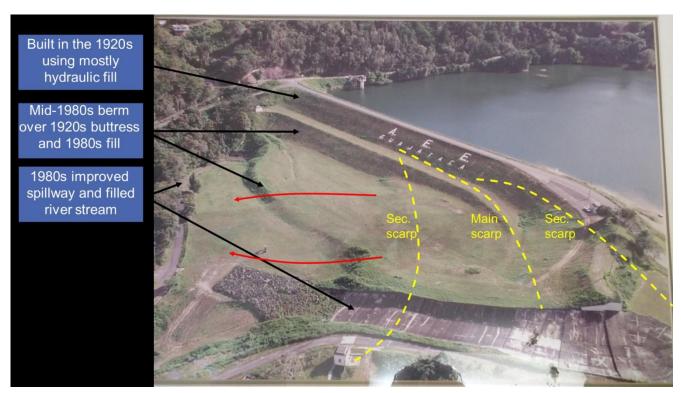
The GEER mission visited Guajataca Dam, where severe damage to the spillway and dam safety concerns prompted the evacuation of about 70,000 downstream residents. Figure 8 shows Guajataca Dam, an earthfill dam built in the 1920s, mostly by hydraulic fill methods, and modified in the 1980s. The dam has a maximum height of about 37 m (121 ft) and a crest 316 m (1,037 ft) long and 9.5 m (31.2 ft) wide, with a "puddle clay" core sloping at about 0.5 to 1 (horizontal to vertical [H:V]). Its upstream and downstream faces slope at ratios of 2:1 H:V or flatter. According to the National Inventory of Dams (USACE, 2016), Guajataca Dam was designed for and owned by the Puerto Rico Electric Power Authority. A detailed description of the history and construction of the dam can be found in USBR (2002).

Note: Figure shows historical and landslide features remediated in the 1980s.

Figure 8. Photo of Guajataca Dam (Lat. +18.397895, Lon. -66.923725), taken a few decades before Hurricane Maria – exact date of photo unknown (adapted from Silva-Tulla et al., 2018).

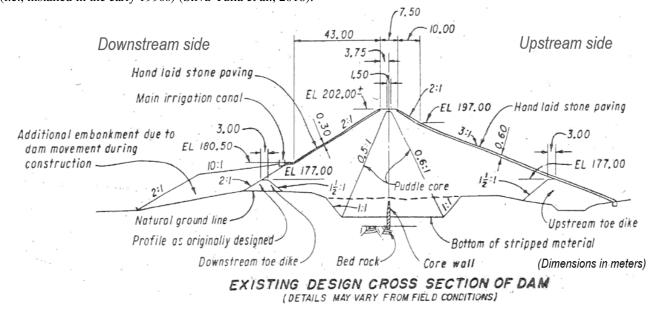
Figure 9 shows the cross section of Guajataca Dam, as reported by USBR (2002). Available records suggest that a large part of the dam consists of hydraulic fill, but its internal geometry and composition remain unclear. For example, the center of the dam is reported as a "puddle core", but the USBR (2002) report suggests that the hydraulic fill process left the coarsest fill materials near the dam faces and the finest in the core area. The same report indicates that fill placement was changed to "dry" roller compaction in 1927 to address field observations of dam instability. Instability during the initial construction of the dam was reported in February 1927 as cracks, slippage, and other signs of movement, including bulging and settlement of the cofferdams. Reportedly, many locations showed movements on both the dam and the downstream natural ground; maximum movements included a 0.96 m (3.2 ft) downstream horizontal displacement and 1.44 m (4.7 ft) of vertical settlement.

Figure 9 shows the remedial berm constructed on the downstream side of the dam early in 1927 after the reservoir was drained, implemented to stabilize the ongoing sliding in the downstream direction. USBR (2002) also indicates that stabilization measures included the installation of numerous drain holes and replacing the fill placement technique to "dry" roller compaction. As construction of the dam proceeded, new movements of up to 35 cm (14 in) were reported on the upstream face and a heel was installed (location unknown). The USBR (2002) report indicates that in November 1927, as the dam was nearing completion, movements reported as "creep-type" were still observed. To enhance stability, fill was placed at the toe of the dam. The USBR (2002) report indicates that crest movements were measured during the years following the original dam's completion. Movement varied from about 35 cm/yr (13.2 in/yr) between 1927 and 1929 to about 1 cm/yr (0.4 in/yr) between 1942 and 1951. In 1954, about 2,000 m³ of fill were added to the crest area to restore its original elevation.

Figure 9. Cross-section of Guajataca Dam from the 1920s (date of drawing is unknown; USBR, 2002).

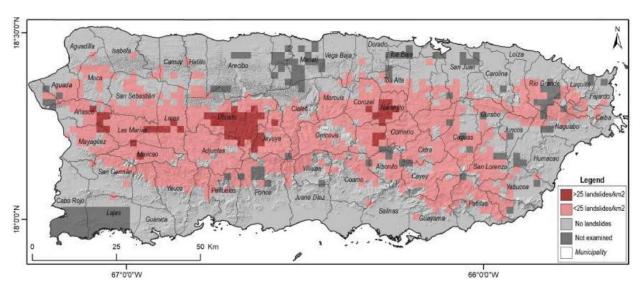
A rapid identification of landslide density across the island was performed by the USGS (Bessette-Kirton et al., 2017 and 2019) by examining post-hurricane satellite and aerial images (Figure 13). The map was generated analyzing FEMA and DigitalGlobe images collected between September 26 and October 8 in order to estimate the number of landslides inside 2 km x 2 km square cells. The authors warn of limitations of the study related to poor visibility associated with clouds, vegetation, and/or shadows. Further, the authors assumed that the majority of landslides detected were triggered by rainfall from Hurricane Maria, but the effects of antecedent rainfall from Hurricane Irma (September 6, 2017) and heavy rainfall reported in the days after Hurricane Maria may have also triggered landslides.

Figure 13. USGS map showing concentration of landslides attributed to Hurricane Maria (Bessette-Kirton et al., 2019).

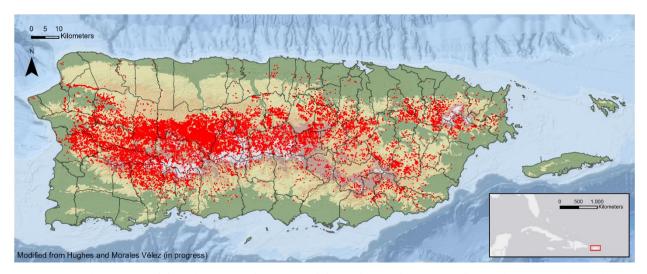
Despite these constraints, this map is useful in helping to identify the most critical areas of the island affected by landslides, and in aiding response and recovery efforts. The map in Figure 14 shows results of an ongoing investigation at UPRM by Hughes and Morales-Vélez (2017), in which more than 40,000 debris flow landslide sites have been identified across PR. Based on results from these two studies, the municipalities most severely impacted by landslides were Añasco, Mayagüez, Las Marías, Maricao, Lares, Utuado, Adjuntas, Jayuya, Ciales, and Orocovis. Three deaths were attributed directly to one of the landslides in the town of Utuado.

Figure 14. More than 40,000 debris flow sites (shown as red dots) identified across PR by Hughes & Morales-Vélez (2017).

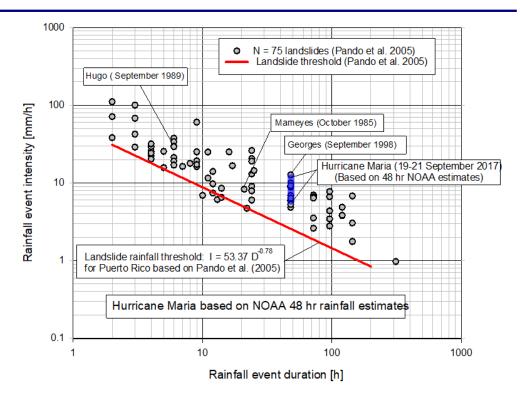
The passing of Hurricane Maria destroyed most rainfall gauges. However, rainfall estimates by NOAA and the National Weather Service for the period of 8:00 AM on September 19 to 8:00 AM on September 21 indicate rainfall ranging between 279 to 559 mm (11 to 22 in) for the municipalities most affected by landslides. For this 48-hour period, the average rainfall intensity would range approximately from about 5.8 to 11.6 mm/hr. Figure 15 shows this estimated range of rainfall intensity for Hurricane Maria, considering a 48-hour duration, together with a preliminary regional landslide rainfall threshold for Puerto Rico by Pando et al. (2005). The estimated rainfall intensity and duration for Hurricane Maria falls above this generalized regional landslide rainfall threshold, consistent with the many documented landslides recorded.

Figure 15. Estimated Hurricane Maria rainfall (blue line) and the Pando et al. (2005) rainfall-induced landslide threshold.

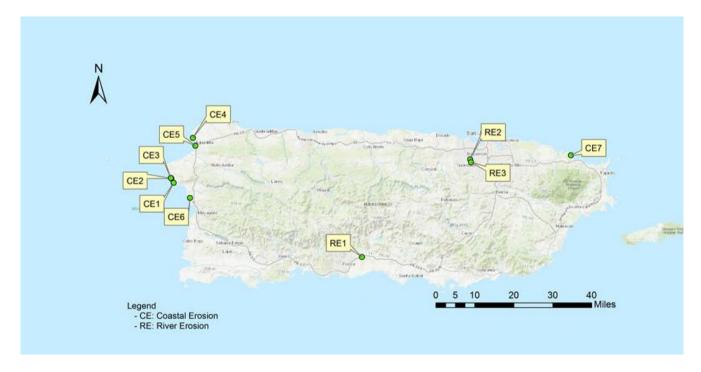
resulting thrust from the debris pushing on their upstream sides. Figure 18 shows the coastal and river scour sites visited by the GEER team. For the sake of brevity, only a couple of these sites are presented herein. A detailed description of all sites shown in this figure appear in the GEER report (Silva-Tulla et al., 2018).

Figure 18. Location of coastal and river scour sites visited by GEER team (Silva-Tulla et al., 2018).

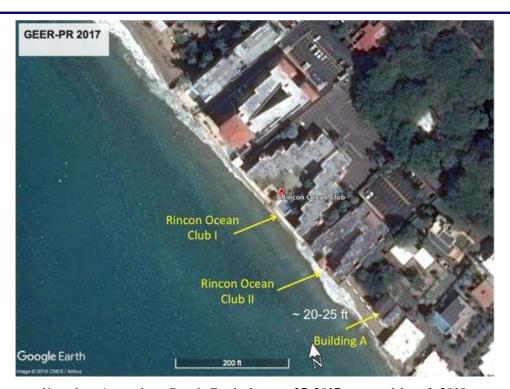
Site CE3, located within the Córcega Beach in the municipality of Rincón on the west coast of PR, showed damage at an oceanfront condominium complex consisting of two buildings (Rincón Ocean Club I and II) and a residence (Building A), as shown in the pre-storm aerial image in Figure 19. The beach width before Hurricane Maria at this site was about 6 to 9 m (20 to 30 ft).

The beachfront in the Córcega Beach area suffered extensive coastal scour. The approximately 6 to 9 m (20 to 30 ft) of beachfront shown in the pre-storm photo (Figure 19) was drastically reduced at the time of the site reconnaissance. The GEER Team did not observe sand washout deposits or shoreline erosion protection measures during the field reconnaissance of Site CE3. Unfortunately, there were no storm tide sensors available near Rincón to help assess tidal levels or the magnitude of wave action during this hurricane. However, NOAA (2017) reported highest water levels of 0.3 to 0.6 m (1 to 2 ft) above maximum higher high water (MHHW) for the northwest coastline of PR, where MHHW is defined as the average daily highest tide. This is consistent with a high-water elevation mark data recorded at USGS Stations (Silva-Tulla et al, 2018).

Note: base image from Google Earth, January 27, 2017, accessed June 3, 2018. Figure 19. Pre-storm aerial image of coastal scour Site CE3 (Silva-Tulla et al., 2018).
