# Geotechnical Extreme Event Site Reconnaissance in Puerto Rico After The Passage of Hurricane Maria

**Francisco Silva-Tulla**, Consulting Civil Engineer, GeoEngineering and Environment, Lexington, Massachusetts, U.S.A.; email: [silva@alum.mit.edu](mailto:silva@alum.mit.edu)

**Miguel A. Pando**, Associate Professor, Department of Civil, Architectural, and Environmental Engineering, Drexel University, Philadelphia, PA, 19104, U.S.A.; email: [miguel.a.pando@drexel.edu](mailto:miguel.a.pando@drexel.edu)

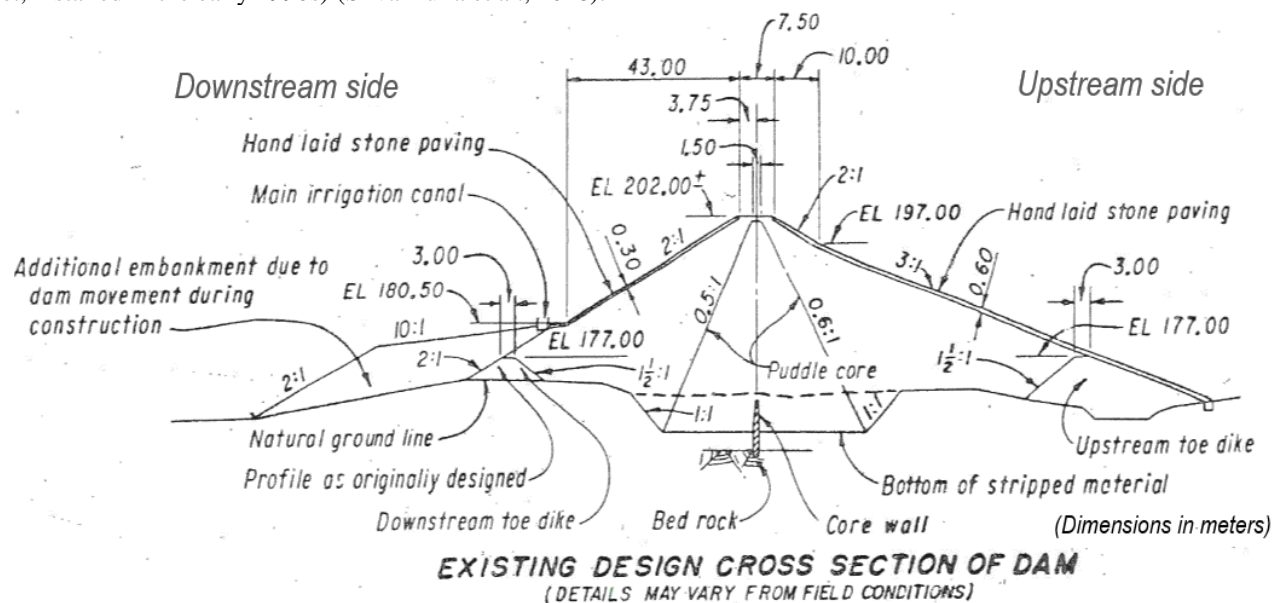
Figure 9. Cross-section of Guajataca Dam from the 1920s (date of drawing is unknown; USBR, 2002).

Figure 9 shows the cross section of Guajataca Dam, as reported by USBR (2002). Available records suggest that a large part of the dam consists of hydraulic fill, but its internal geometry and composition remain unclear. For example, the center of the dam is reported as a “puddle core”, but the USBR (2002) report suggests that the hydraulic fill process left the coarsest fill materials near the dam faces and the finest in the core area. The same report indicates that fill placement was changed to “dry” roller compaction in 1927 to address field observations of dam instability. Instability during the initial construction of the dam was reported in February 1927 as cracks, slippage, and other signs of movement, including bulging and settlement of the cofferdams. Reportedly, many locations showed movements on both the dam and the downstream natural ground; maximum movements included a 0.96 m (3.2 ft) downstream horizontal displacement and 1.44 m (4.7 ft) of vertical settlement.

Figure 9 shows the remedial berm constructed on the downstream side of the dam early in 1927 after the reservoir was drained, implemented to stabilize the ongoing sliding in the downstream direction. USBR (2002) also indicates that stabilization measures included the installation of numerous drain holes and replacing the fill placement technique to “dry” roller compaction. As construction of the dam proceeded, new movements of up to 35 cm (14 in) were reported on the upstream face and a heel was installed (location unknown). The USBR (2002) report indicates that in November 1927, as the dam was nearing completion, movements reported as “creep-type” were still observed. To enhance stability, fill was placed at the toe of the dam. The USBR (2002) report indicates that crest movements were measured during the years following the original dam’s completion. Movement varied from about 35 cm/yr (13.2 in/yr) between 1927 and 1929 to about 1 cm/yr (0.4 in/yr) between 1942 and 1951. In 1954, about 2,000 m<sup>3</sup> of fill were added to the crest area to restore its original elevation.

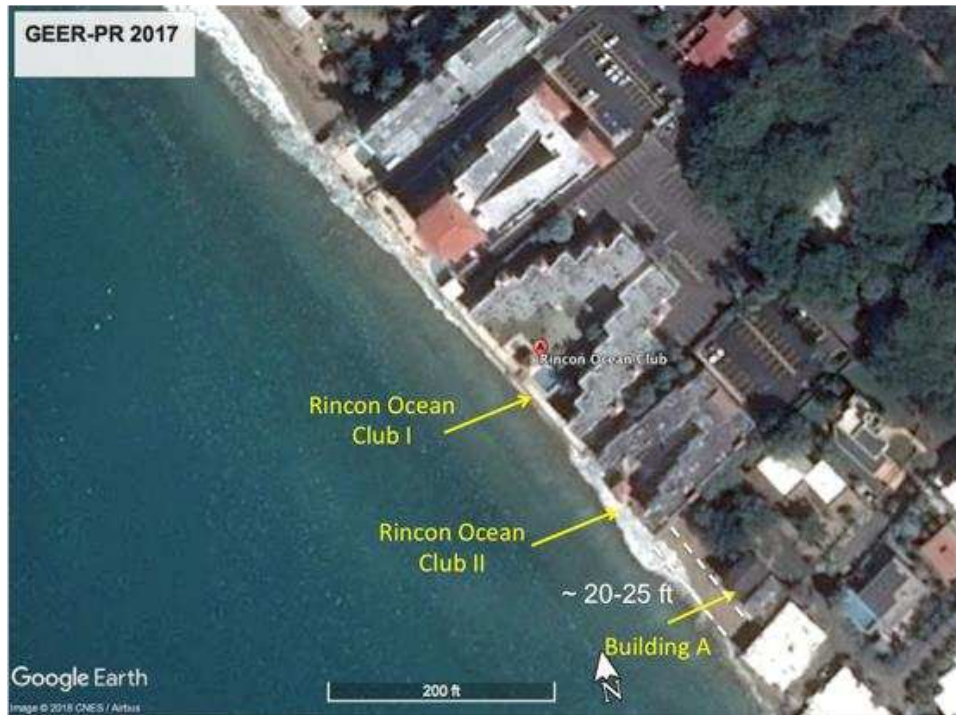
*Figure 19. Pre-storm aerial image of coastal scour Site CE3 (Silva-Tulla et al., 2018).*

Site CE3, located within the Córcega Beach in the municipality of Rincón on the west coast of PR, showed damage at an oceanfront condominium complex consisting of two buildings (Rincón Ocean Club I and II) and a residence (Building A), as shown in the pre-storm aerial image in Figure 19. The beach width before Hurricane Maria at this site was about 6 to 9 m (20 to 30 ft).

The beachfront in the Córcega Beach area suffered extensive coastal scour. The approximately 6 to 9 m (20 to 30 ft) of beachfront shown in the pre-storm photo (Figure 19) was drastically reduced at the time of the site reconnaissance. The GEER Team did not observe sand washout deposits or shoreline erosion protection measures during the field reconnaissance of Site CE3. Unfortunately, there were no storm tide sensors available near Rincón to help assess tidal levels or the magnitude of wave action during this hurricane. However, NOAA (2017) reported highest water levels of 0.3 to 0.6 m (1 to 2 ft) above maximum higher high water (MHHW) for the northwest coastline of PR, where MHHW is defined as the average daily highest tide. This is consistent with a high-water elevation mark data recorded at USGS Stations (Silva-Tulla et al, 2018).
