Hurricane Irma: Consequences of Intense Rainfall and Storm Surge from a Tropical Storm in North and Central Florida

ABSTRACT: Hurricane Irma affected the Florida peninsula from September 9-11, 2017, with high winds, rainfall, and storm surge. Although the storm made landfall on the west coast of Florida, impacts of the rainfall and storm surge affected central and northeast Florida. A GEER team mobilized on September 23, 2017, spent three days documenting sinkhole damage in central Florida, coastal scour and erosion along the northeast coast of Florida, and infrastructure damage in northeast Florida. Numerous sites with geotechnical damage were documented but this case history focuses specifically on sinkhole damage in The Villages, erosion and scour at Vilano Beach, failure of a concrete cover earth dam at Hampton Lake, and bridge embankment damage on US-17 over the Trout River. The most notable challenges to reconnaissance were the widespread and varied nature of the damages from Hurricane Irma and the rapid repair of damaged infrastructure that required the team to work closely with local, state, and federal officials to obtain documentation of the damage prior to repair.

Refe

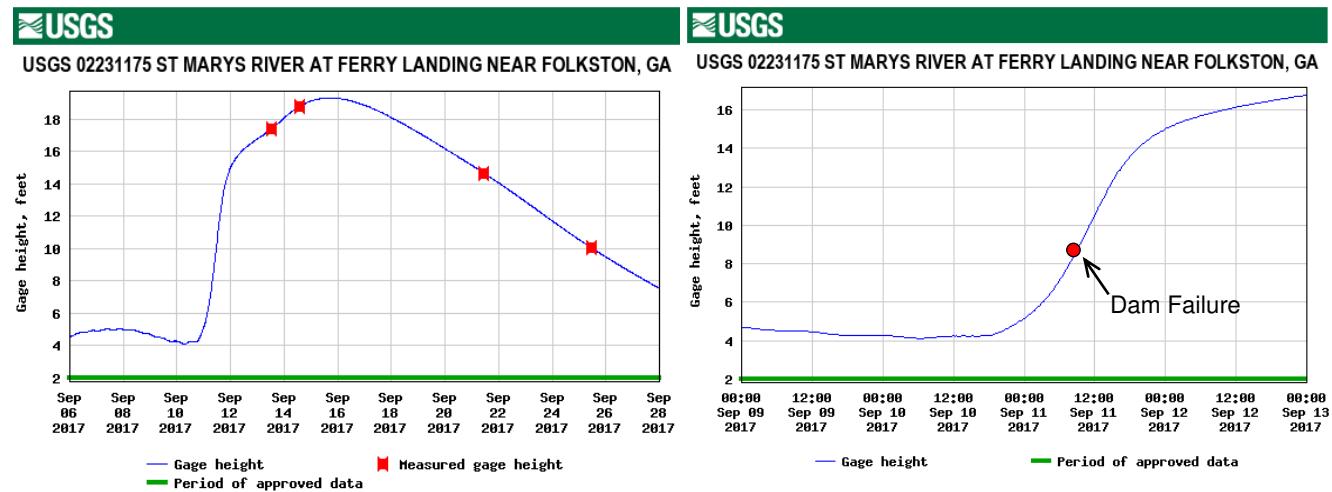
Cangialosi et al. (2018) report that record flooding occurred at Lake Hampton, with rainfall between 0.18 m to 0.25 m (0.6 to 0.8 ft) (Figure 2) and storm surge water levels between 1.2 m to 1.6 m (3.9 ft to 5.2 ft) above MHHW in the St. Johns River. The St. Marys River outlet to the Atlantic Ocean is approximately 35 km (21.7 mi) north of the St. Johns River outlet (Figure 3); thus, storm surge likely propagated similarly upstream in the St. Marys River. Figure 19 illustrates water level height in the St. Marys River approximately 9 km (5.6 mi) upstream from the Pigeon Creek outlet. Water level initially increased significantly from approximately 1.3 m (4 ft) to 4.5 m (15 ft) during Hurricane Irma and continued to increase for several days thereafter. The initial rapid initial water level increase is likely from a combination of overland flow in the watershed, back up of water into the tributaries of the St. Johns River due to the flooding, and storm surge water level increases described in Cangialosi et al. (2018). The subsequent slower increase is from water entering the St. Marys River from overland flow and groundwater following infiltration.

Figure 19: St. Marys River hydrograph elevations in NAVD 88 at the USGS 02231175 St. Marys River gage at Ferry Landing near Folkston, Georgia, prior to and after Hurricane Irma (USGS 2018).
