Hurricane Irma: Consequences of Intense Rainfall and Storm Surge from a Tropical Storm in North and Central Florida

Reference: Landon M. E., Hudyma N. W., and Sharma R. S. (2020). Hurricane Irma: Consequences of Intense Rainfall and Storm Surge from a Tropical Storm in North and Central Florida. International Journal of Geoengineering Case Histories, Volume 5, Issue 4, pp. 26-46, doi: 10.4417/IJGCH-05-04-02

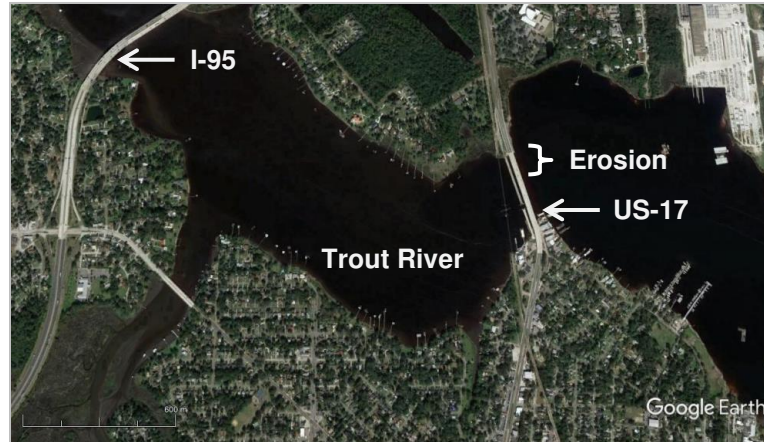
Figure 20: Location of the US 17 bridge over the Trout River in Jacksonville, Florida (Google Earth 2018).

The US-17 bridge (structure number 720011, Figure 20) over the Trout River in Jacksonville, Duval County, Florida, was built in 1958 and has four lanes that convey approximately 12,000 vehicles per day (City-Data, 2018). The Trout River is a tributary of the St. Johns River and thus tidally influenced. The soil embankment supporting the roadway sits atop a concrete support wall that is approximately 1 m to 2 m (3.2 to 6.6 ft) above the Trout River water level, depending on the tide. The soil embankment is stabilized along the front and sides by a concrete facing and supported at the furthest extent of the concrete where it meets the grassy embankment by a stacked concrete-sack wall. Utilities are installed in the embankment 1.5 m (4.9 ft) below the finished grade, and include sewer pipes, access structures, and electrical conduit.
