Reconnaissance of the New Orleans Hurricane and Storm Damage Risk Reduction System after Hurricane Gustav

ABSTRACT: On October 2 and 3, 2008, a group of civil engineers sponsored by the National Science Foundation (NSF) and organized by the Geoengineering Extreme Events Reconnaissance (GEER) Association, visited the New Orleans area to assess levee performance during hurricane Gustav. This paper summarizes the team's observations and understanding of the state of the New Orleans Hurricane and Storm Damage Risk Reduction System (HSDRRS) in the fall of 2008 and the performance of elements of the HSDRRS during Hurricane Gustav. The fundamental conclusion was that the HSDRRS performed well under the surge and wave stresses generated by Gustav. The team's observations led to lessons about dangers to floodwalls from boats and barges, the importance of timely preparation for hurricanes, erosion resistance of clay levees, and the need for continued emphasis on evacuation for life protection.

International Journal of Geoengineering Case Histories, Volume 5, Issue 4, pp. 129-154, doi: 10.4417/IJGCH-05-04-

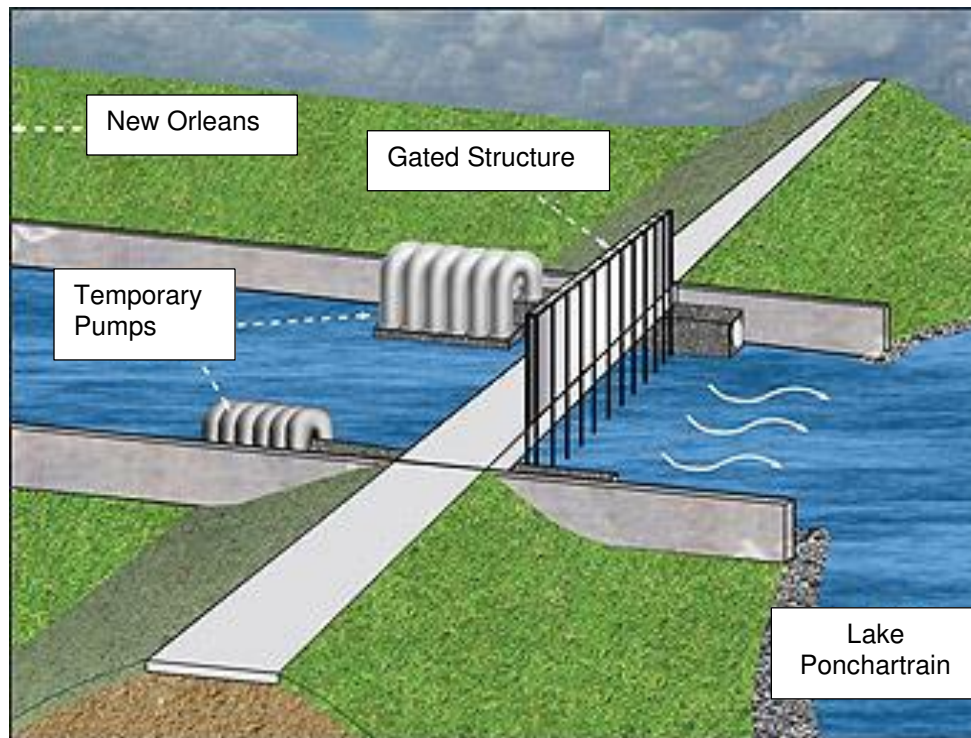
Figure 7. Schematic of canal closure facilities .(http://www.mvn.usace.army.mil/hps2/hps_outfall_canals.asp)

Drainage Canal Closures – The USACE increased the flood protection for the drainage canals by constructing interim floodgates at the Lake Pontchartrain end of the canals to block storm surges from flowing into the canals and overloading the I-walls. Large pumping facilities were installed adjacent to the gates to provide a means of evacuating canal storm drainage around the gates when closed. Figure 7 shows a schematic of the canal closure structures.

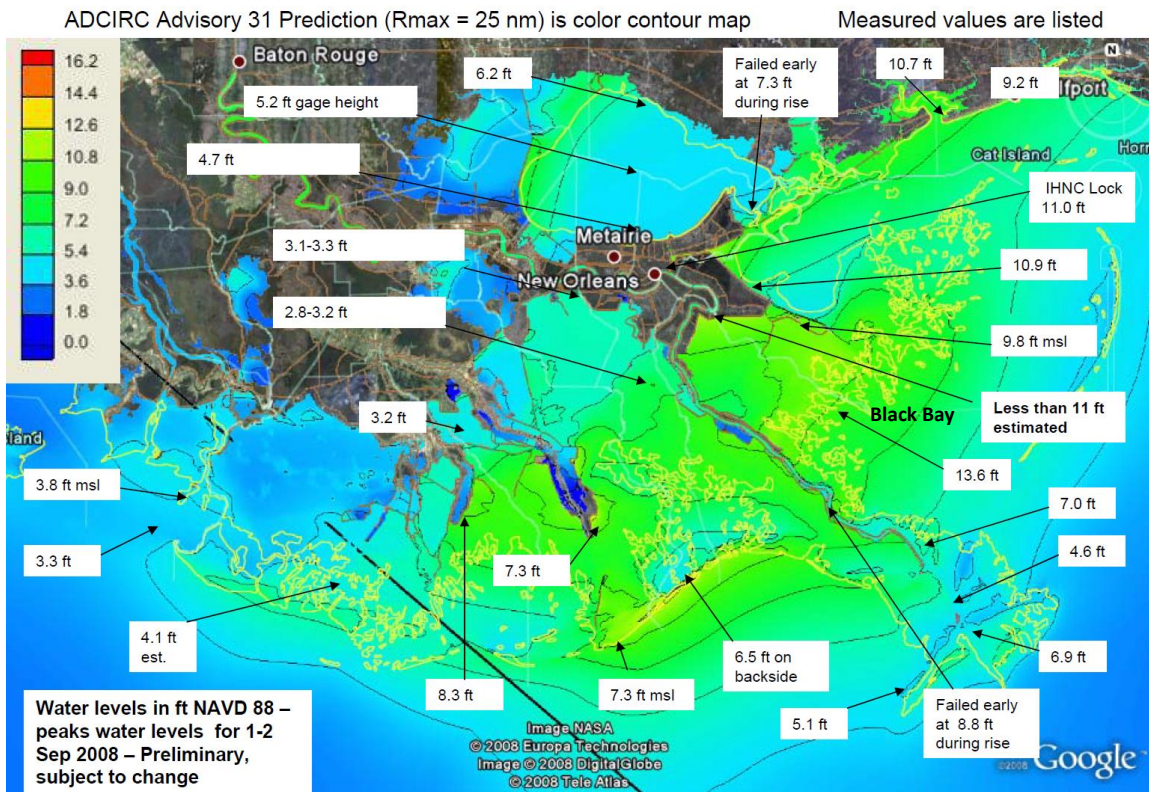
Figure 9. Post-storm assessment of peak water levels during Gustav based on measurements and observations. Only Imperial units were given. Graphic based on preliminary data. (USACE, New Orleans District)

As visible in Figure 9, the storm surge from Hurricane Gustav reached a maximum level, almost 4.3 m (14 ft) (North American Vertical Datum of 1988, NAVD 88), southeast of New Orleans in the marsh bordering Black Bay . Along the New Orleans HSDRRS, the greatest storm surge levels were in the Inner Harbor Navigation Canal (IHNC), also referred to as the Industrial Canal. At the IHNC Lock, the peak water level reached 3.4 m (11 ft). In contrast, the peak storm surge levels in the IHNC during Hurricane Katrina were approximately 1 m (3 ft) higher (IPET 2008), given that the measured peak water level at the IHNC Lock during Katrina was 4.4 m (14.4 ft). Figure 10 shows hindcast hydrographs illustrating the difference in flood levels between Katrina and Gustav at the north end of the MRGO waterway levee.
