Reconnaissance of the New Orleans Hurricane and Storm Damage Risk Reduction System after Hurricane Gustav

ABSTRACT: On October 2 and 3, 2008, a group of civil engineers sponsored by the National Science Foundation (NSF) and organized by the Geoengineering Extreme Events Reconnaissance (GEER) Association, visited the New Orleans area to assess levee performance during hurricane Gustav. This paper summarizes the team's observations and understanding of the state of the New Orleans Hurricane and Storm Damage Risk Reduction System (HSDRRS) in the fall of 2008 and the performance of elements of the HSDRRS during Hurricane Gustav. The fundamental conclusion was that the HSDRRS performed well under the surge and wave stresses generated by Gustav. The team's observations led to lessons about dangers to floodwalls from boats and barges, the importance of timely preparation for hurricanes, erosion resistance of clay levees, and the need for continued emphasis on evacuation for life protection.

Reconnaissance of the New Orleans Hurricane and Storm Damage Risk Reduction System after Hurricane Gustav.

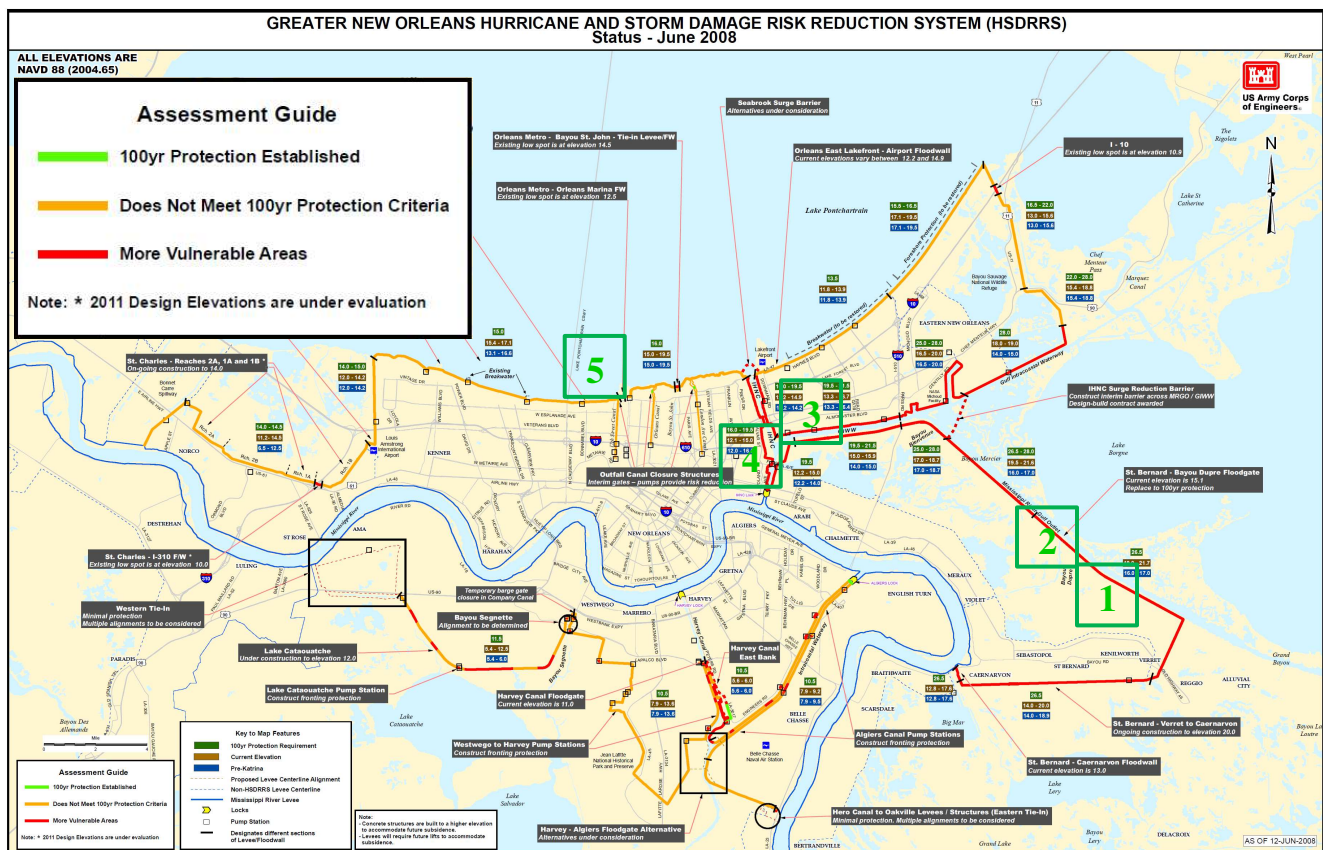
Figure 1. HSDRRS Status Plan, June 2008.

Figure 1 shows the layout and status of the HSDRRS as reported by the USACE in June 2008, about two months before the arrival of Gustav. Our group visited selected locations along the HSDRRS; specifically, where the team knew breaches occurred during Katrina or where our USACE guides identified areas of interest. Table 1 lists the pre-Katrina HPS and June

2008 HSDRRS structure elevations from Figure 1 for the various sites that the team visited or researched. The improvements to the HSDRRS as of August 2008 were, in many places, temporary, to provide a heightened interim level of protection until the planned improvements could be fully completed. The USACE reported completion of those improvements in May 2018.

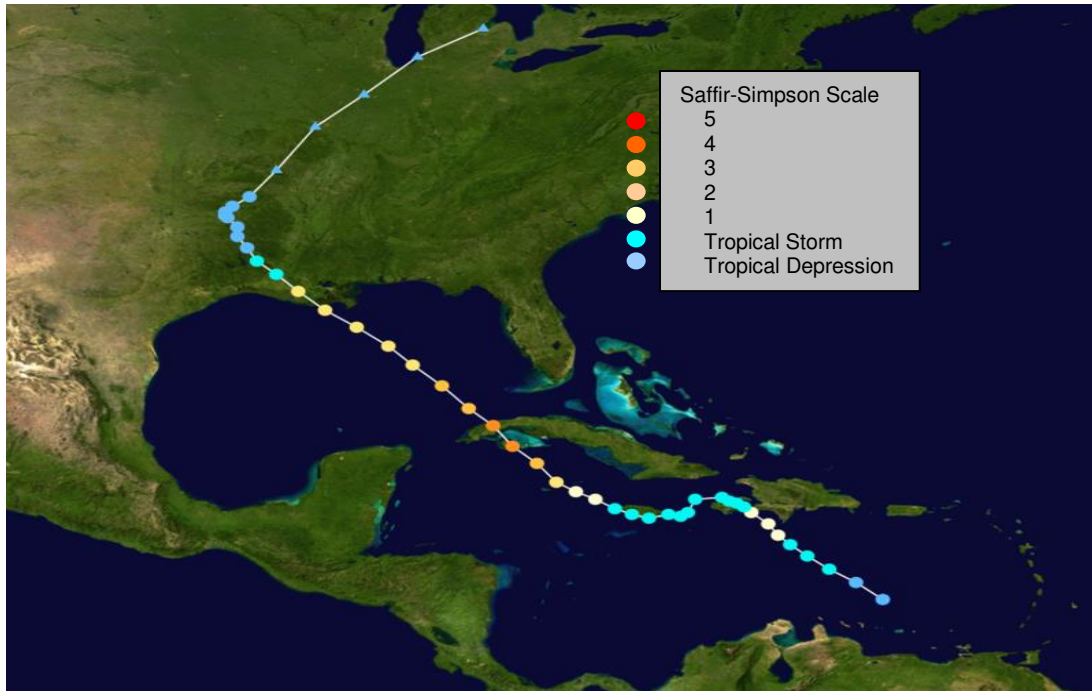
Figure 8. Track of Hurricane Gustav. Picture adapted from National Hurricane Center with background from National Aeronautics and Space Administration (NASA) satellite imagery.

Hurricane Gustav entered the Gulf of Mexico on August 31, 2008, with maximum sustained winds of 135 mph (Category 4) and a minimum central pressure of 958 millibars. The track for Hurricane Gustav is shown in Figure 8. It made landfall just west of Grand Isle in Cocodrie, Louisiana, at about 9:30 AM on September 1, 2008. At landfall, Gustav had maximum sustained winds of about 177 km/hour (110 miles/hr) (Category 2), a minimum central pressure of 955 millibars, and a Radius of Maximum Wind of 46 km (25 nautical miles). Hurricane force winds extended out 129 km (70 nautical miles) from its center at landfall.

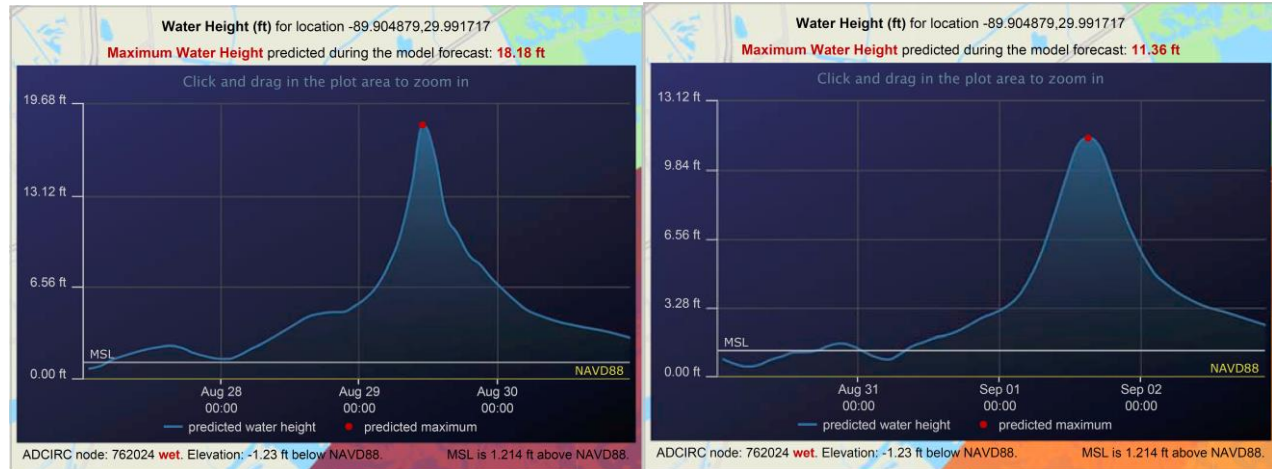
Figure 10. Hindcast hydrographs for Katrina (left, 5.5 m [18.2 ft] peak) and Gustav (right, 3.5 m [11.4 ft] peak) storm surges along MRGO levee. Only Imperial units were retrieved. (<https://cera.coastalrisk.live/>)
