Reconnaissance of the New Orleans Hurricane and Storm Damage Risk Reduction System after Hurricane Gustav

ABSTRACT: On October 2 and 3, 2008, a group of civil engineers sponsored by the National Science Foundation (NSF) and organized by the Geoengineering Extreme Events Reconnaissance (GEER) Association, visited the New Orleans area to assess levee performance during hurricane Gustav. This paper summarizes the team's observations and understanding of the state of the New Orleans Hurricane and Storm Damage Risk Reduction System (HSDRRS) in the fall of 2008 and the performance of elements of the HSDRRS during Hurricane Gustav. The fundamental conclusion was that the HSDRRS performed well under the surge and wave stresses generated by Gustav. The team's observations led to lessons about dangers to floodwalls from boats and barges, the importance of timely preparation for hurricanes, erosion resistance of clay levees, and the need for continued emphasis on evacuation for life protection.

Reference: Wooten L., Gilbert R. B., Marcuson, III W. F., Harder, Jr. L. F., and Nicholson P. G. (2020).

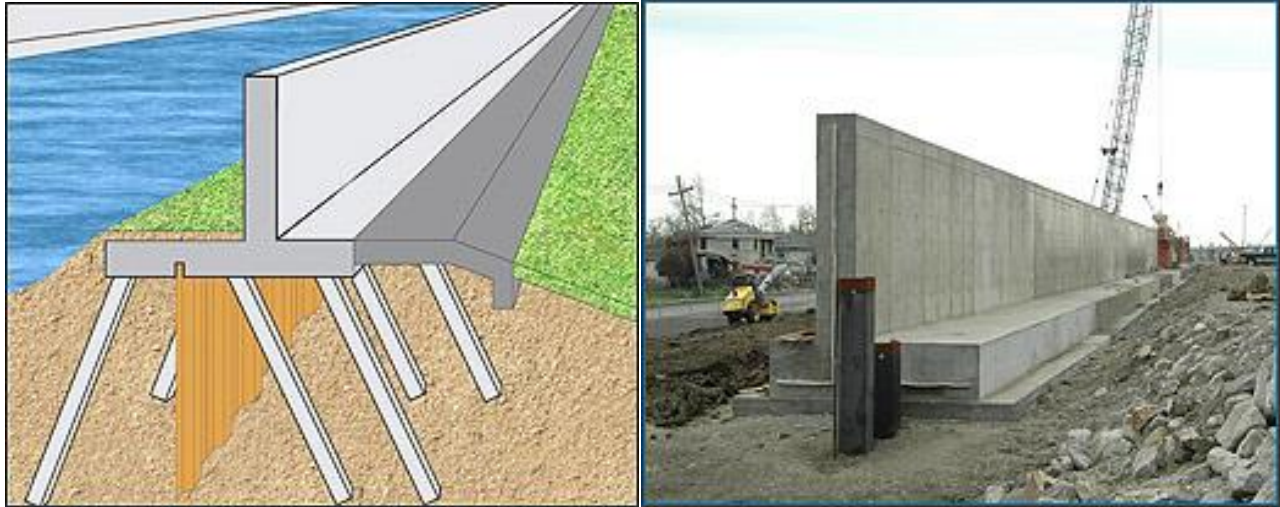
Figures 4 and 5. T-wall schematic and photograph of T-wall under construction.
(http://www.mvn.usace.army.mil/hps2/hps_outfall_canals.asp)

This entire stretch of I-wall, even the section between the two breaches that survived Katrina, was replaced with a T-wall (Figures 3, 4, and 25). The I-wall section south of Claiborne Avenue that did not breach in Katrina was left in place but was reinforced with a larger earthen berm and a buttressing structural concrete splash apron to strengthen the section, reduce the wall height, and provide overtopping scour protection (Figure 26).

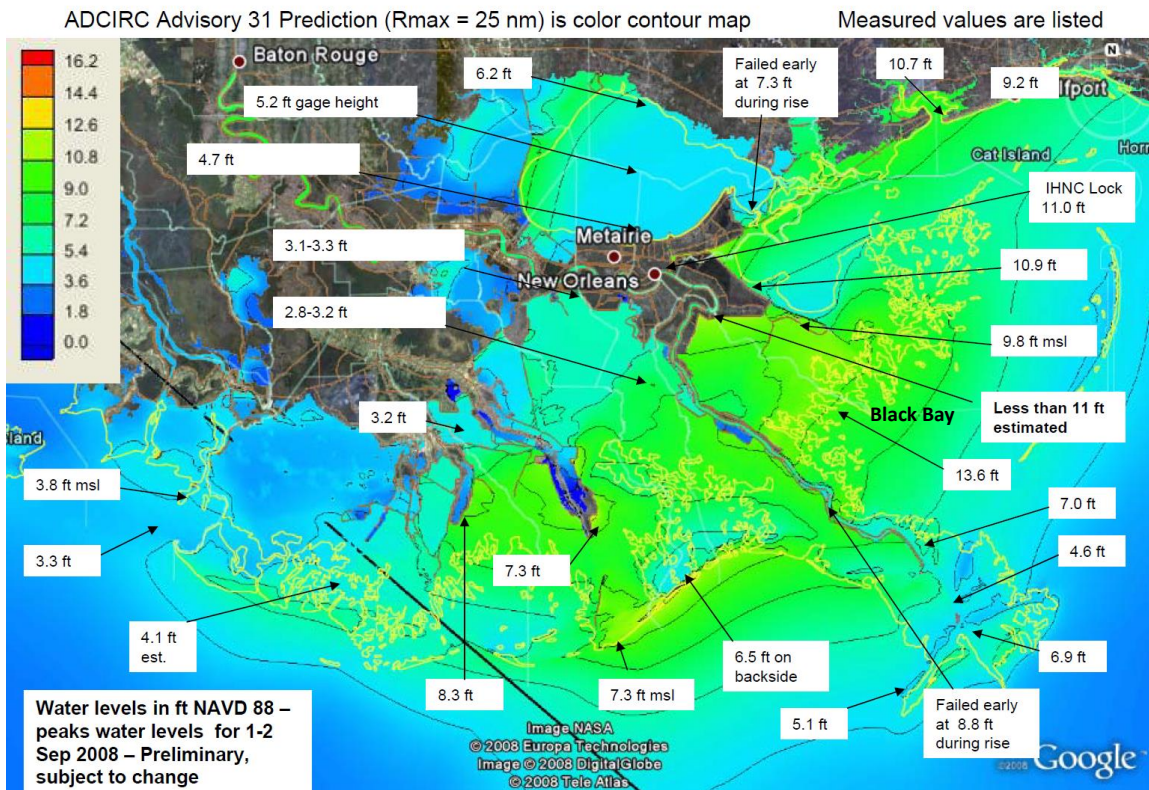
Figure 9. Post-storm assessment of peak water levels during Gustav based on measurements and observations. Only Imperial units were given. Graphic based on preliminary data. (USACE, New Orleans District)

As visible in Figure 9, the storm surge from Hurricane Gustav reached a maximum level, almost 4.3 m (14 ft) (North American Vertical Datum of 1988, NAVD 88), southeast of New Orleans in the marsh bordering Black Bay . Along the New Orleans HSDRRS, the greatest storm surge levels were in the Inner Harbor Navigation Canal (IHNC), also referred to as the Industrial Canal. At the IHNC Lock, the peak water level reached 3.4 m (11 ft). In contrast, the peak storm surge levels in the IHNC during Hurricane Katrina were approximately 1 m (3 ft) higher (IPET 2008), given that the measured peak water level at the IHNC Lock during Katrina was 4.4 m (14.4 ft). Figure 10 shows hindcast hydrographs illustrating the difference in flood levels between Katrina and Gustav at the north end of the MRGO waterway levee.
