## Reconnaissance of the New Orleans Hurricane and Storm Damage Risk Reduction System after Hurricane Gustav

**ABSTRACT:** On October 2 and 3, 2008, a group of civil engineers sponsored by the National Science Foundation (NSF) and organized by the Geoengineering Extreme Events Reconnaissance (GEER) Association, visited the New Orleans area to assess levee performance during hurricane Gustav. This paper summarizes the team's observations and understanding of the state of the New Orleans Hurricane and Storm Damage Risk Reduction System (HSDRRS) in the fall of 2008 and the performance of elements of the HSDRRS during Hurricane Gustav. The fundamental conclusion was that the HSDRRS performed well under the surge and wave stresses generated by Gustav. The team's observations led to lessons about dangers to floodwalls from boats and barges, the importance of timely preparation for hurricanes, erosion resistance of clay levees, and the need for continued emphasis on evacuation for life protection.

International Journal of Geoengineering Case Histories, Volume 5, Issue 4, pp. 129-154, doi: 10.4417/IJGCH-05-04-

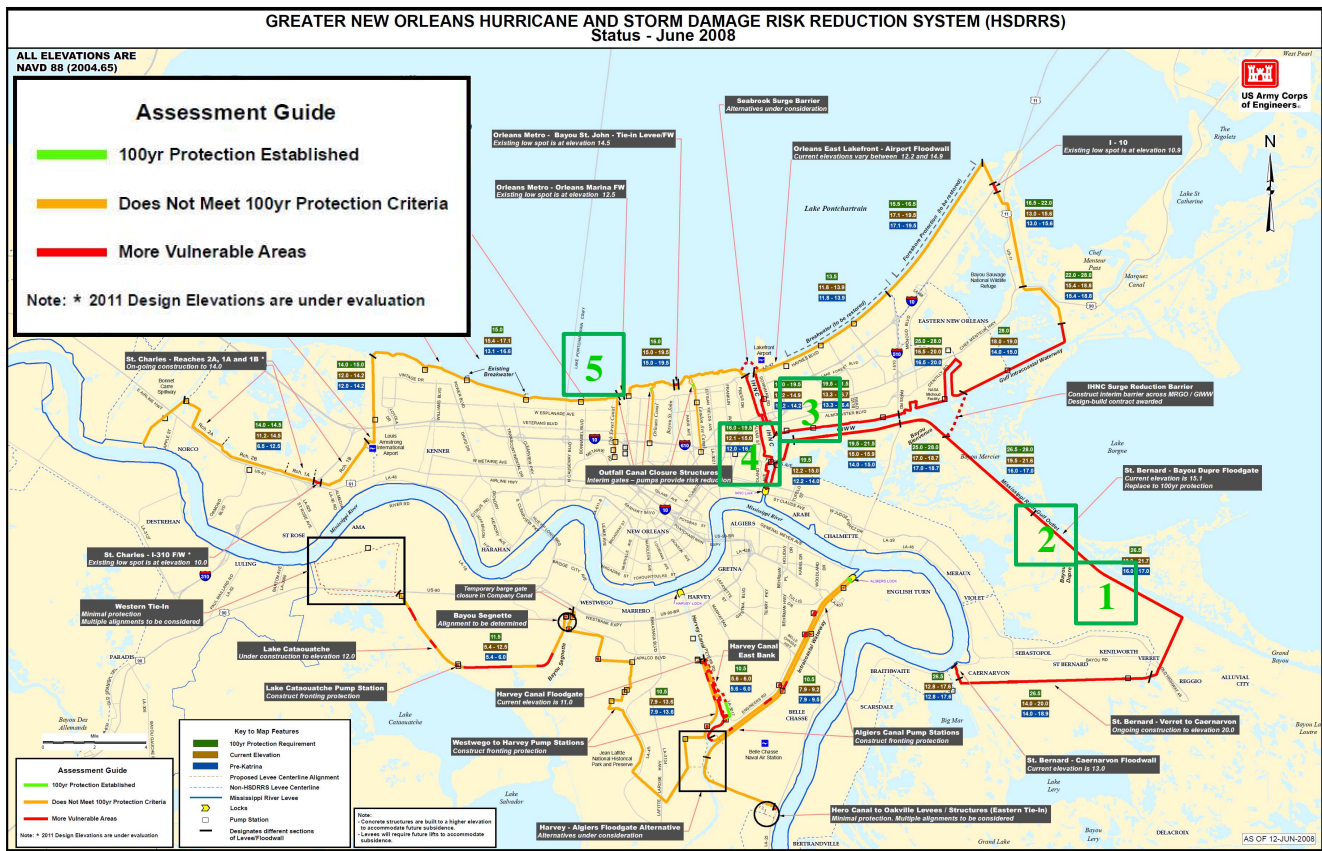
Figure 1. HSDRRS Status Plan, June 2008.

Figure 1 shows the layout and status of the HSDRRS as reported by the USACE in June 2008, about two months before the arrival of Gustav. Our group visited selected locations along the HSDRRS; specifically, where the team knew breaches occurred during Katrina or where our USACE guides identified areas of interest. Table 1 lists the pre-Katrina HPS and June

2008 HSDRRS structure elevations from Figure 1 for the various sites that the team visited or researched. The improvements to the HSDRRS as of August 2008 were, in many places, temporary, to provide a heightened interim level of protection until the planned improvements could be fully completed. The USACE reported completion of those improvements in May 2018.

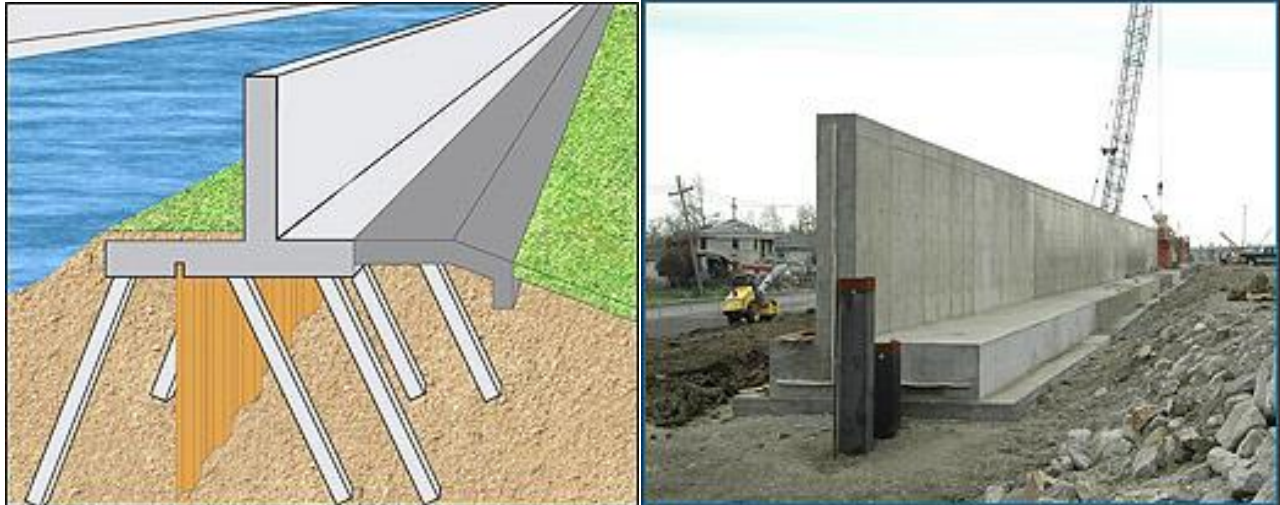
Figures 4 and 5. T-wall schematic and photograph of T-wall under construction.  
([http://www.mvn.usace.army.mil/hps2/hps\\_outfall\\_canals.asp](http://www.mvn.usace.army.mil/hps2/hps_outfall_canals.asp))

This entire stretch of I-wall, even the section between the two breaches that survived Katrina, was replaced with a T-wall (Figures 3, 4, and 25). The I-wall section south of Claiborne Avenue that did not breach in Katrina was left in place but was reinforced with a larger earthen berm and a buttressing structural concrete splash apron to strengthen the section, reduce the wall height, and provide overtopping scour protection (Figure 26).

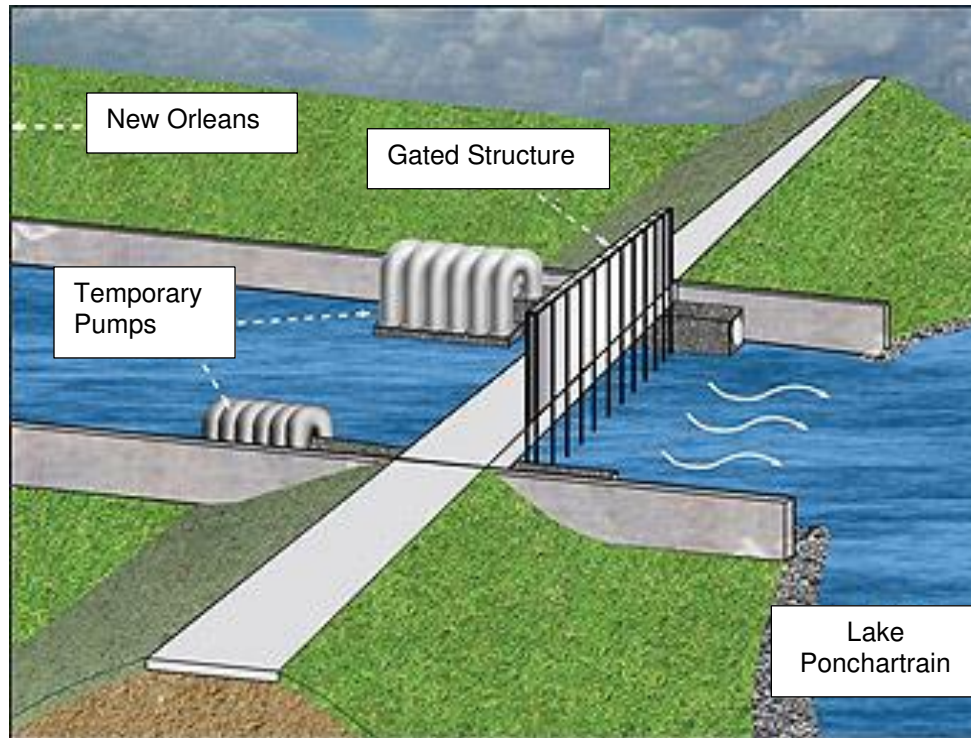
Figure 7. Schematic of canal closure facilities .([http://www.mvn.usace.army.mil/hps2/hps\\_outfall\\_canals.asp](http://www.mvn.usace.army.mil/hps2/hps_outfall_canals.asp))

Drainage Canal Closures – The USACE increased the flood protection for the drainage canals by constructing interim floodgates at the Lake Pontchartrain end of the canals to block storm surges from flowing into the canals and overloading the I-walls. Large pumping facilities were installed adjacent to the gates to provide a means of evacuating canal storm drainage around the gates when closed. Figure 7 shows a schematic of the canal closure structures.

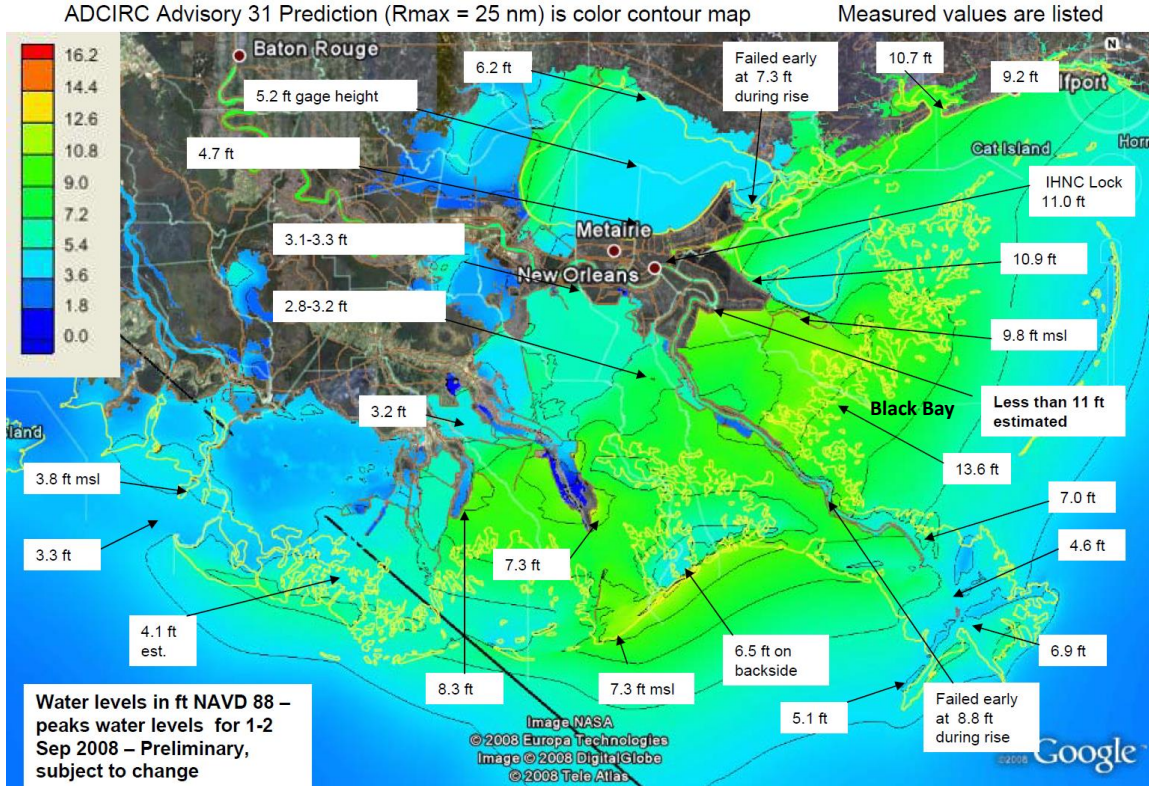
Figure 9. Post-storm assessment of peak water levels during Gustav based on measurements and observations. Only Imperial units were given. Graphic based on preliminary data. (USACE, New Orleans District)

As visible in Figure 9, the storm surge from Hurricane Gustav reached a maximum level, almost 4.3 m (14 ft) (North American Vertical Datum of 1988, NAVD 88), southeast of New Orleans in the marsh bordering Black Bay . Along the New Orleans HSDRRS, the greatest storm surge levels were in the Inner Harbor Navigation Canal (IHNC), also referred to as the Industrial Canal. At the IHNC Lock, the peak water level reached 3.4 m (11 ft). In contrast, the peak storm surge levels in the IHNC during Hurricane Katrina were approximately 1 m (3 ft) higher (IPET 2008), given that the measured peak water level at the IHNC Lock during Katrina was 4.4 m (14.4 ft). Figure 10 shows hindcast hydrographs illustrating the difference in flood levels between Katrina and Gustav at the north end of the MRGO waterway levee.

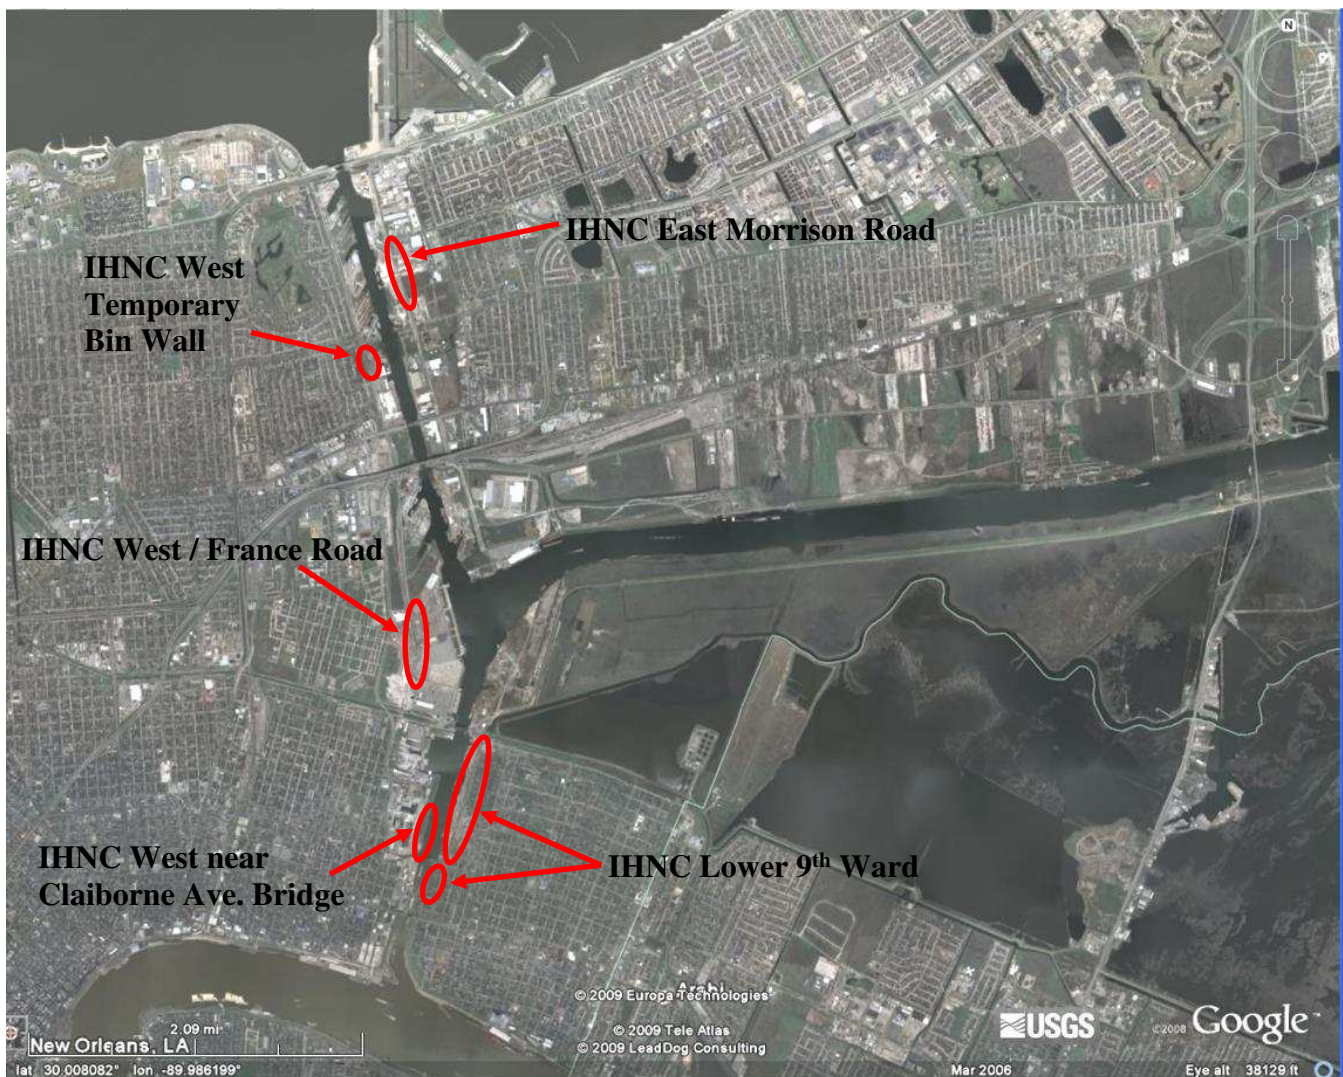
Figure 15. Areas of reconnaissance along IHNC. (Google Earth Image)

The storm surge from Hurricane Gustav in the metro New Orleans area was most dramatic along the IHNC, where several previous floodwall and levee failures resulted in catastrophic damage during Hurricane Katrina. Waves from Gustav overtopped the floodwalls at some locations along the western side of the IHNC. Figure 15 shows the locations of our reconnaissance along the IHNC.

On the western central section of the IHNC (see Figure 15), opposite the junction of the IHNC with the GIWW, the floodwall/levee system is located landward of industrial port facilities, up to about 460 m (1500 ft) from the IHNC. France Road and a railroad parallel much of this part of the HSDRRS. Overtopping surge and waves during Katrina resulted in three breaches in this area.

Clear photographic evidence showed wave overtopping during Hurricane Gustav along the T-wall located on the west side of the IHNC just north of Claiborne Avenue (see Figure 15 for location, and Figures 21 and 22 for photographs during hurricane). This T-wall had previously survived Hurricane Katrina. A concrete splash apron at the toe of the wall on the protected side was added after Katrina to protect from erosion. The wall performed well during Gustav. During the field reconnaissance, the team saw no noticeable sign of distress in the wall, including the joints between concrete panels and in the new concrete splash apron. There was evidence of minor erosion beyond the splash apron on the protected side as well as debris left by the overtopping (Figure 23).

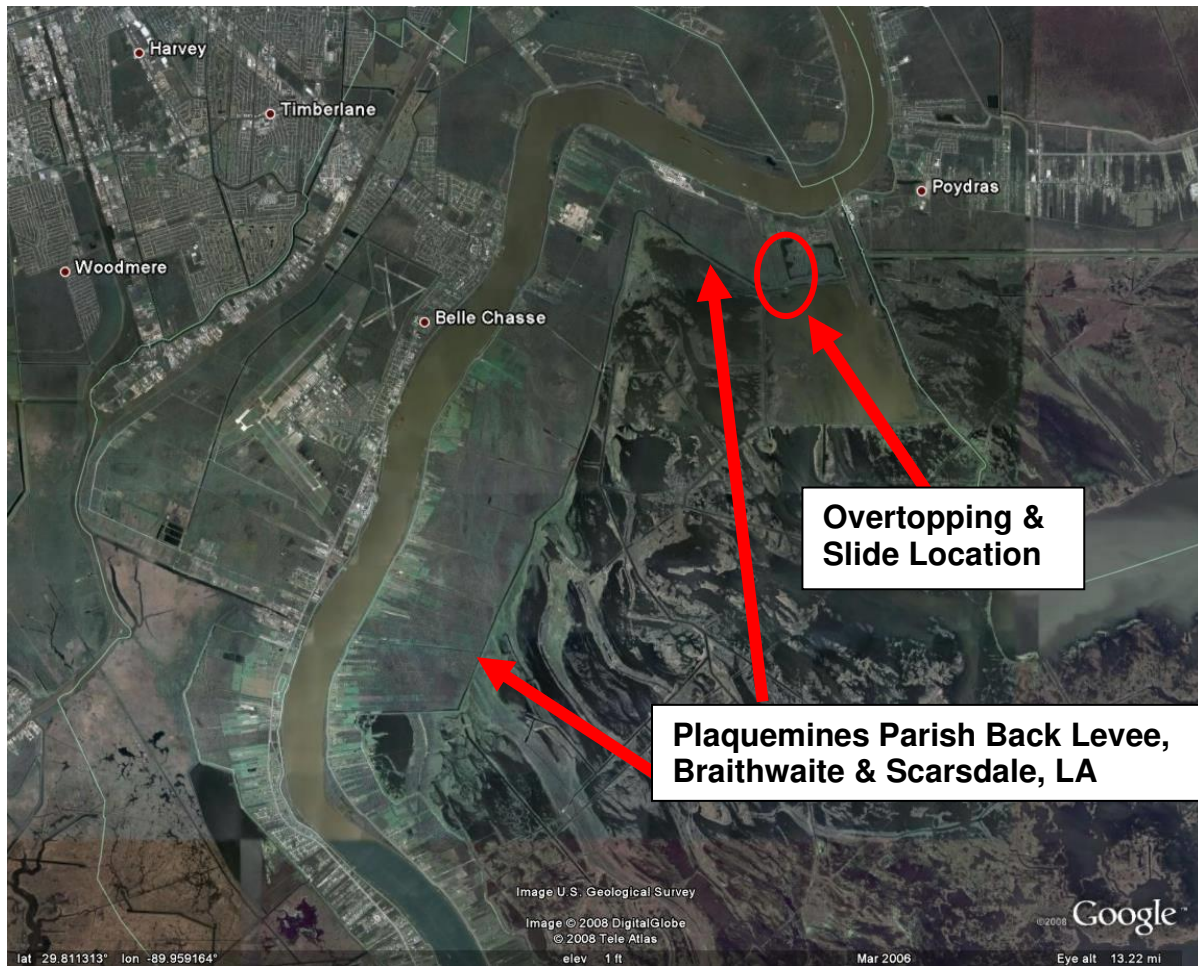
Figure 34. Plaquemines Parish back levee near Braithwaite and Scarsdale, LA. (Google Earth / USGS Imagery)

The team visited one length of non-federal back levee, which was constructed and maintained by Plaquemines Parish and which is not considered part of the New Orleans area HSDRRS. Our team observed about half of the northeastern-most back levee of the Parish, located as shown in Figure 34.

At the time of our visit, multiple sections of the levee crest were still covered with a slit-film woven geotextile, held in place with a continuous sand bag berm on the flood side and by intermittent sand bags on the protected side of the crest. Based on our observations and on interviews with a pump station operator, it appears that much of the back levee was overtopped and that a slope slide or slough had occurred on the protected side of the levee along one ~90-m- (~300-ft-) long levee section as shown in Figure 35. Figure 36 shows a part of the scarp for that slough. The team also observed that desiccation cracks were prevalent along parts of the levee. The desiccation cracks may have contributed to the slide by allowing overtopping water pressures into embankment zones critical to slope stability. The placement water content, compaction, and organic content of the back-levee soils were not known and may be factors in the susceptibility of the levee soils to desiccation cracks and erosion.

Along more southerly sections of the levee, the team observed signs of overtopping with less dramatic effects. Debris from overtopping and erosion gullies, often covered with sand bags, was prevalent along all sections of the levee.
