Reconnaissance of the New Orleans Hurricane and Storm Damage Risk Reduction System after Hurricane Gustav

Reconnaissance of the New Orleans Hurricane and Storm Damage Risk Reduction System after Hurricane Gustav.

International Journal of Geoengineering Case Histories, Volume 5, Issue 4, pp. 129-154, doi: 10.4417/IJGCH-05-04-07

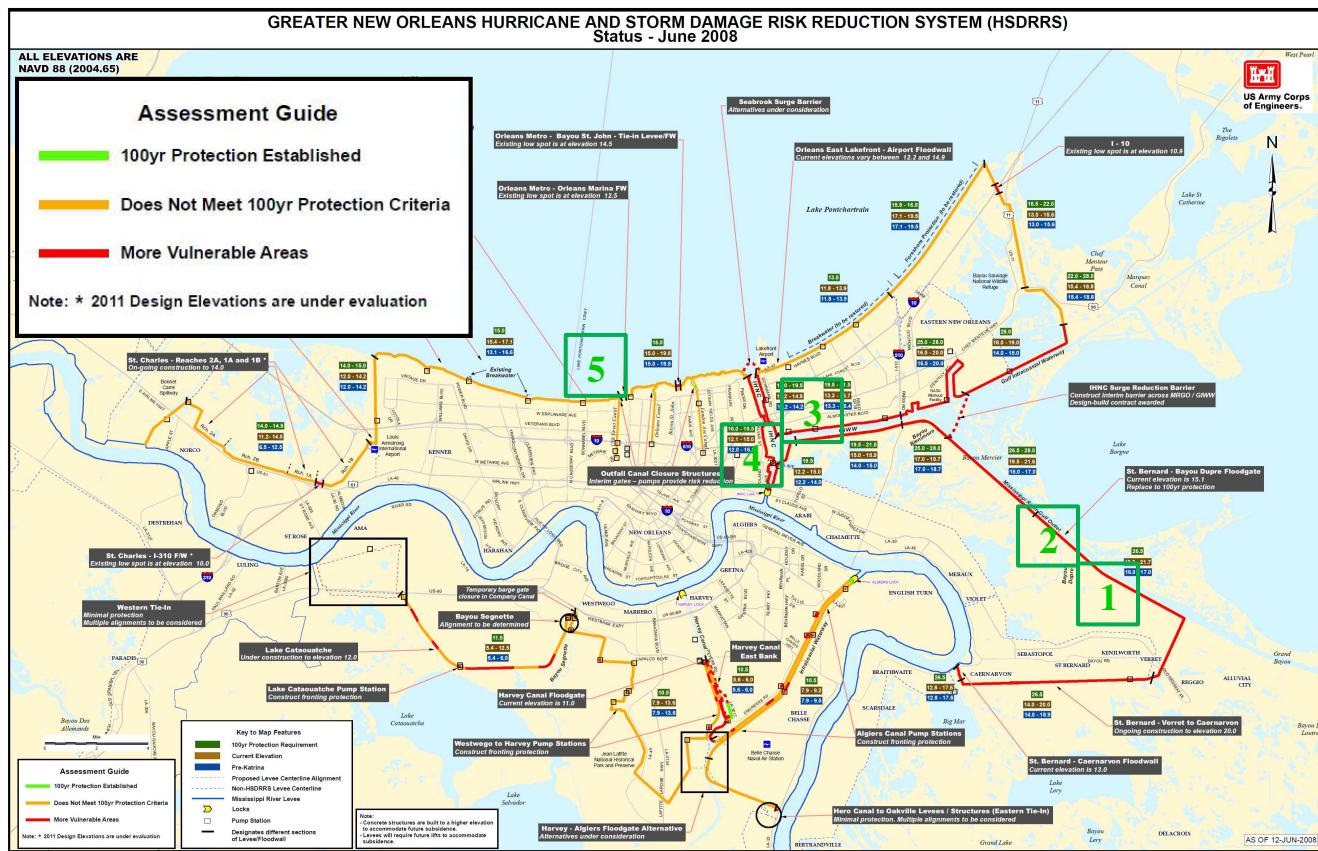
Figure 1 shows the layout and status of the HSDRRS as reported by the USACE in June 2008, about two months before the arrival of Gustav. Our group visited selected locations along the HSDRRS; specifically, where the team knew breaches occurred during Katrina or where our USACE guides identified areas of interest. Table 1 lists the pre-Katrina HPS and June

Figure 1. HSDRRS Status Plan, June 2008.
http://www.mvn.usace.army.mil/hps/pdf/2008_Storm_Vulnerability_Elev_final.pdf

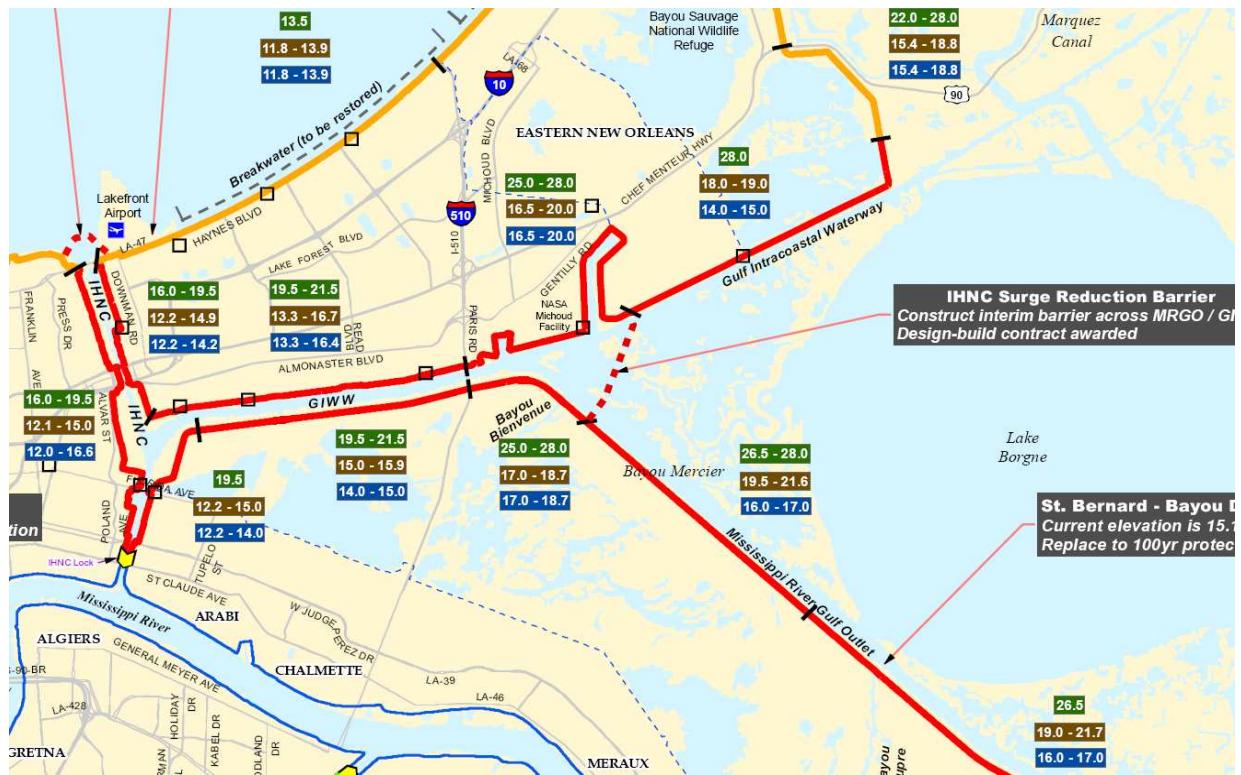
Figure 2. Section of HSDRRS plan, eastern New Orleans and St. Bernard Polders. (http://www.mvn.usace.army.mil/hps/pdf/2008_Storm_Vulnerability_Elev_final.pdf)

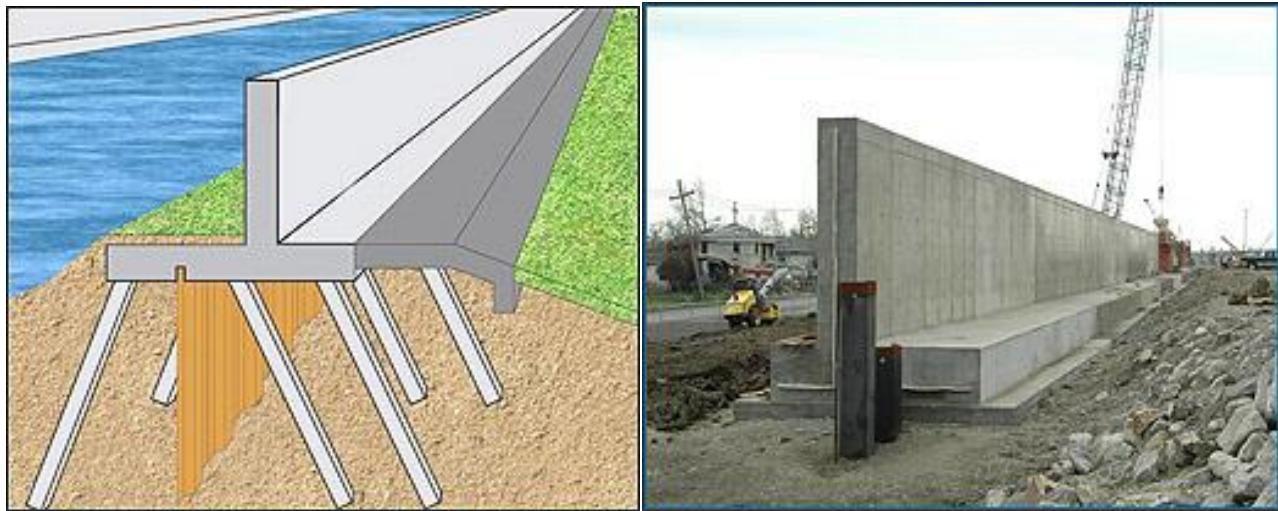
*Figures 4 and 5. T-wall schematic and photograph of T-wall under construction.
http://www.mvn.usace.army.mil/hps2/hps_outfall_canals.asp*

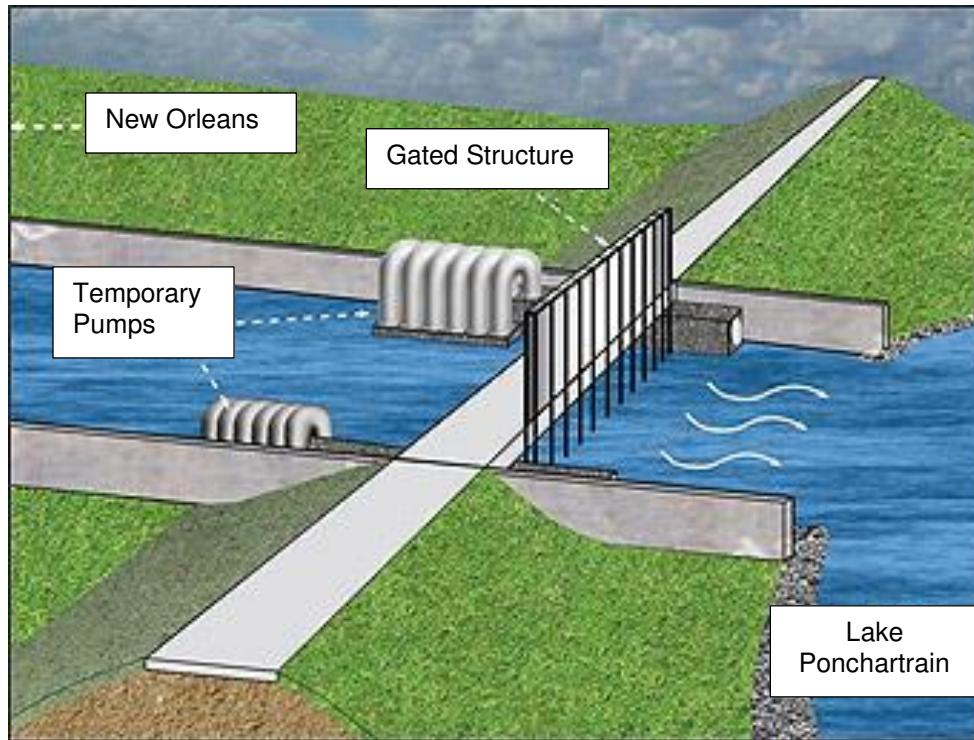
Figure 7. Schematic of canal closure facilities .(http://www.mvn.usace.army.mil/hps2/hps_outfall_canals.asp)

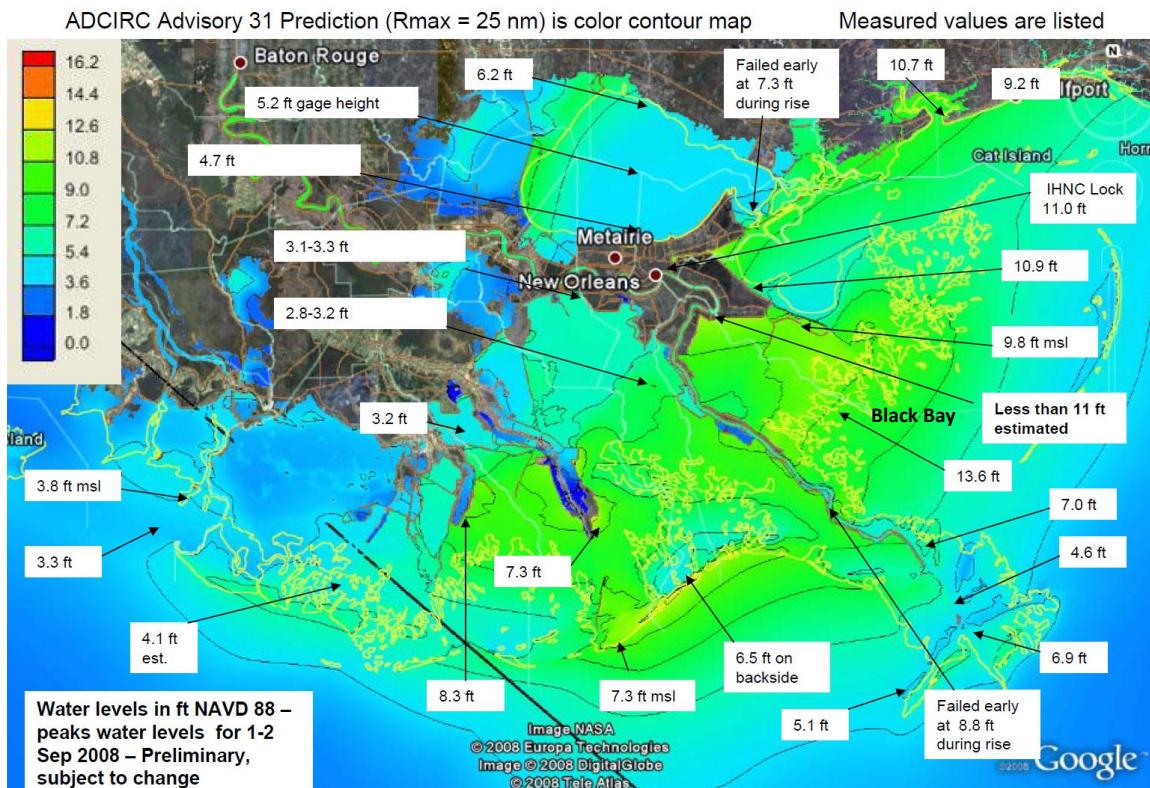
As visible in Figure 9, the storm surge from Hurricane Gustav reached a maximum level, almost 4.3 m (14 ft) (North American Vertical Datum of 1988, NAVD 88), southeast of New Orleans in the marsh bordering Black Bay . Along the New Orleans HSDRRS, the greatest storm surge levels were in the Inner Harbor Navigation Canal (IHNC), also referred to as the Industrial Canal. At the IHNC Lock, the peak water level reached 3.4 m (11 ft). In contrast, the peak storm surge levels in the IHNC during Hurricane Katrina were approximately 1 m (3 ft) higher (IPET 2008), given that the measured peak water level at the IHNC Lock during Katrina was 4.4 m (14.4 ft). Figure 10 shows hindcast hydrographs illustrating the difference in flood levels between Katrina and Gustav at the north end of the MRGO waterway levee.

Figure 9. Post-storm assessment of peak water levels during Gustav based on measurements and observations. Only Imperial units were given. Graphic based on preliminary data. (USACE, New Orleans District)

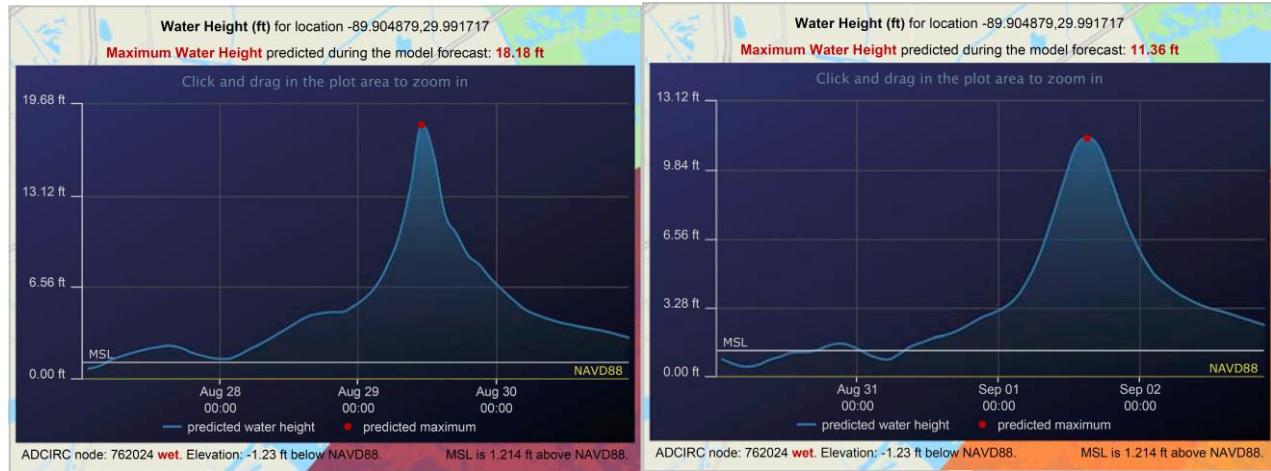
Figure 10. Hindcast hydrographs for Katrina (left, 5.5 m [18.2 ft] peak) and Gustav (right, 3.5 m [11.4 ft] peak) storm surges along MRGO levee. Only Imperial units were retrieved. (<https://cera.coastalrisk.live/>)

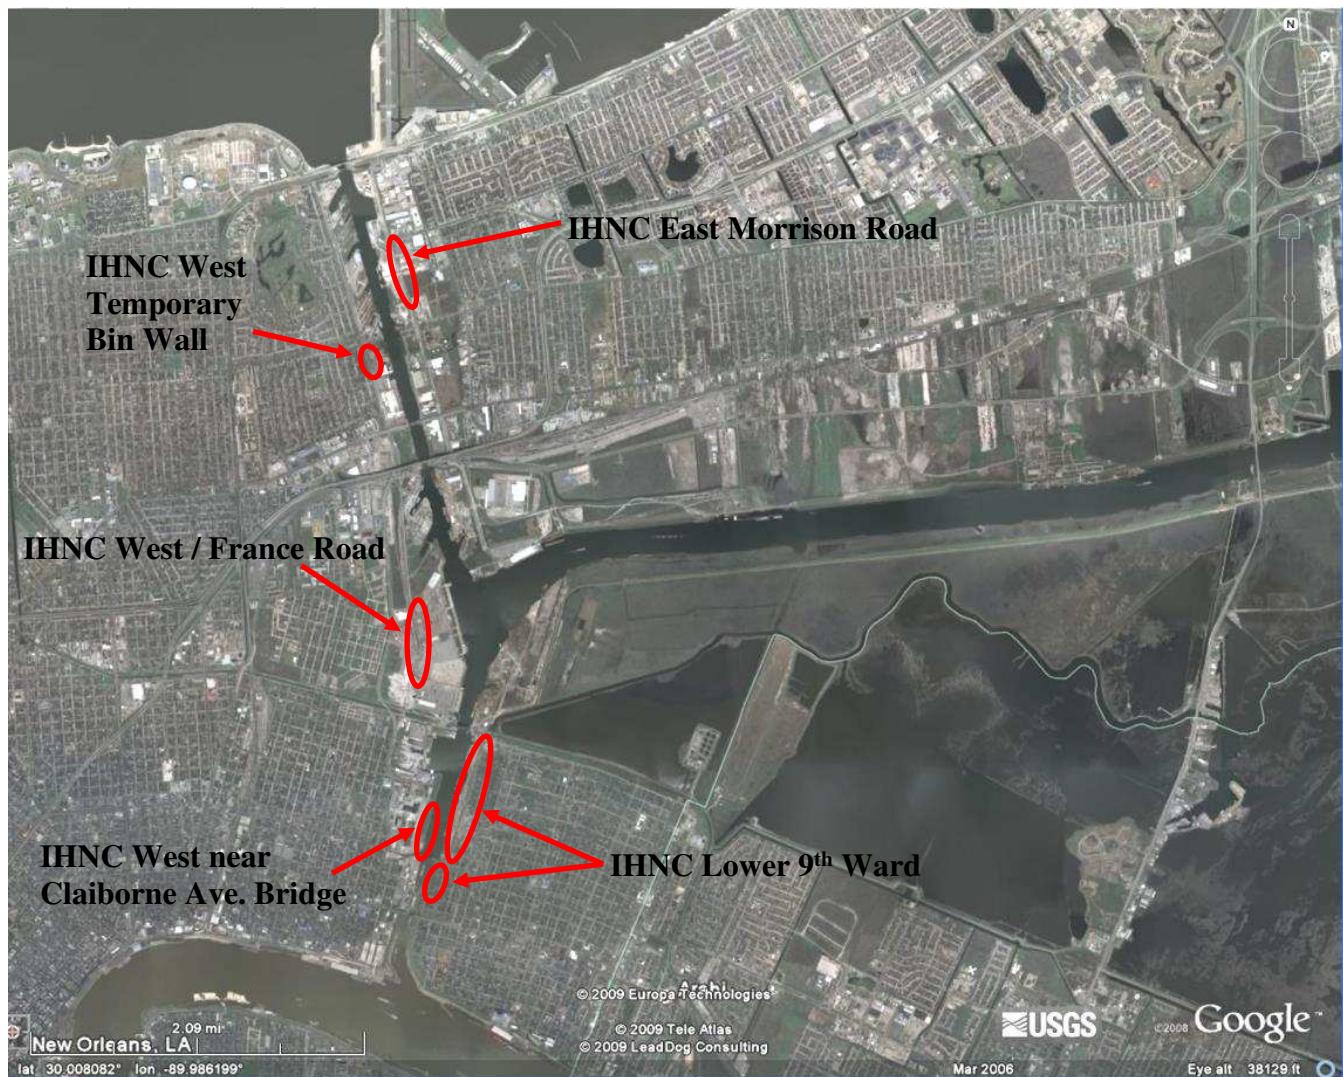
The storm surge from Hurricane Gustav in the metro New Orleans area was most dramatic along the IHNC, where several previous floodwall and levee failures resulted in catastrophic damage during Hurricane Katrina. Waves from Gustav overtopped the floodwalls at some locations along the western side of the IHNC. Figure 15 shows the locations of our reconnaissance along the IHNC.

Figure 15. Areas of reconnaissance along IHNC. (Google Earth Image)

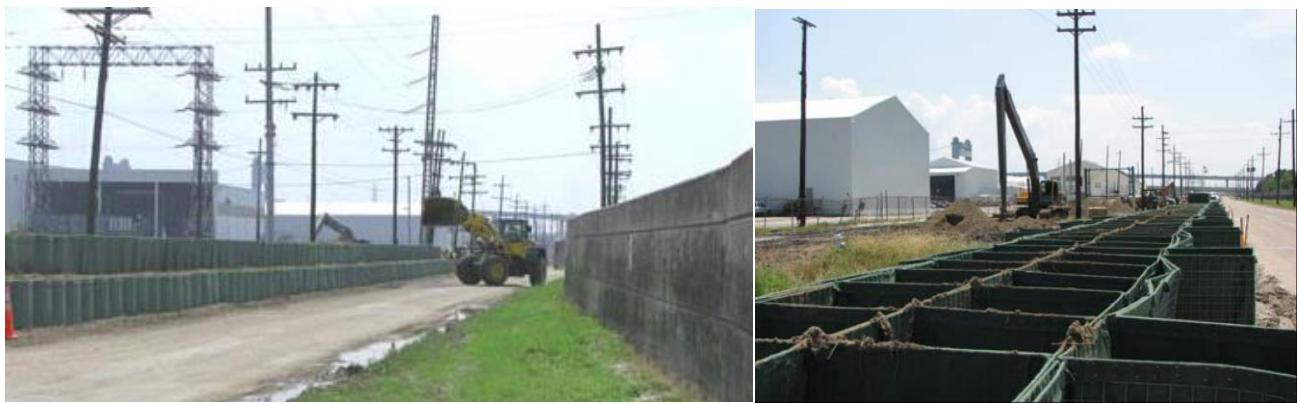
Immediately prior to Gustav, the USACE constructed a ~550-m- (~1800-ft-) long temporary bin wall using HESCO baskets to protect one length of the I-wall along the northwest side of the IHNC that did not meet required stability criteria. Figure 30 shows the temporary bin wall under construction by the USACE, and Figure 31 shows the bin wall immediately after Gustav.

Figure 30. Temporary bin wall under construction, IHNC West along France Road. (August 2008, 30.0157° N, 90.0324° W, http://www.mvn.usace.army.mil/HPS>Status%20Report%20Newsletters/Sept_9_2008.pdf)

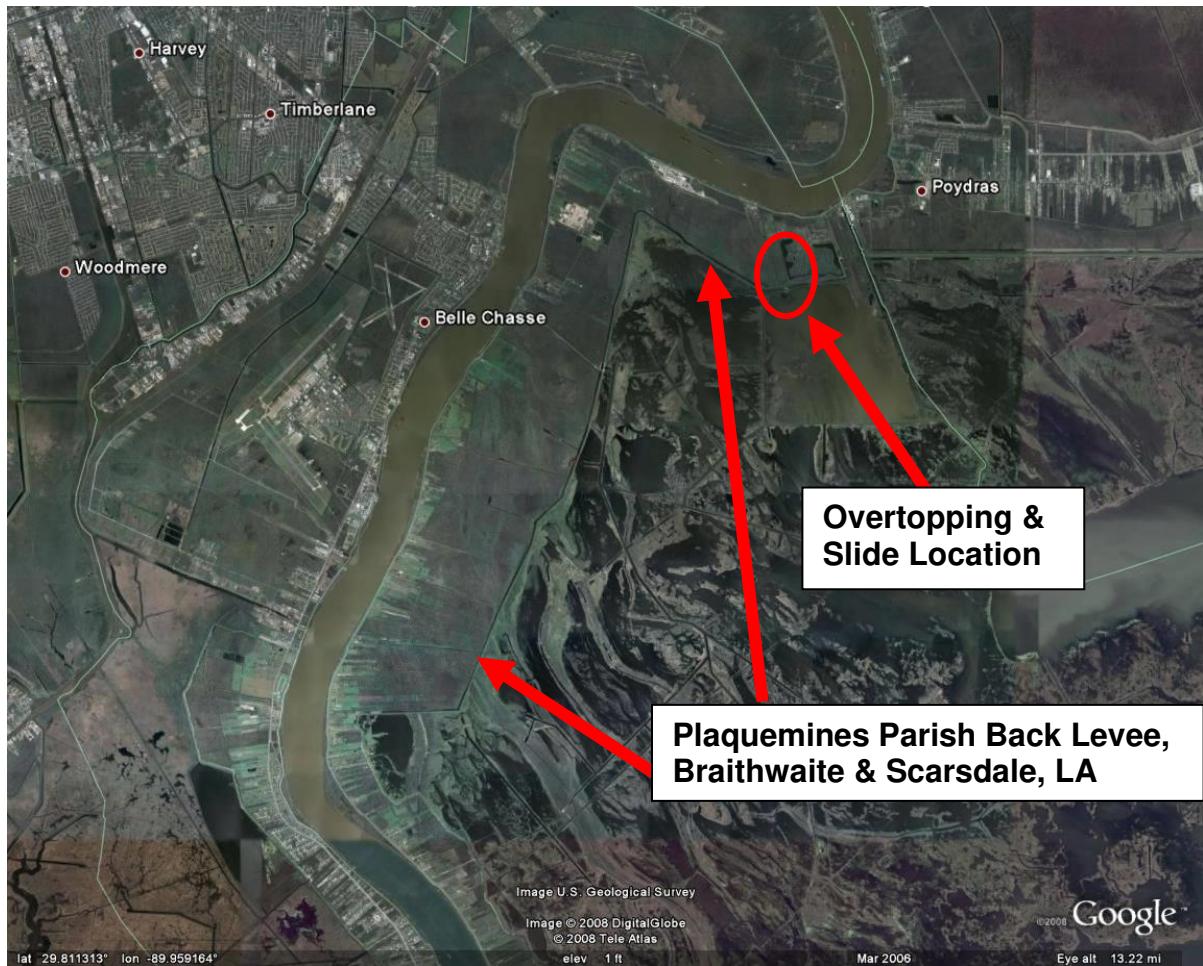
The team visited one length of non-federal back levee, which was constructed and maintained by Plaquemines Parish and which is not considered part of the New Orleans area HSDRRS. Our team observed about half of the northeastern-most back levee of the Parish, located as shown in Figure 34.

At the time of our visit, multiple sections of the levee crest were still covered with a slit-film woven geotextile, held in place with a continuous sand bag berm on the flood side and by intermittent sand bags on the protected side of the crest. Based on our observations and on interviews with a pump station operator, it appears that much of the back levee was overtopped and that a slope slide or slough had occurred on the protected side of the levee along one ~90-m- (~300-ft-) long levee section as shown in Figure 35. Figure 36 shows a part of the scarp for that slough. The team also observed that desiccation cracks were prevalent along parts of the levee. The desiccation cracks may have contributed to the slide by allowing overtopping water pressures into embankment zones critical to slope stability. The placement water content, compaction, and organic content of the back-levee soils were not known and may be factors in the susceptibility of the levee soils to desiccation cracks and erosion.

Along more southerly sections of the levee, the team observed signs of overtopping with less dramatic effects. Debris from overtopping and erosion gullies, often covered with sand bags, was prevalent along all sections of the levee.

Figure 34. Plaquemines Parish back levee near Braithwaite and Scarsdale, LA. (Google Earth / USGS Imagery)
