Images Collected from the Internet Reveal the Failing Mechanism of the Tailing Dam Breach at Kolontar, Hungary

Jozsef Garai, Retired Professor from the Department of Civil Engineering, University of Debrecen, Ótemető u. 2-4, 4028 Debrecen, Hungary; email: jozsefgarai29@gmail.com

Reference: Garai J., and Kovács I. (2025). *Images Collected from the Internet Reveal the Failing Mechanism of the Tailing Dam Breach at Kolontar, Hungary*. International Journal of Geoengineering Case Histories, Volume 8, Issue 1, 52 (2011) 10 4417/HGGH 20 21 24

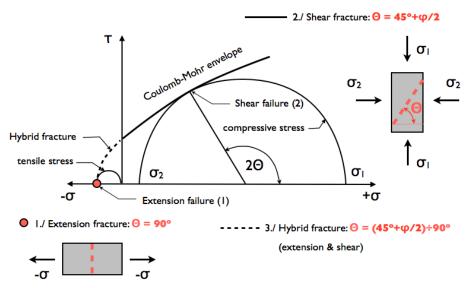
Figure 4. The two types of fractures are extension and shear. The dashed line shows the area where hybrid fractures occur, resulting from the transformation from extension to shear failure (Ramsey & Chester, 2004). The angles of the failed surface or fractures are given in relation to the principal stresses for the different failures.

Location II is in the middle of the North dam. The fracture pattern is quite complex. Based on the fracture pattern, it can be identified that the fractures -2_a and -2_b relate to bending (Figure 6). The tension side of the bending was the outer side of the reservoir. However, on this side (outward from the reservoir), shear fractures 0_c and 0_d are also present, indicating compression stress on the same side (Figures 4 and 5).

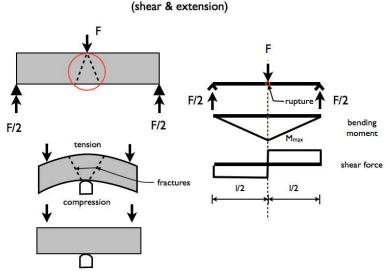
If the tensile strength of the substance is weaker than the compression, like rocks and concrete, then the tensile resistance of the substance is first exhausted and extension fracture develops (Figure 5b). If the bending is accompanied with shear stress, like a beam loaded in the middle, then a hybrid fracture pattern should develop (Melvin, 1993), as shown in Figure 6.

Figure 6. Combined extension and shear stress occurs in a beam when the load acts in the middle. This "bending force" produces hybrid fractures, resulting in a triangular or trapezoidal fracture shape (Melvin, 1993).
