Quarry-Induced Slope Instability at a Broadcasting Transmission Plant near Valcava, Lombardia, Italy

ABSTRACT: Since 2006, a broadcasting tower and ancillary buildings on the top of a hill adjacent to a large, active limestone quarry, in northern Italy near the village of Valcava, has been heavily damaged by ground deformation due to slope instability. In 2005, the quarry began to work the slope toward the broadcasting plant, releasing bedding planes that affected the tower site: a number of fractures occurred in the warehouse and in the ground around it, that grew particularly during significant rainfalls. In October 2006 a landslide occurred in the quarry area, close to the broadcasting site. In order to understand what induced the fracture process in the buildings and define a support system to stabilize the broadcasting site, a detailed geotechnical survey and a number of numerical slope stability analyses were carried out. One of the main goals of the paper is to underline the effectiveness of the numerical analyses to understand the instability phenomena when they are particularly complex. Furthermore, by using a reliable numerical model with a good understanding of site geo

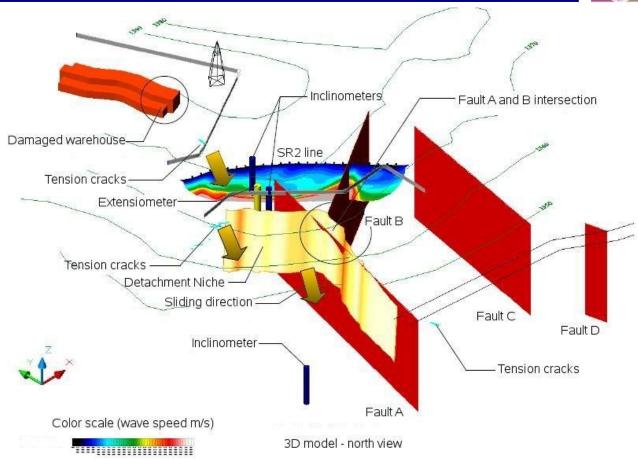
One seismic refraction and two geo-electrical soundings were located near the warehouse on the unstable slope, toward the pit. Another pair of seismic and geo-electrical outlines was located close to the broadcasting tower base (Figures 6 and 7). The data were processed with tomographic technique (Hampson & Russel, 1984; Olsen, 1989) and then interpreted considering the conventional exploration with core-drilling data. Similar results were generated in the slope and in the tower area. Upslope of the warehouse, in the tower area, there is a superficial layer of fill about 3 m deep, underlain by a layer of fractured limestone overlying apparently intact bedrock at a depth of about 16 m, as shown in Figure 8. Near the warehouse, upslope from the landslide, a pit showed the same stratigraphic sequence is observed in the tower area, as well as evidence of the two main faults A and B (Figure 9). Because of fault B, the apparently intact limestone is found at a depth of more than 20 m. The seismic survey thus confirmed the likelihood that the sliding surface was located above a depth of 20 m.

Figure 7. Three dimensional model for the seismic and geo-electrical survey.

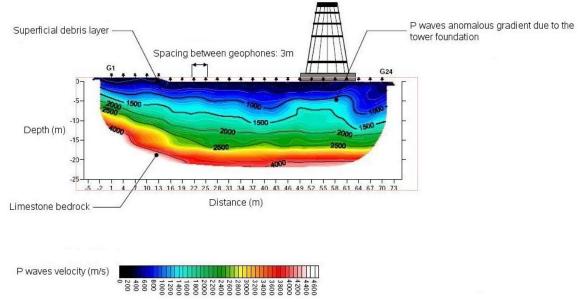
Figure 8. Seismic refraction survey results: P waves velocity trend inside the rock mass near the broadcasting tower.

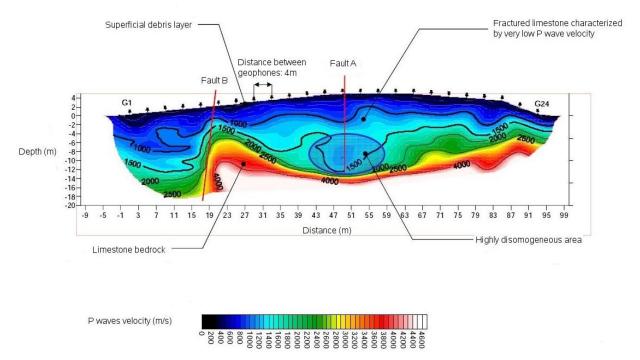
Figure 9. Seismic refraction survey results: P waves velocity trend inside the rock mass, below the warehouse area.

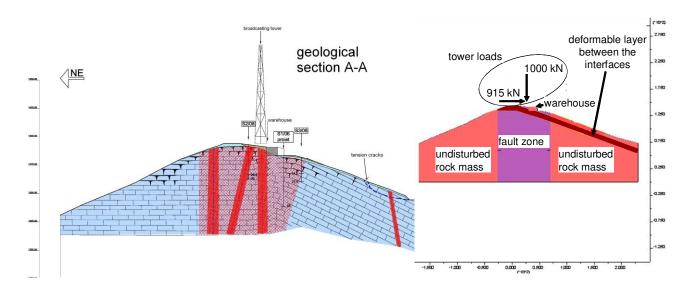
A section of interest was modeled (section A-A in Figure 1 and Figure 11, left), in the NE-SW direction, between the broadcasting site and the pit, across the zone in which tension cracks were observed and close to the landslide. According to the geotechnical characterization, two materials with different mechanical characteristics were used in the model: one to represent the fractured fault zone in the central part of the model, below the broadcasting plant, and the other to simulate the undamaged rock mass.

An ideal elasto-plastic model was considered for the rock mass, the interfaces and the ubiquitous joints. Plane strain conditions were assumed in 2D analyses. The strength and deformability parameters used in the numerical analyses, defined by the geotechnical characterization (minimum values), reduced by a partial safety factor of 2 for the cohesion and 1.25 for the friction coefficient, are collected in Table 5. The model was discretized with quadrangular, four-nodes plane elements; the presence of the warehouse on the top of the slope has been simulated using quadrangular elements with linear elastic behavior (unit weight: 10 kN/m³, elastic parameters equal to those of the undisturbed rock mass). A vertical force of 1000 kN and a horizontal force of 915 kN were applied on the top of the slope, to simulate the broadcasting tower loading, according to the tower design data (Figure 11, right).

Figure 11. Geological section A-A (left) and model for numerical analyses (right).

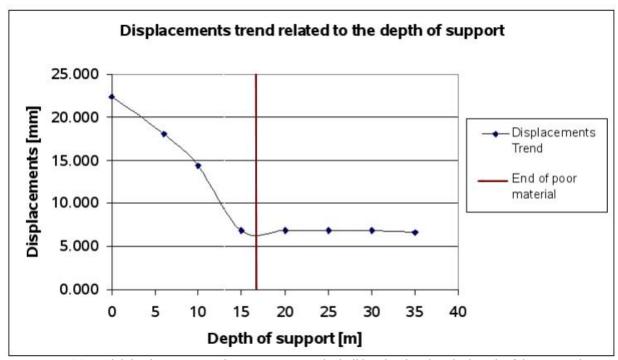
Figure 16. Model displacements in the area upstream the bulkhead, related to the length of the micropiles (assuming that in-situ bedrock is at 16 m depth).

The results (Figure 16) confirm that the minimum length for the micropiles is about 16 m (the depth at which the boundary between the weaker layer and the undisturbed rock mass is located). On the other hand micropile lengths greater than 20 m don't provide further benefit to the plant stability. It is possible to conclude that 27 m is a good estimate of the length for the micropiles.

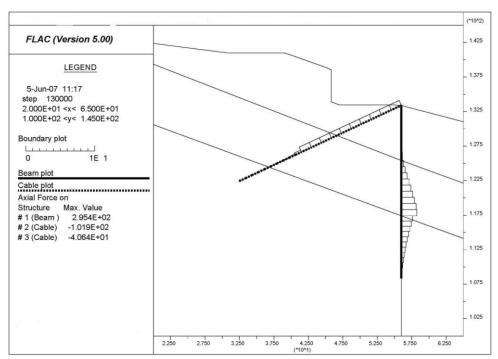
Figure 17. Axial forces acting on micropiles and anchors.

numerical analyses provided the normal force, bending moment and shear force acting on the micropiles and the axial forces acting on the anchors (Figures 17, 18 and 19). These results were used to design the steel elements.

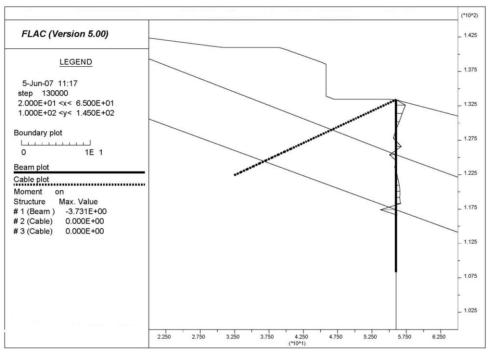
Figure 18. Bending moment acting on micropiles.

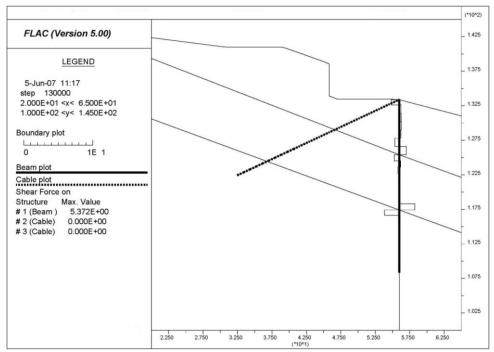
Figure 19. Shear force acting on micropiles.
