Embankment Failure in Residual Soils at Nivsar, Ratnagiri

ABSTRACT: The Nivsar Yard embankment was constructed by the Konkan Railways in 1994. Near the station building, the 22m high embankment runs parallel to the Kajali River for a stretch of about 100m. This stretch has experienced failure and settlement related problems since the record-breaking July 2005 rainfall. Corrective ground improvement measures were implemented immediately after the monsoon. However, these measures were inadequate because the failure surface reappeared during the following monsoon. The failure surface mirrored the shape and size of the failure observed in 2005. Since then after nearly every monsoon, the embankment has moved despite precautionary measures taken by the railway to arrest the movement. The hydrogeological and geotechnical properties which affect slope stability are first discussed. The stability of the embankment is then evaluated at 5 sections drawn along the slope. Two cases are considered. In the first case, the stability of the unreinforced slope is calculated. In the second case, calculations are done using the slope reinforced with soil nails and micropiles installed in 2005 and 200

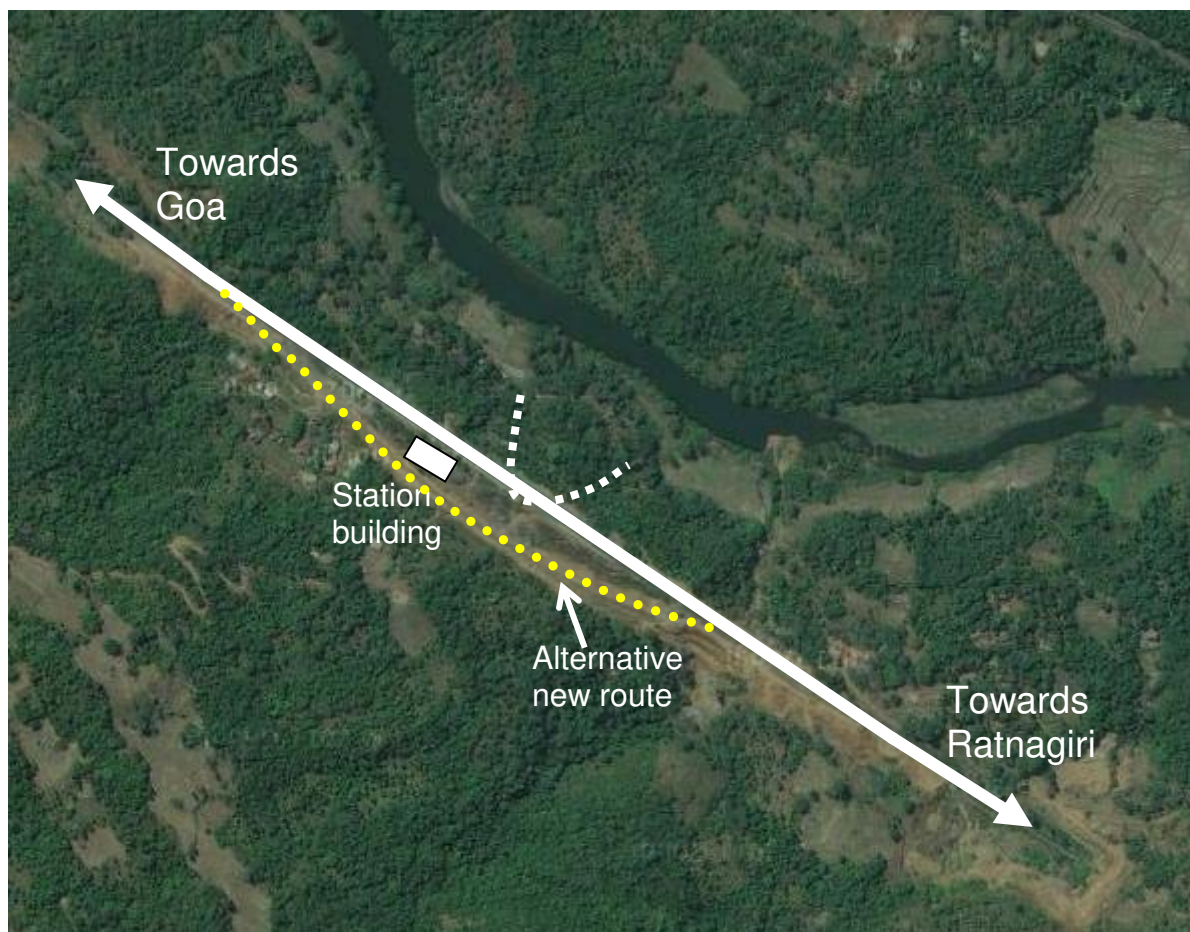
Figure 1. Nivsar Station in Ratnagiri District of Maharashtra (Source: Google earth). Note: The dashed line shows the approximate location of the embankment failure .

In 2010, the rail track was realigned to bypass the failure surface. This arrangement provided immediate relief to the rail-traffic. Figure 1 also shows the new alternate route used by the Konkan Railways. Since then, three other lines have been realigned to follow this alternate route. Irrespective of the above change in the rail alignment, Figure 3 also shows that the rate of settlement of the embankment has reduced since the 2009 monsoon. It is plausible to assume that the slump accumulated at the toe has reduced the gradient and hence affected the soil movement over this period (Figure 5). The site was re-investigated in 2010. The results of the re-investigation are part of this present study. The objective of this paper is to investigate the slope failure at Nivsar as recorded since the year 2005. Stability of the embankment before and after the ground improvement works is discussed. Railway loads from the old as well as the new rail alignment were used in the analysis. The critical failure circle for each case is shown to be affected by the geometry of the slope and the hydrogeological conditions at the site.

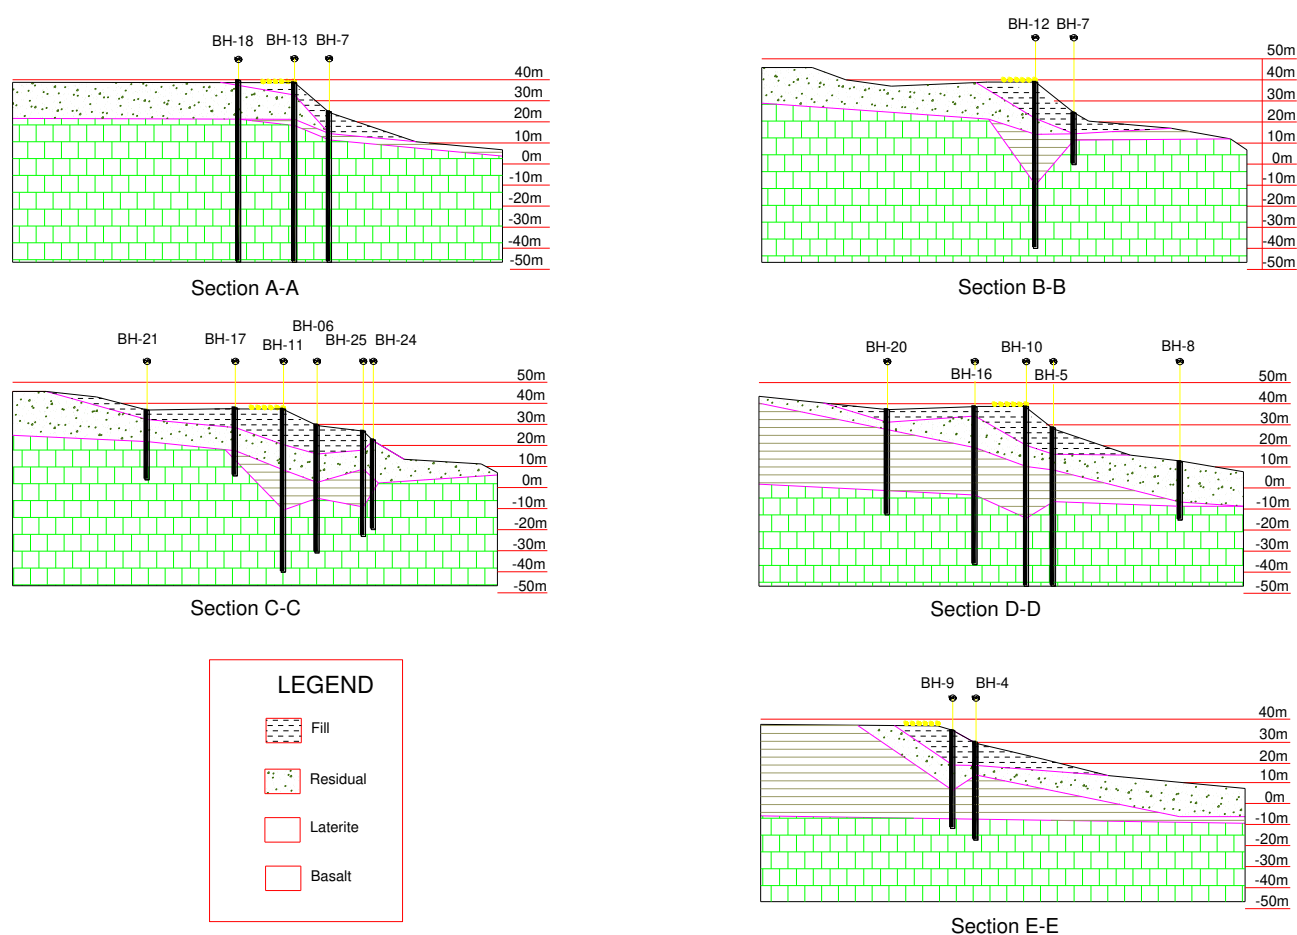
Using the borehole data, five cross-sections were drawn to interpret the subsurface profile of the site. The five sections are marked as A-A to E-E in Figure 7 and are shown in Figure 9. Sections B-B to D-D were chosen to represent the edges and centre of the failure zone. Laterites were nearly absent in section A-A and had the maximum presence in section D-D. The average geotechnical properties at each section are shown in Table 4. The material properties in Table 4 were obtained from the field and laboratory testing programme monitored jointly by Konkan Railways and IIT Bombay. Direct shear tests were conducted to obtain c' and ϕ' . Unconsolidated undrained (UU) triaxial tests were conducted to obtain c_u . The secant Young's modulus, E , of selected samples was obtained from stress-strain curves on UU samples confined with 50 to 200 kN/m² mean stress. Unconfined compression tests were conducted to obtain the c_u of laterites and basalt.

Figure 9. Subsurface profile at the site. Location of sections A-A to E-E are as per Figure 7.

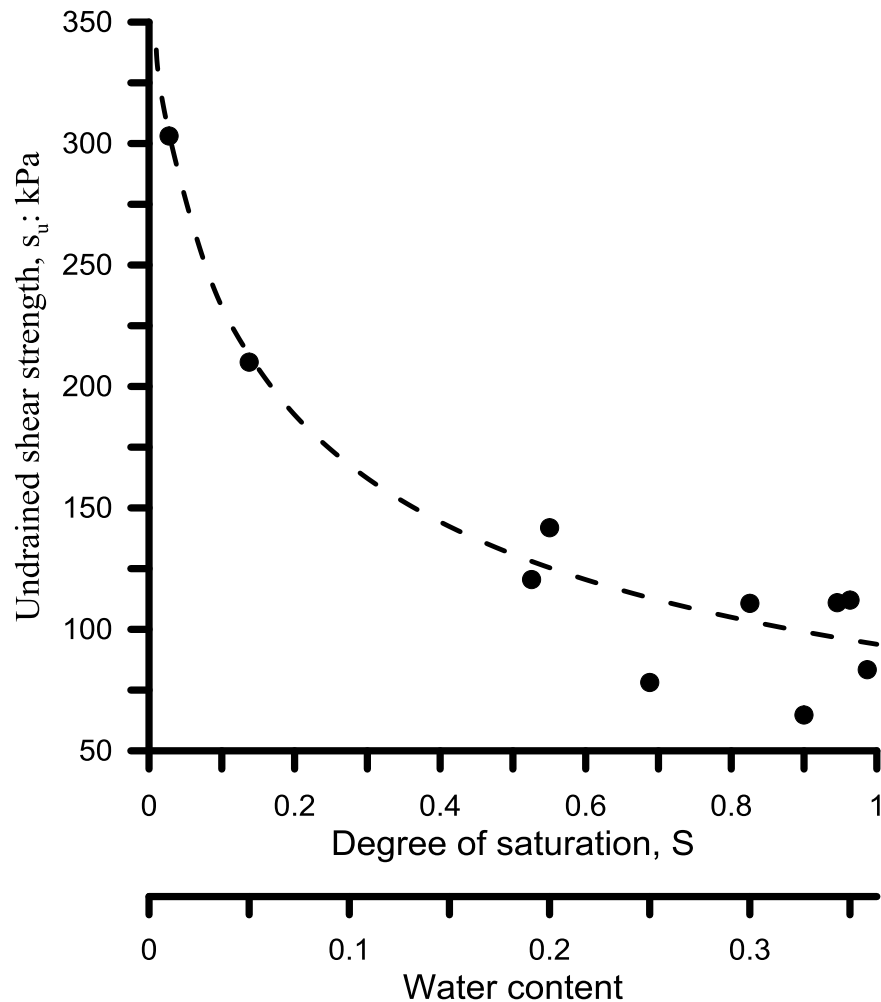
The above slope stability analysis only permits the estimation of the safety factor using the effective (or drained) shear strength parameters. It does not account for the change in strength of the soil due to the change in the degree of saturation as the rainwater percolates. An experimental programme was therefore designed to also study the effect of the change in the degree of saturation on the strength of the residual soils. A series of routine UU-triaxial shear tests were conducted on remoulded and reconstituted samples at 100 to 200 kN/m² cell pressure. The samples were compacted at constant void ratios but different degree of saturation. The dry unit weight of all the samples was within the range of 13.5 to 14 kN/m³. The tests were carefully conducted to avoid any change in water content during the testing procedure. However, it must be noted that since most of the samples were partially saturated, the tests were not truly undrained. There was no arrangement to measure the pore pressure suction because its effect was considered to be insignificant in view of the short duration of the test (Vanapalli et al. 1999). Figure 13 shows the variation of the undrained shear strength, s_u with the degree of saturation, S . Despite the scatter of the data points, the results appear to suggest that the water content has significant influence on the strength of residual soils. For instance, the figure shows that an increase in S from 0.1 to 1 caused s_u to decrease by over 100%. Notwithstanding the above, the results also permit a semi-empirical relationship to be fitted to the data:

Figure 13. Variation of undrained shear strength, with degree of saturation at constant void ratio/dry density.
