The May 25th 2011 Railroad Embankment Failure in Ann Arbor, Michigan, As a Means for Teaching Geotechnical Engineering

Dimitrios Zekkos, Associate Professor, Department of Civil and Environmental Engineering, University of Michigan, Ann Arbor, Michigan, USA; email: zekkos@geoengineer.org

Reference: Zekkos, D., Athanasopoulos-Zekkos, A., Grizi, A., and Greenwood, W. (2016). *The May 25th 2011 Railroad Embankment Failure in Ann Arbor, Michigan, As a Means for Teaching Geotechnical Engineering*. International Journal of Geoengineering Case histories, Vol.3, Issue 4, p.234-245. doi: 10.4417/IJGCH-03-04-03

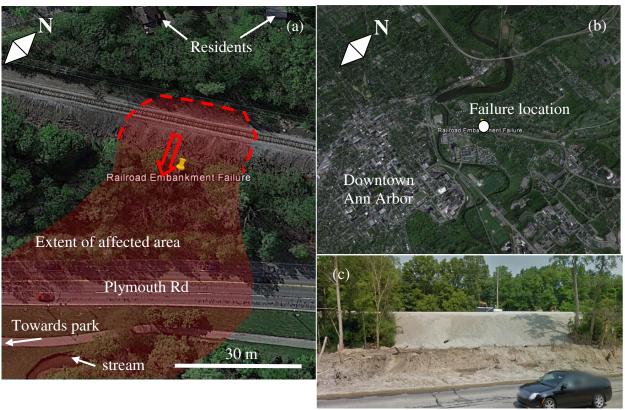
Figure 2. (a) Satellite imagery of the railroad embankment at the failure location; (b) location of the failure; (c) View of the repair works as recorded by coincidence by the Google Earth Camera.
