# Remediation of The Pissouri Landslide in Cyprus

**ABSTRACT:** During the winter of 2001-2002, a landslide of 80.000 m<sup>3</sup> was activated and moved downslope at the Northeast outskirts of the Pissouri village in Cyprus (Limassol prefecture), displacing a section of a country road that was crossing the upper part of the sliding mass and destroying three newly built residences. This paper presents the geologic and hydrogeologic regime of the landslide and its implication on the landslide's mobilization. Geotechnical site investigation and post failure monitoring, in conjunction with slope stability back analysis formed the basis for the study of the slide and subsequently guided the remediation strategy. Various possible interventions to stabilize the slope and allow the safe reconstruction of the displaced road have been investigated and compared considering both economic and environmental criteria. The performance of the remediation measures has been studied in terms of stability safety, using numerical models previously calibrated via back analyses. Observations made during the execution of the stabilization works provided additional data verifying and supplementing the o

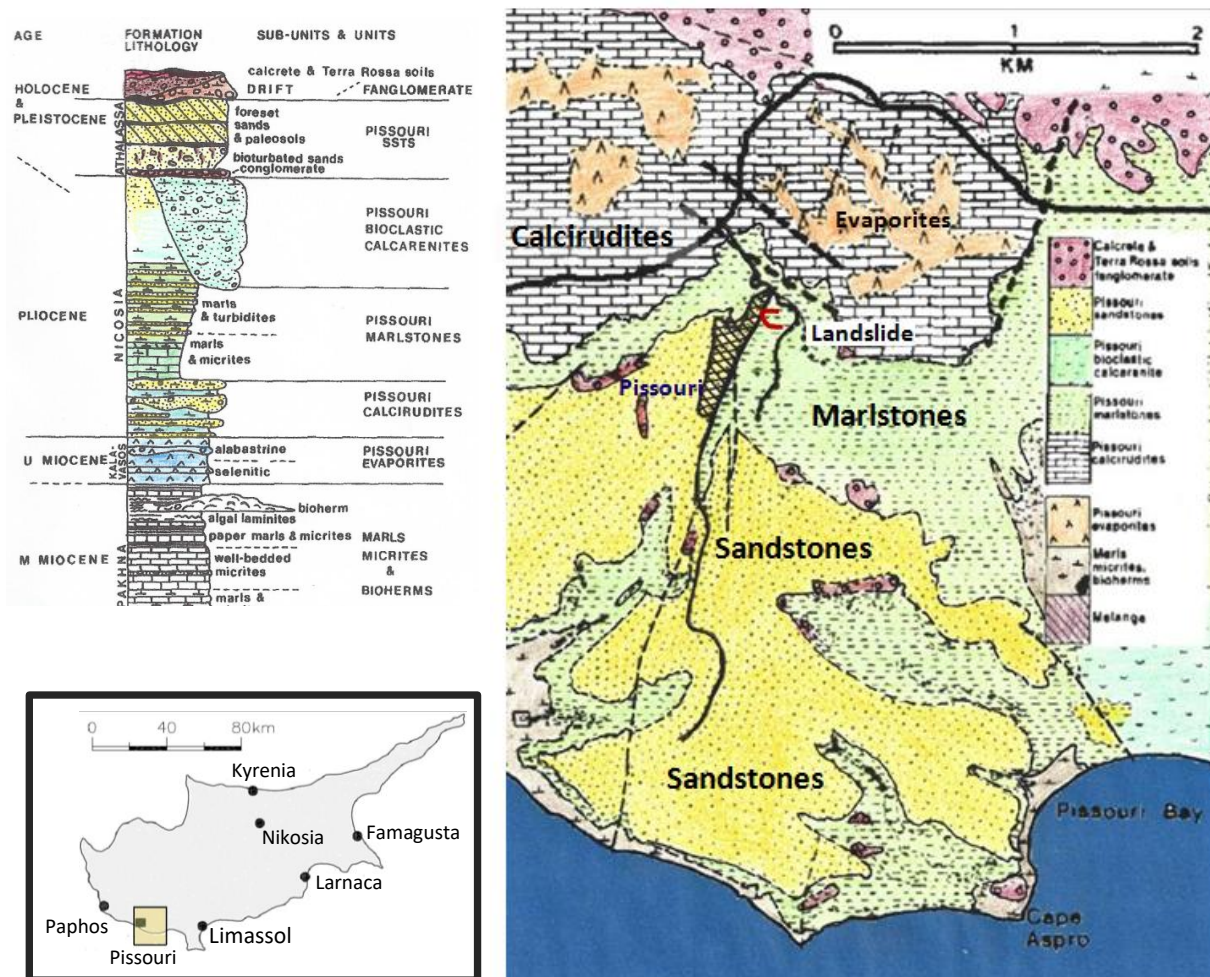
reddish - brown rock which in places disintegrates into a compound of marl blocks within a matrix of stiff fissured silty/clayey soil. The regional distribution of the aforementioned sedimentary units is depicted in Figure 3 (after Stow et al., 1995). The location of the landslide is also noted on the map.

Figure 3. Regional Geology of the Pissouri area. The village is developed on sandstones (yellow) underlain by the Pissouri marls (olive green). Geology after Stow et al., (1995)

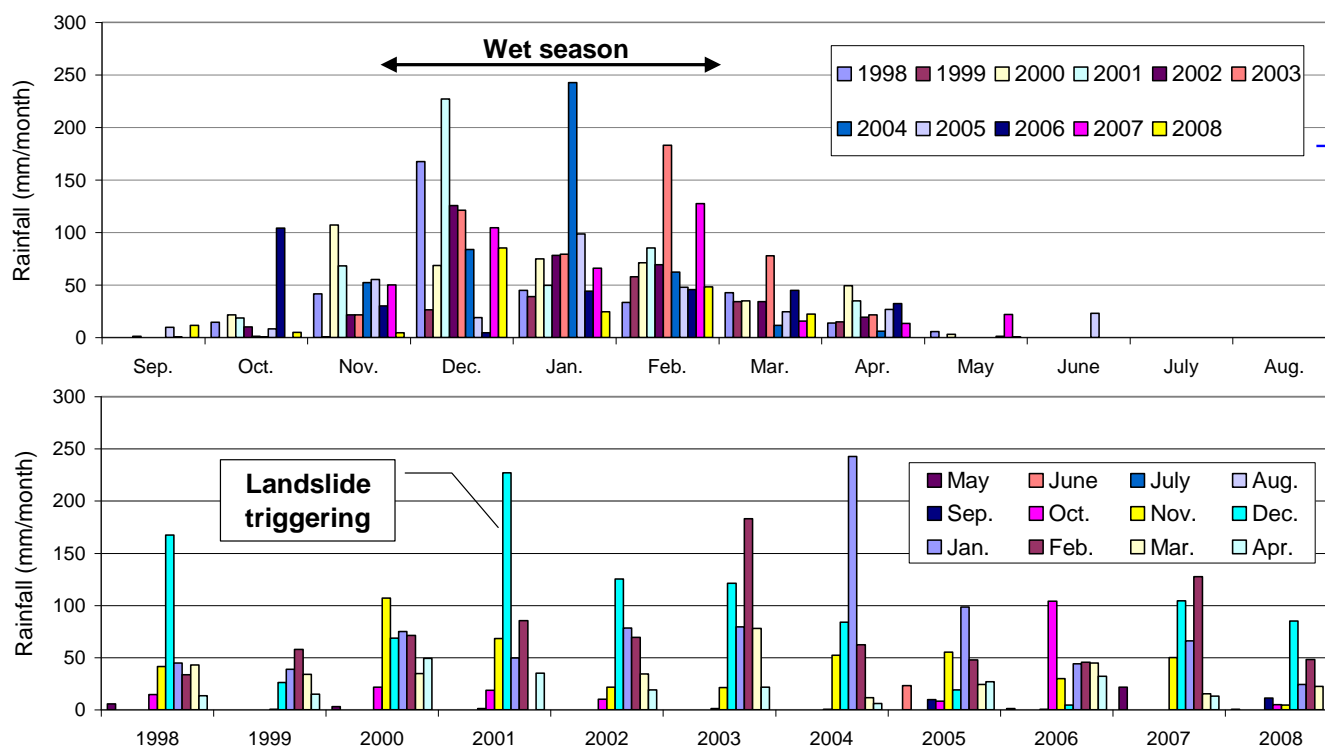
In the Limassol prefecture in particular, the annual precipitation is low, averaging 300-400 mm per year. The monthly rainfall time series retrieved by the Pissouri meteorological station during the 1998-2008 decade is presented in Figure 4. It is observed that during the December of 2001, when the Pissouri landslide was mobilized, precipitation was indeed high, exceeding 230 mm, but not a unique event in the decade. High precipitation undoubtedly triggered the landslide, but the contribution of other factors to slope instability should also be investigated. The high precipitation of December 2001 is associated with subsequent landslide events that took place in other parts of the island, as reported by Hadjigeorgiou et al., (2006) and Kyriakou & Hadjigeorgiou (2008).

Figure 4 Seasonal (upper figure) and annual (lower figure) distribution of monthly precipitation for the decade 1998 ~ 2008. Data from the "Pissouri" meteorological station.

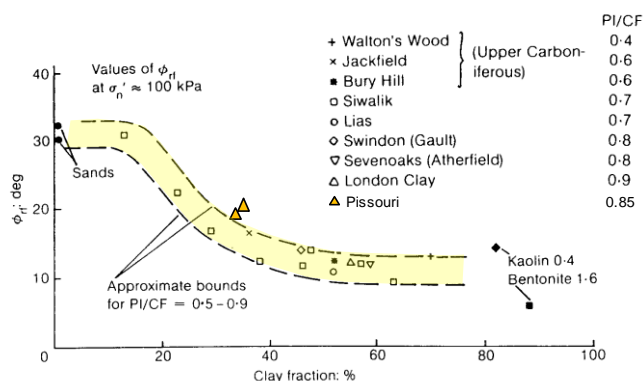
Figure 8. A comparison of the residual angle of shearing resistance of the weathered Pissouri marl with the dataset presented by Skempton (1985).

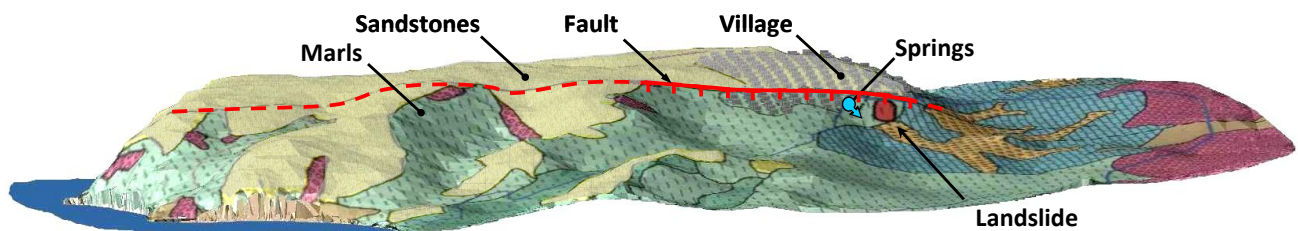
A field survey of the broader landslide area, led to the location of a number of natural springs and a few manmade wells, as well the mapping of distinct stratigraphic and tectonic features. The hydrogeologic regime was further studied by projecting the geological units presented in Figure 3 on a digital elevation model of the broader Pissouri area. Figure 9 presents the outcome of this exercise. The vertical scale of the ground relief is stretched (H/V 2:1) to better depict the interplay of surface drainage patterns and geological structure. From the figure it becomes evident that the more permeable capping sandstones of the Pissouri hilltop comprise the main aquifer of the area. A few wells sunk in the top hill area have been exploited constantly in the past by the villagers and provided the main source of water for the settlement. A study of the drainage pattern indicate that surface water flows in low gradients towards the southeastern edge of the village (Figure 10) and infiltrates the capping sandstone stratum, during the wet season, recharging the aquifer. Subsequently, groundwater seeps towards the slopes surrounding the hill and overflows at specific locations of the contact between the more permeable

Figure 9. Hydrogeologic setting of the Pissouri area. Geological units (after Stow et al., 1995) are projected on the distorted relief of the Pissouri hill (exaggerated vertical scale H/V 2:1). Location of the landslide and the springs with respect to the major hydrogeologic units are also noted.

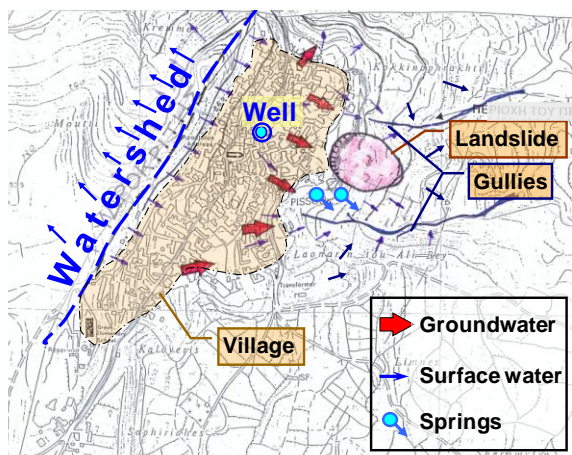
sandstones with the impermeable underlying marls, as shown schematically in Figure 10. A few seasonally discharging springs and water collecting wells have been located at the southeastern edge of the hill, near the landslide site (see Figure 11), which are exploited by local farmers for irrigation. A probable fault trending NNE-SSW, mapped by Stow et al. (1995), is running parallel to the eastern boundary of the village and dissects the sandstone layer. This fault is believed to control the steeper slopes of the Eastern side of the hill and is probably associated with the presence of the water springs down slope.

Figure 10. Surface and subsurface drainage patterns. Arrows indicate surface and subsurface water flow. Springs and wells are also noted.

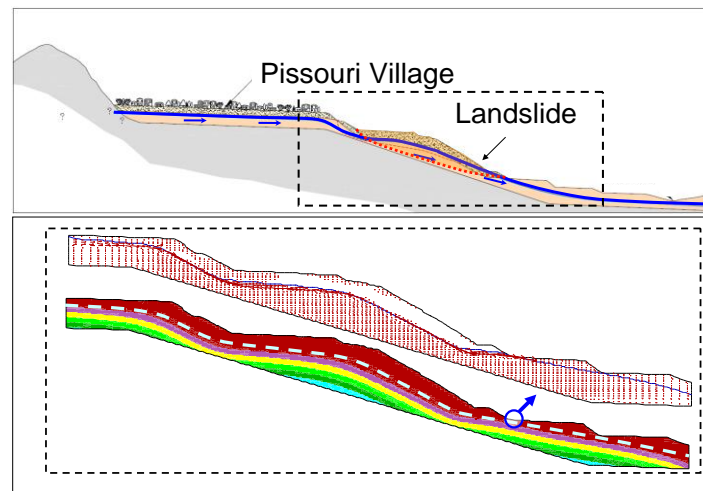
Groundwater flow and pore pressure distribution within the sliding mass was further studied, by analysing simple two dimensional numerical models, which were set up by the finite difference code FLAC. Inflow-outflow equilibrium considerations, in conjunction with the seepage analysis, performed by FLAC, provided an additional means to study and verify the water infiltration, movement and outflow pattern in the landslide area. A typical seepage model representing the eastern slope of the village, is illustrated in Figure 12. The piezometric lines have been computed on a number of transverse and longitudinal sections and were used to build the three-dimensional model presented in Figure 13. The inferred piezometric surface is found at shallow depths, in areas where vegetation growth is more intense, as observed in aerial

Figure 12. Typical results of the seepage analysis (flow vectors and pore water pressures).

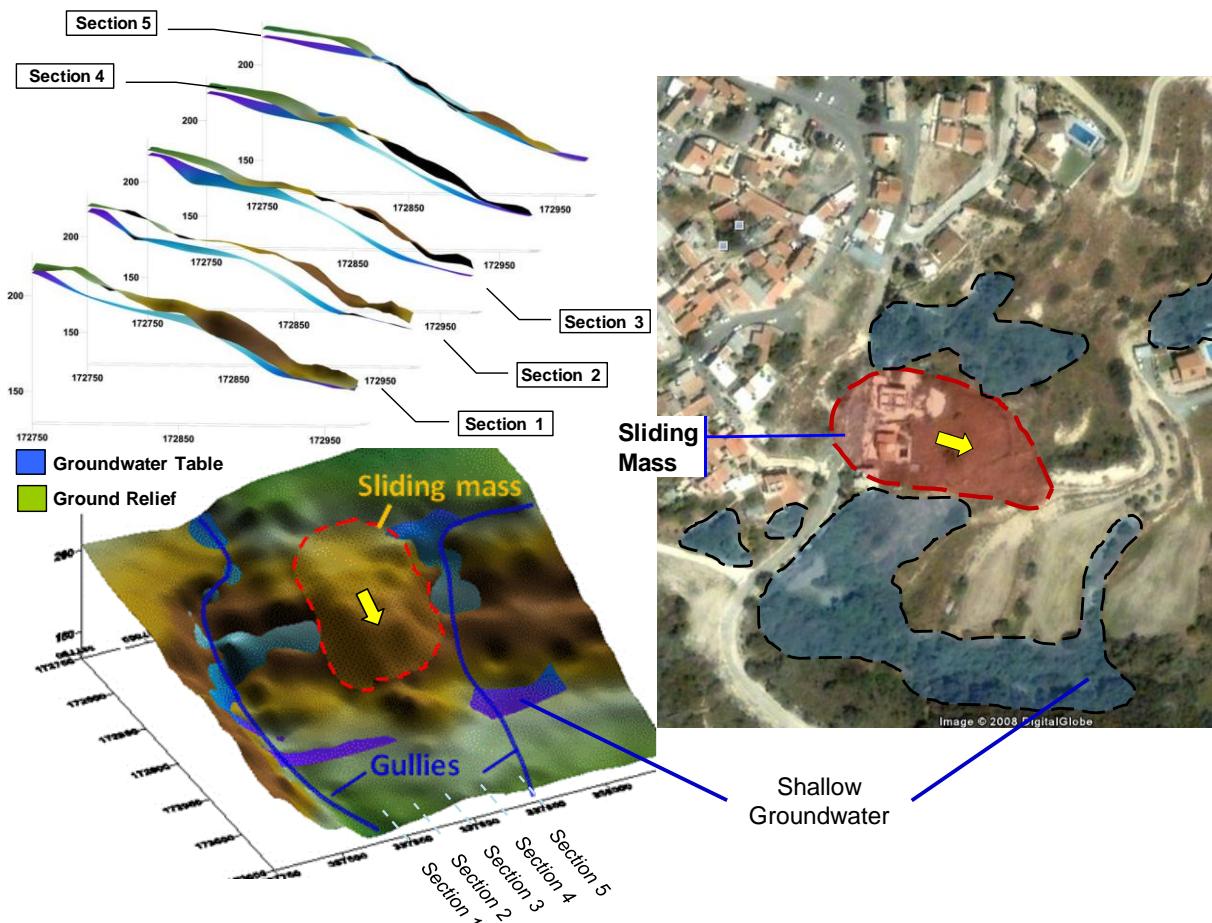
photographs, (Figure 12) and compares well with groundwater level measurements from piezometers installed in the vicinity of the landslide. The piezometric surface of Figure 13 represent the average dry season water table. During a wet season the water table within the landslide mass is expected to rise significantly and the development of a perched water table during thunderstorms should also be considered.

Figure 13. Left: A digital elevation model of the landslide area, overlain to the surface of the computed groundwater table. The groundwater table geometry is also presented as a series of sections in the upper figure. Right: Blue areas in satellite image indicate areas where the ground water table is at shallow depth and coincide with the most densely vegetated areas.

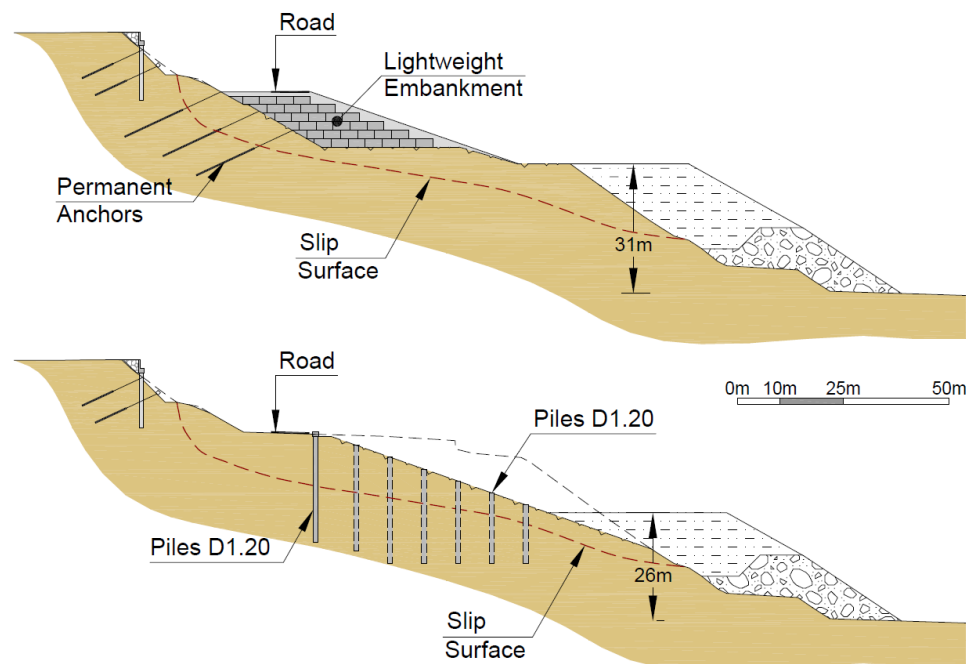
Figure 15. Landslide remediation - Alternative design solutions.

In order to develop a robust remediation strategy and to meet the value engineering requirements set by the district administration, alternative stabilization strategies were considered, coherent design options were developed, and subsequently evaluated in terms of economy, constructability and environmental compatibility. A wide spectrum of alternatives was investigated. An initial thought to completely abandon the site and deviate the road did not prove to be feasible. Stabilization of the slide solely by a high and massive toe stabilizing buttress proved also impracticable. Consequently the construction of a modest toe buttress and the simultaneous reduction of ground weight at the upper part of the sliding mass via ground removal and its replacement by lightweight material (EPS geofoam) was the first option developed. A second option involved the construction of a medium sized toe buttress, the trimming of the upper part of the sliding mass to remove as much of its weight as possible and the dowelling of the remaining soil mass, by means of large diameter bored concrete piles. Outline design of the two alternatives are presented in figure 15.

The last option proved to be more robust, reliable, cost effective, and better fit to the constructability requirements, since it required materials, equipment and expertise available locally on the island. It was also found that it had a smaller impact to the landscape and the environment in general. After deciding to adopt this solution, the design was further developed, the construction procedure was studied more thoroughly and every construction stage was checked by means of detailed stability calculations. The layout of the adopted solution is presented in figure 16. The lower part of the landslide is stabilized first by means of a toe buttress fill resting on a drainage blanket, to allow for unobstructed drainage of the natural ground behind it. For the existing gullies running along the two sides of the sliding mass, erosion protection works (lining of the stream courses with gabions) were foreseen to protect the native soils and the toe buttress. Bored piles 1.20 m in diameter were placed in a staggered, 12×12 m pattern further up on the trimmed slope, to dowel the existing slide surface, but also to prevent shallower slides on pre-sheared surfaces from being mobilized, especially during the anticipated development of perched water tables during the more intense rainfall events anticipated. Along the downslope borderline of the road, a row of bored piles, 1.20 m in diameter at 3.0 m spacing, was designed, to reduce the amount of fill necessary for resetting the road pavement at its initial elevation and to ensure the integrity of the road pavement from ground movements. Sewage pipes running under the road pavement were carefully constructed to ensure that no leakage would escape and infiltrate within the sliding mass. The back scarp area which was left by the landslide movement as a degrading steep slope was protected and stabilized by means of a permanent anchored wall. This intervention fulfilled also the requirement to protect the buildings situated on the upslope crest. Groundwater within the remaining sliding mass was decided to be controlled by constructing a trench drain at the back scarp area of the landslide, which would collect the water seeping from the uphill area and discharge it towards the neighbouring gullies.
