A Large Scale Landslide in a Coal Mine in Marly Formations: Evaluation, Analysis and Rehabilitation

ABSTRACT: This paper describes a large scale landslide in a coal mine in Servia area in Kozani, Greece, which occurred in February 2011. The landslide, of ~250m width and ~350m length, took place in marly lacustrine sediments. The main factors for the manifestation of the landslide were a temporary interruption of works, the existence of a specific weak surface, the clayey nature and the sensitivity of marl to environmental agents, the action of water and the large slope height. Due to the magnitude and the position of the failure, a geotechnical solution was proposed that involved rearrangement of ground masses. The proposed solution led to successful rehabilitation and unimpeded continuation of the exploitation process.

Reference: Prountzopoulos, G., Fortsakis, P., Marinos, V. and Marinos, P. (2016). *A Large Scale Landslide in a Coal Mine in Marly Formations: Evaluation, Analysis and Rehabilitation*. International Journal of Geoengineering Case histories, Vol.4, Issue 1, p.29-45. doi: 10.4417/IJGCH-04-01-03

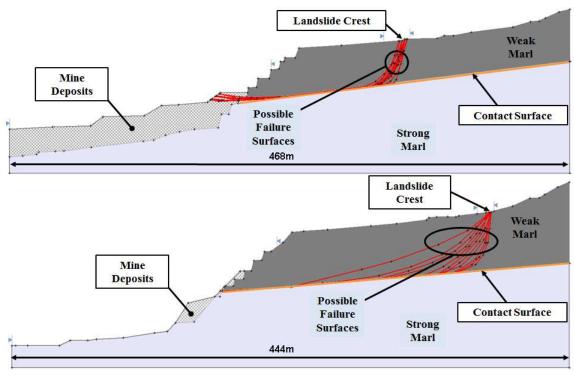
Given the three dimensional character of the landslide, as mentioned earlier, two analysis sections were systematically checked (Sections 2 and 3) so as to estimate some rational parameters for the assessment of rehabilitation proposals. Figure 5 illustrates the analysis sections along with their main features. The process that was adopted is summarized in the following steps:

Figure 5. Analysis Section 2 (up) and 3 (down). Slide software model.

- 1. Section 3 yielded somehow higher values of the safety factor compared to Section 2 for the same geotechnical and groundwater conditions, which is attributed to the different geometry of these sections, both in terms of topography and failure surface geometry. The real (three dimensional) safety factor, when 2D analyses are used, can only be approached indirectly, as a weighted average of its values from various analysis sections (Cavounidis, 1987 & 1988). In that sense, the representative range of geotechnical parameters values should be such that results in safety factor values slightly more than 1.0 for Section 3 and slightly less than 1.0 for Section 2.

- 5. In-situ observations of the shape of the failure surface along Sections 2 & 3 and corresponding selection of possible failure surfaces during the back analyses were reflected on the resulting Safety Factor vs. ϕ_{surf} curves. Specifically, for Section 2, where the major part of the landslide was along the contact surface between the upper weak and the underlying rocky marl, the effect of ϕ_{marl} on the safety factor value is not significant. On the contrary, the results from Section 3, where a considerable part of the failure surface seemed to be included in the upper weak marl formation, show a quite significant effect of ϕ_{marl} on the computed safety factor.
