## A High Rock Cut Stabilization in Muscat City, Oman

**ABSTRACT:** A large road box cut was constructed in hilly terrain of Muscat city, Oman, in an area underlain by the geologically complex Sahtan and Mahil formations comprising of limestone, dolomite, sandstone and siltstone with interbedded soft calcareous mudstone. The rockmass contains a large number of small scale faults, shear zones, minor folds and solution cavities. The maximum height of the cut was 50 m with slope angle of 1V:0.25H, and intermediate benches generally 3 m wide. To control vibrations in the urban neighborhood located nearby and avoid damage to the rockmass, a very cautious and time consuming excavation approach was adopted using rock breakers. The excavation work was completed in 2010. Oman has a hyper-arid environment with scarce rainfall for many months. However, occasionally the area is hit by intense rainstorms. During Cyclone Phet and accompanying rains in June 2010, part of the cut slope failed with a downslope movement of about 800 m<sup>3</sup> of massive rock. This necessitated a post-excavation re-evaluation of the cut slope, which culminated in design modifications, and construction of long te

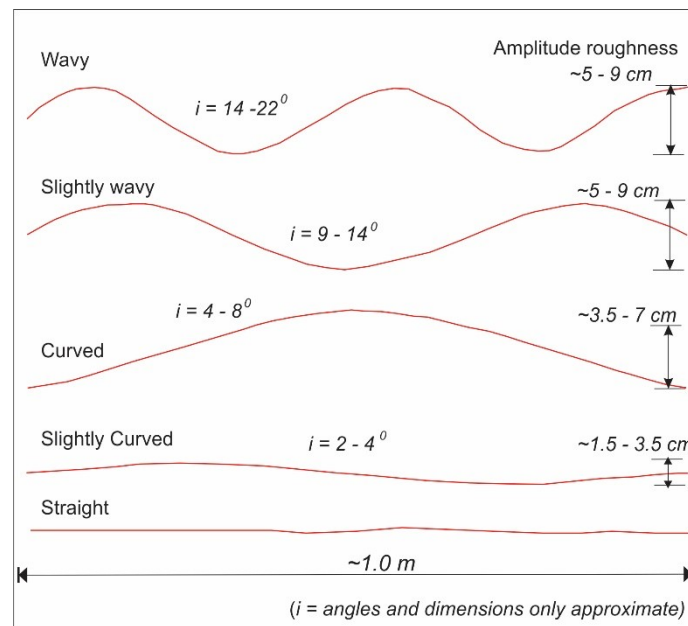
Figure 6. Large scale roughness profiles.

Hack et. al. (2003) reported that the large scale waviness contributed in increasing the friction angle of a discontinuity. Figure 6 shows the approximate addition to the friction angle that should be incorporated in the design for waviness of various amplitudes in the discontinuities over 1 meter length (Hack et. al. 2003). Miller (1988) reported that the waviness angle could be calculated from the observed variation in the dip of any discontinuity in the field.

Mapping of the geological structures in both Box Cuts revealed a high degree of variability in waviness. In Box Cut #1 measurements of a single bed over 5.0 m trace length gave a range of dips of 31° to 43°, with a mean of 35°. The dip direction ranged from 315 to 335°. Observations were also made on a smaller scale where there were variations with a general waviness ( $\phi_w$ ) that was on the order of  $\pm 5^\circ$  over a few meters.
