Emergency Bridge Scour Countermeasure in Marin County, California, United States

ABSTRACT: *The Lucas Valley Road Bridge over Miller Creek in Marin County, California was identified as scour critical in August 2017. Within four months (just before the rainy season in California), structural, hydraulic, and monitoring countermeasures were installed at the bridge. Structural countermeasures included lowering the foundation at Pier 2. Hydraulic countermeasures included rock riprap around Piers 2 and 3 to inhibit local pier scour and a series of criss cross weirs downstream to inhibit downstream head cutting. Monitoring countermeasures included a stage gage installation to monitor water surface elevation, a sonar device installation at the upstream and downstream ends of Pier 2 to monitor local pier scour and rock riprap movement, and sensitive tilt-meters to monitor movement of the bridge to give the local agency sufficient time to close the bridge prior to potential bridge collapse. This paper will focus on the case study of why the bridge is scour critical, and describe the countermeasures proposed to protect the safety of the travelling public.*

This paper presents the results of

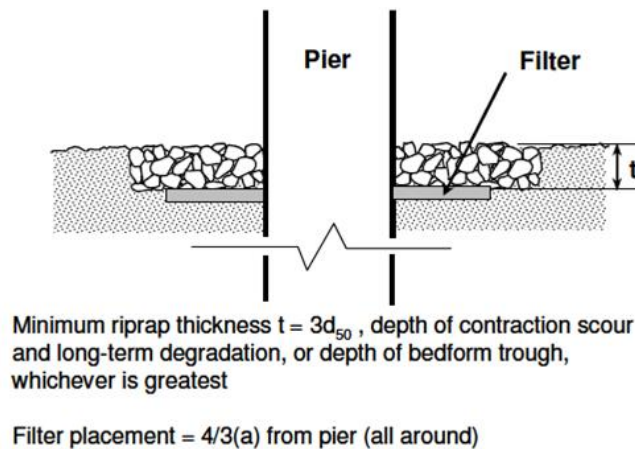
Figure 14. Rock riprap placement cross section per HEC-23 (from Lagasse et al., 2012).

Based upon the Isbash equation, assuming subcritical flow, the minimum d_{50} stone size is 0.6 meters, which is 1/2 Ton or Class VII rock riprap. A minimum thickness of 3 d_{50} as shown in Figure 14 or 2-meter thickness was used for the channel design.

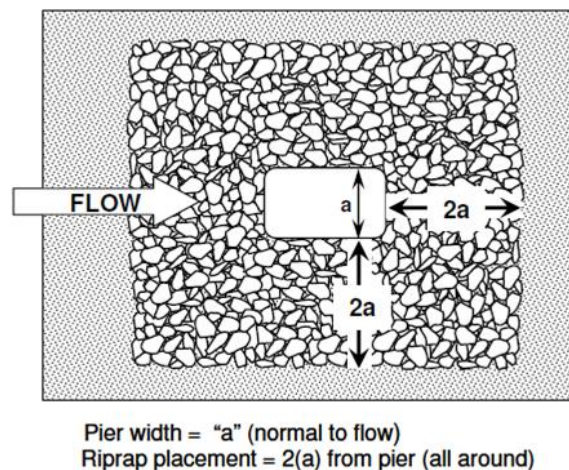
Figure 15. Rock riprap placement plan view per HEC-23 (from Lagasse et al., 2012).

The extent of the riprap is a function of the pier width. For the proposed pier width of 1 meter, the riprap needed to extend 2 meters from each side of the pier and upstream and downstream, as shown in Figure 15.
