# Images Collected from the Internet Reveal the Failing Mechanism of the Tailing Dam Breach at Kolontar, Hungary

**ABSTRACT:** *The failure of the red sludge tailing dam at Kolontar in 2010 was the most severe environmental disaster in the history of Hungary. The official investigations are confidential because the legal case has not been closed. The publicly accessible information from the breach of the dam are the photographs taken by the media and news agencies. Collecting these images and analyzing the recorded fractures and displacements of the dam reveal the failing mechanism. The breach of the dam resulted from failing to sliding, which had been developed in three stages. This conclusion is consistent with the observed movements of the dam deduced from a persistent scattered radar interferometry deformation analysis conducted between 2003 and 2010.*

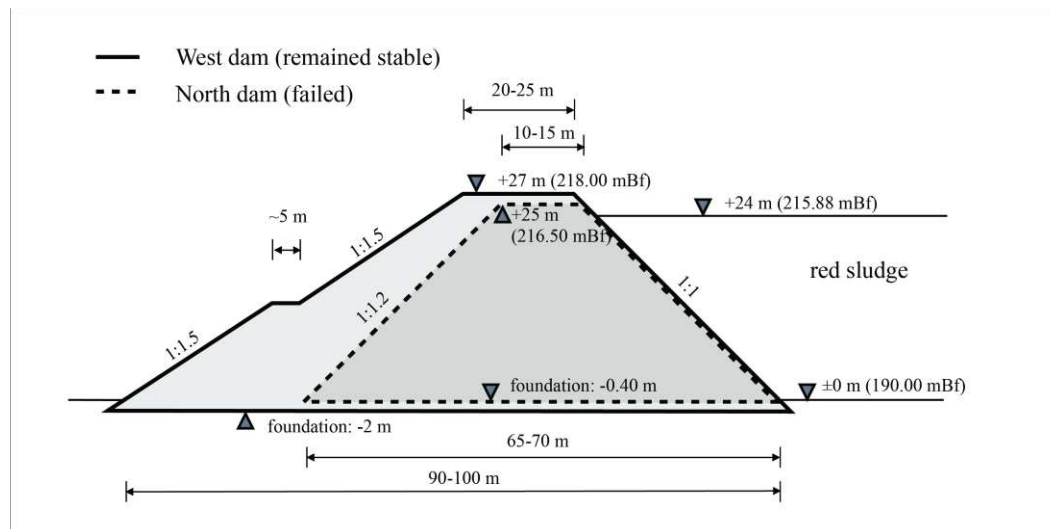
Figure 3. The cross sections of the North and West dams (Farkas et. al., 2013). The Northern dam primarily was designed to separate two reservoirs. The cross section of the dam therefore is significantly smaller in comparison to the West dam, which was designed to support the sludge pressure of the reservoir.
