# Reclamation and Safety of High Cantilever Strong Box Pipe Pile Seawall in Marine Clay

**ABSTRACT:** A high cantilever seawall was constructed in soft clay of 15 m to 32 m thickness and the enclosed water between the shoreline and the seawall was reclaimed. The area was 7 hectare and the reclamation height ranged from 10 m to 20 m. The reclamation methods were controlled and not intended to cause additional incremental deflection to the already high design deflection of -385 mm or 0.89% of H ( $H = 44$  m is defined as rotating and not cantilever height). However the different methods of reclamation had a significant influence on the slurry clay flows and thus caused additional incremental deflection. The slurry clay flows pushed the deflection of seawall to an additional maximum magnitude of -353 mm or 0.80% of H. The maximum seawall deflection of -526 mm or 1.20% of H was based on inclinometer IW1903 readings. At such high seawall movement, the inclinometer deflection profiles indicate safety in the design and the long term deflection is stable. This reclamation experience indicates that it is difficult to control slurry clay flows in future high reclamation filling of 10 m to

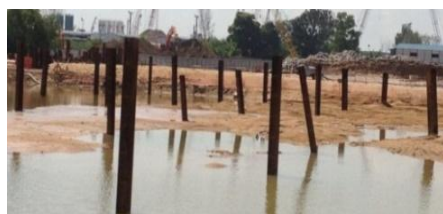
**Pond A**  
Controlled filling layout with kingposts in progression of 0.5 m thick sand layer at every 10 m x 10 m grid.

Figure 12. Photograph showing controlled filling method C for stage 3 reclamation.

Reclamation by controlled filling method C for filling into ponds B, A and C is shown in Figure 12. This control filling of 0.5 m thickness with Grade A material was enforced for the clay slurry ponds A, B and C. For pond A, a grid pattern of 10 m x 10 m was set up for the filling that was carried out in progression. At each step of progression, the fill thickness was

not exceeding 0.5 m. Even with such stringent control filling, some of the kingposts were noted to tilt. The method of reclamation was extremely slow and may cause clay squeezing of thickness less than 0.5 m. Similar layering reclamation filling in 0.5 m thickness was carried out for ponds B and C.

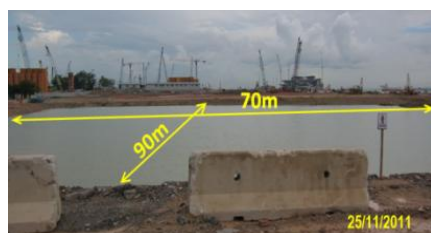
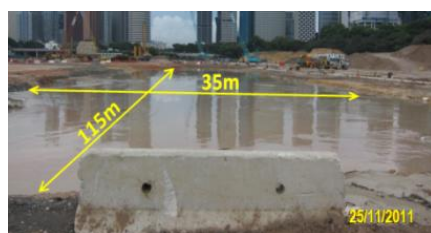
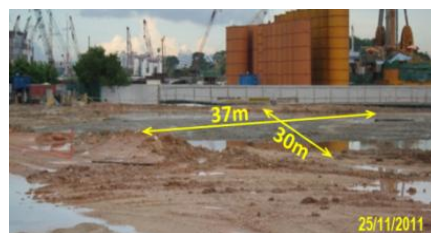
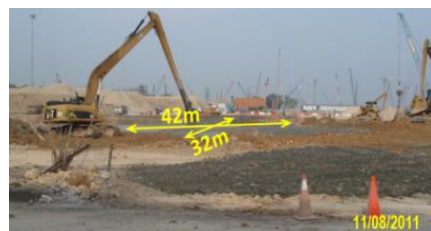
Figure 13. Slurry clay ponds A, B, C and D.

(a) Photograph of pond A (90 m x 70 m x 5.5 m) with slurry clay heaved from RL94.5 m to RL100 m.

(b) Photograph of pond B (115 m x 35 m x 8 m) with slurry clay heaved from RL94 m to RL102 m.

(c) Photograph of pond C. (37 m x 30 m x 7.5 m) with slurry clay heaved from RL94.5 m to RL102 m.

(d) Photograph of pond D (42 m x 32 m x 5.5 m) with slurry clay heaved from RL96.5 m to RL102 m.

The clay slurry ponds B and C were observed on 25 Nov 2011 as shown in Figure 13, when the clay slurry was pushed sideways and upward to the pond water level RL102.0 m. Pond A was still submerged in water and the clay slurry thickness was determined by chain sounding.
