# A geocomposite barrier for hydrocarbon containment in the Arctic

**ABSTRACT:** The paper describes the background and remediation steps that were taken to contain migration of a subsurface hydrocarbon contaminant plume at a site in the Canadian Arctic. A composite liner consisting of a novel fluorine surface-treated high-density polyethylene geomembrane and a geosynthetic clay liner was selected as the short-term (several years) barrier solution. The paper describes the design details, the selection criteria, and the challenges that were overcome to install the barrier system. A complimentary program of site monitoring is underway together with a parallel program of laboratory testing investigating the long-term effects of freeze-thaw, low temperatures, and contact with jet fuel on specimens of the barrier components. Results from site monitoring show that the barrier system is performing as planned three years after installation. Laboratory tests completed to date show that the geosynthetic barrier materials can be expected to maintain acceptably low rates of hydrocarbon diffusion and advection well beyond the original 3-year design life of the barrier system.

Bathurst, R. J.,

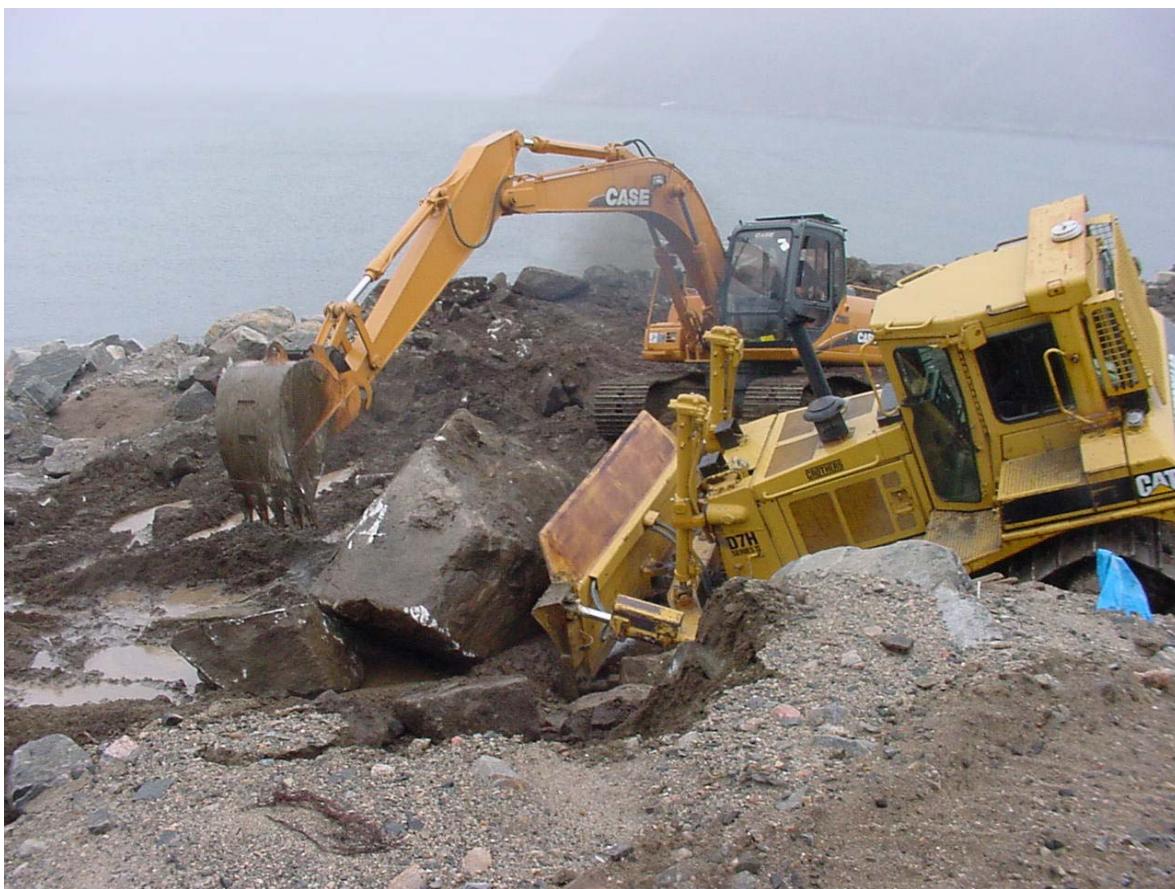
Figure 4. Photograph illustrating large boulders encountered at east end of trench excavation.

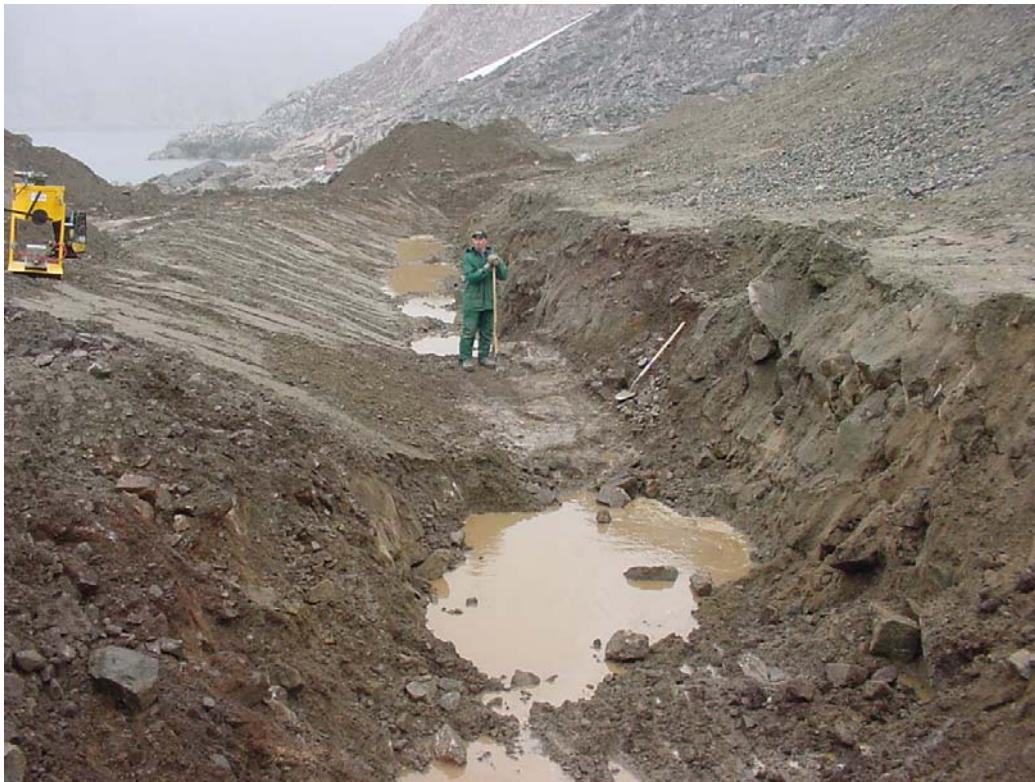
Figure 5. Photograph of trench excavation illustrating bedrock encountered at trench bottom.

The barrier system was designed to be placed on the down-slope side of the excavated trench. The decision for a sloped installation was largely dictated by factors such as available manpower and ease of construction. It was recognized that this approach would require more geosynthetic barrier material and excavation than an alternative vertical wall system. However, a vertical trench was not possible because of the presence of large boulders and the possibility of intercepting the groundwater table that could lead to trench wall instability. Photographs of trench excavation illustrating ground conditions at the site are shown in Figures 4 and 5. The groundwater table was not observed during excavation of the trench nor was there visual evidence of free product LNAPL. The ponded water on the permafrost layer in Figure 5 was the result of rainfall runoff.

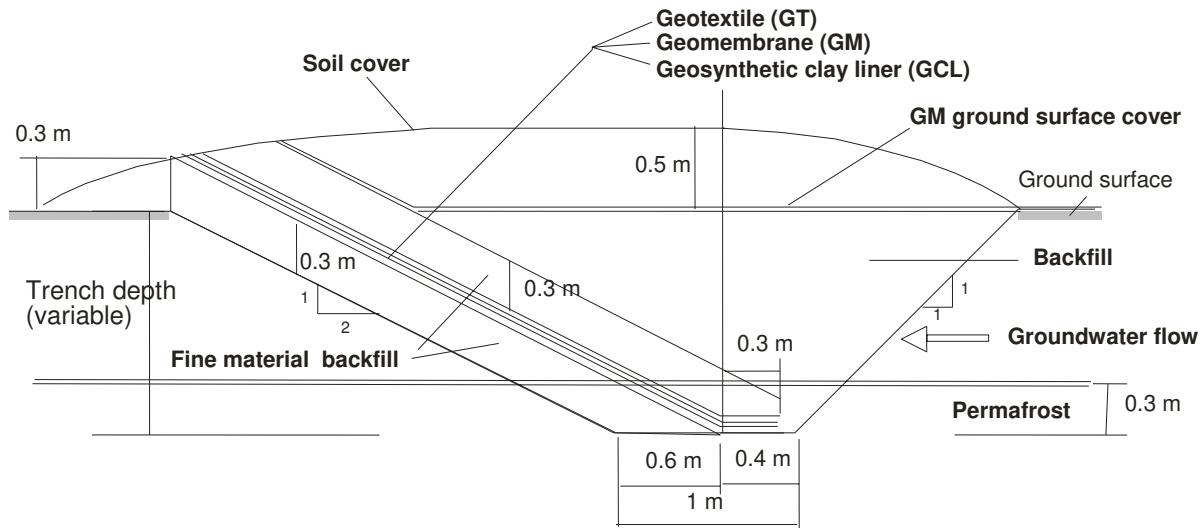
Figure 6. Installation of geosynthetic barrier system anchored in permafrost (Case 1).

The trench excavation geometry of the sloped barrier method is illustrated in Figures 6 and 7. The two trench cross-sections are the same with the exception of the anchorage detail at the bottom of the trench (i.e. anchorage in soil or attachment to bedrock). The trench was excavated with the downstream side at about 1:2 (vertical: horizontal) slope prior to installation of the geosynthetic barrier.

Figure 6 shows the geosynthetic barrier system for the case where the bottom of the barrier is anchored in permafrost soil (Case 1) to a depth of 0.3 m. The primary barrier is an HDPE geomembrane sheet with fluorination pre-treatment supplied by Fluoro-Seal Inc. (Sangam et al. 2001; Sangam and Rowe 2005).

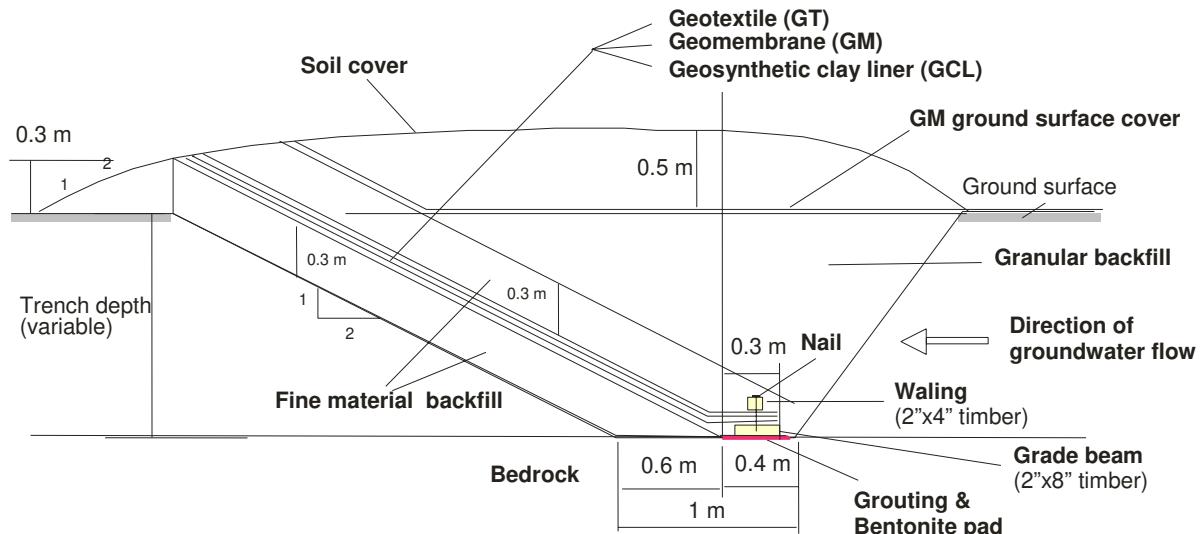
Figure 7. Installation of geosynthetic barrier system anchored to bedrock (Case 2).

The composite system was extended below the permafrost table where practicable. At locations where the excavation trench is located on bedrock, the installation scheme identified as Case 2 was used (Figure 7). The bedrock was cleaned by power washing before using bentonite powder and grout (Sika Arctic Grout) to fill rock surface voids or cracks and to seat a timber grade beam at the bedrock surface. The installation of the geocomposite liner was similar to that shown in Figure 6. Once the two liners were in place, the construction method called for a timber waling to be placed over the geocomposite liner and nailed through to the timber grade beam to secure the bottom end of the barrier. Once buried, water

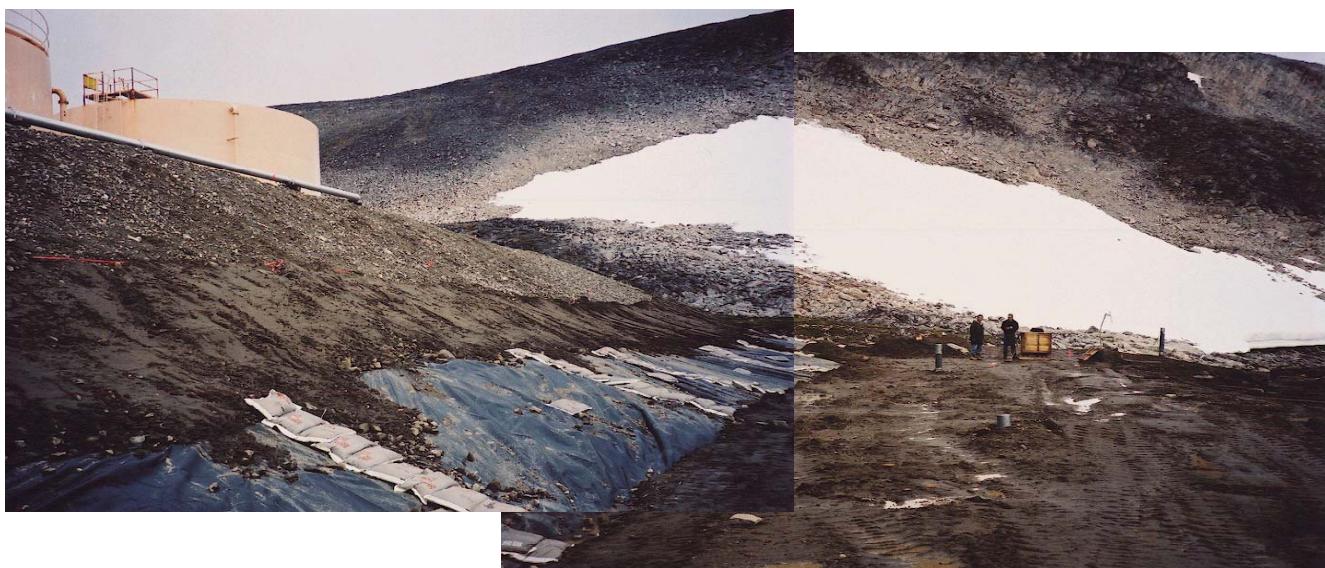
Figure 9. Photograph showing geomembrane cover sheet placed over and upstream of the geocomposite barrier.

After the geosynthetic barrier was in place, the liner system was then covered with a 0.3 m-thick layer of minus 50 mm gravel. This construction stage is illustrated in the photograph in Figure 8. Next, the trench was backfilled using the excavated materials and the ground surface graded and covered by a low weight pre-seamed scrim-reinforced polyethylene geomembrane (Layfield RPE 25) with a thickness of 0.51 mm and a tensile strength of 1,510 N. The boundaries of the cover sheet were anchored into a 1 to 1.5 m-deep trench and ballasted using on-site backfill and sand bags to prevent wind uplift (Figure 9). The cover sheet extended to the downstream side beyond the excavation and below the backfill mound covering the barrier installation. The cover sheet was intended to minimize infiltration from rainfall and snowmelt into the contaminated zone upgradient of the barrier system.

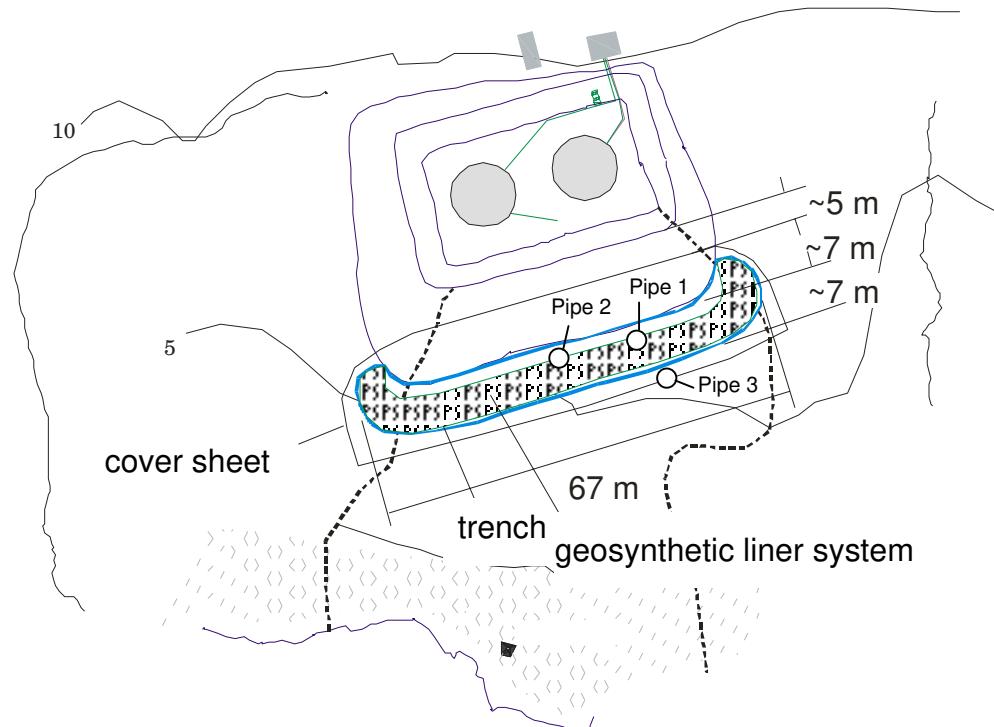
Figure 10. Plan view of containment barrier system location and instrumentation pipe locations.

The final trench was excavated in a single straight length about 67 m long with shorter curved sections at each end to bring the barrier trench into contact with the tank farm berms. The location of the trench was dictated by ground conditions that prevented the barrier system from being placed in the boulder field identified in Figure 3. The final alignment is shown in Figure 10. The consequences of the lack of geotechnical data available at the design stage of this project became apparent at the beginning of construction. The depth to permafrost was discovered to be up to 2.6 m deep, significantly greater than the average 1.5 m assumed at the time of the design. The increased depth is believed to be due to the proximity of the trench to the ocean and the large depth of fill that had been placed at the site during site leveling to accommodate the new tank farm. The deeper excavation led to a 73% increase in the amount of the geosynthetic materials required. The demand for minus 50 mm gravel (cushion) was also greatly increased. Shortening of the original trench length and careful management of the quantity of construction materials was required to ensure that there were sufficient geosynthetic materials to build the barrier system.

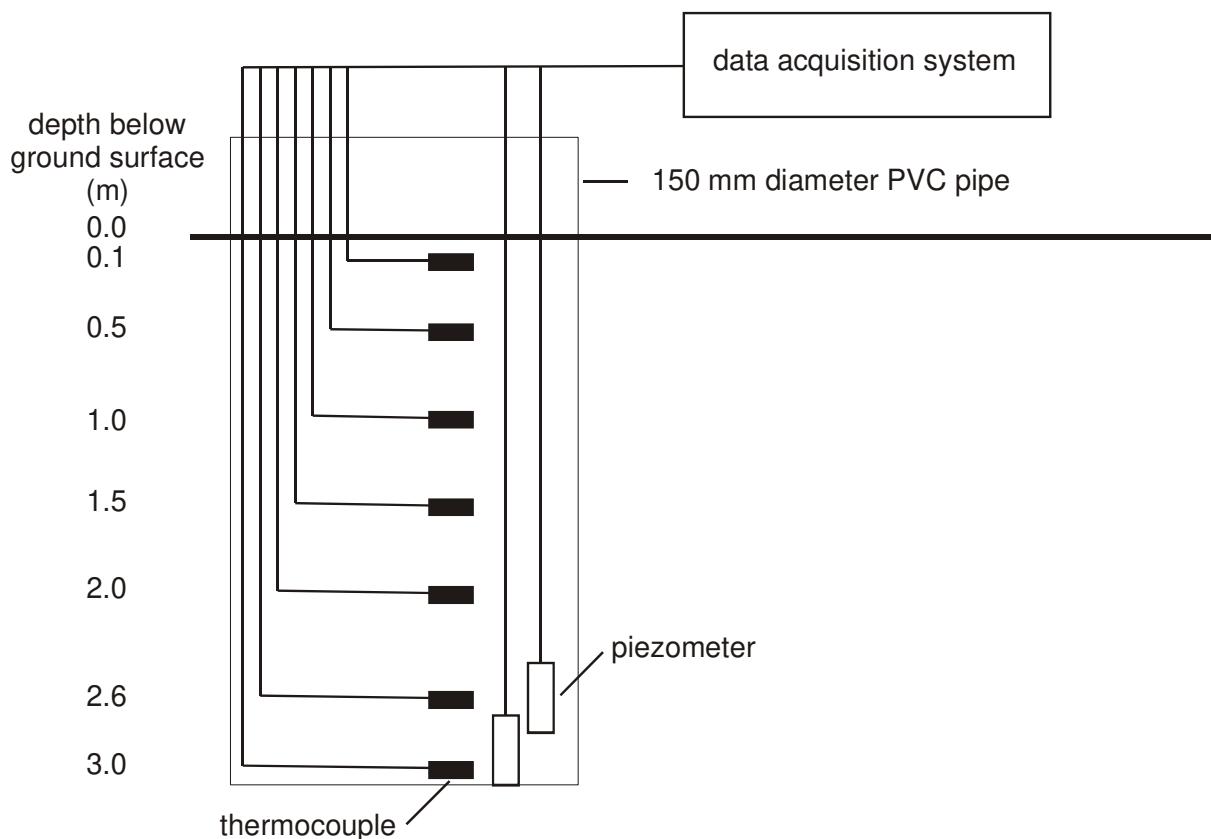
Figure 11. Example thermocouple and piezometer installation (Pipe 1 – upstream of geocomposite barrier).

In order to assess the thermal and groundwater regimes at the site, 16 thermocouples and 6 piezometers were installed in three 150 mm-diameter PVC pipes extending to the bottom of the trench excavation. Two pipes were installed immediately upstream of the barrier system and one immediately downstream. The pipes were placed while the excavation was open. An example installation is illustrated in Figure 11. The data acquisition system (Campbell Scientific) was specially designed for harsh environments and consists of a memory module that can be swapped out at intervals and the data downloaded. The module can store up to one year of data. A battery supply connected to a solar panel is used to power the system.

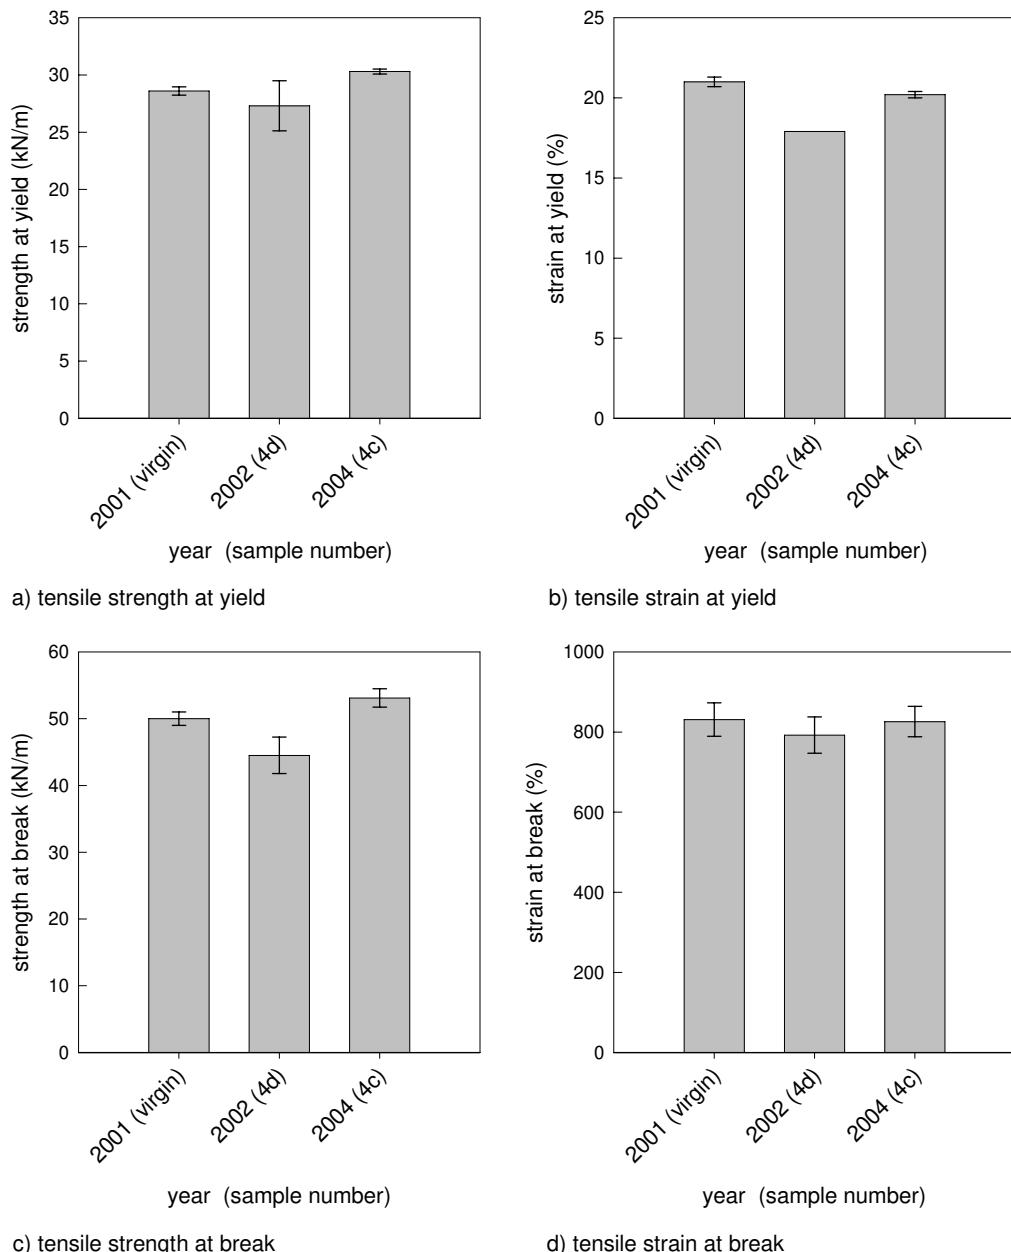
Figure 15. Mechanical load-strain properties of virgin and exhumed 1.5 mm-thick fluorinated HDPE geomembrane samples. Notes: 5 specimens per sample; error bars represent  $\pm 1$  standard deviation.

Conventional tensile tests carried out in accordance with ASTM D6693 and a displacement rate of 50 mm/min have been performed on archived and exhumed specimens of the 1.5 mm-thick fluorinated geomembrane material used at the Brevoort site. Tensile strengths at break and yield together with corresponding strain values are reproduced in Figure 15. Based on the data available there is no indication of a systematic and significant change in the index tensile properties of the f-HDPE geomembrane since installation.
