## A geocomposite barrier for hydrocarbon containment in the Arctic

**ABSTRACT:** *The paper describes the background and remediation steps that were taken to contain migration of a subsurface hydrocarbon contaminant plume at a site in the Canadian Arctic. A composite liner consisting of a novel fluorine surface-treated high-density polyethylene geomembrane and a geosynthetic clay liner was selected as the short-term (several years) barrier solution. The paper describes the design details, the selection criteria, and the challenges that were overcome to install the barrier system. A complimentary program of site monitoring is underway together with a parallel program of laboratory testing investigating the long-term effects of freeze-thaw, low temperatures, and contact with jet fuel on specimens of the barrier components. Results from site monitoring show that the barrier system is performing as planned three years after installation. Laboratory tests completed to date show that the geosynthetic barrier materials can be expected to maintain acceptably low rates of hydrocarbon diffusion and advection well beyond the original 3-year design life of the barrier system.*

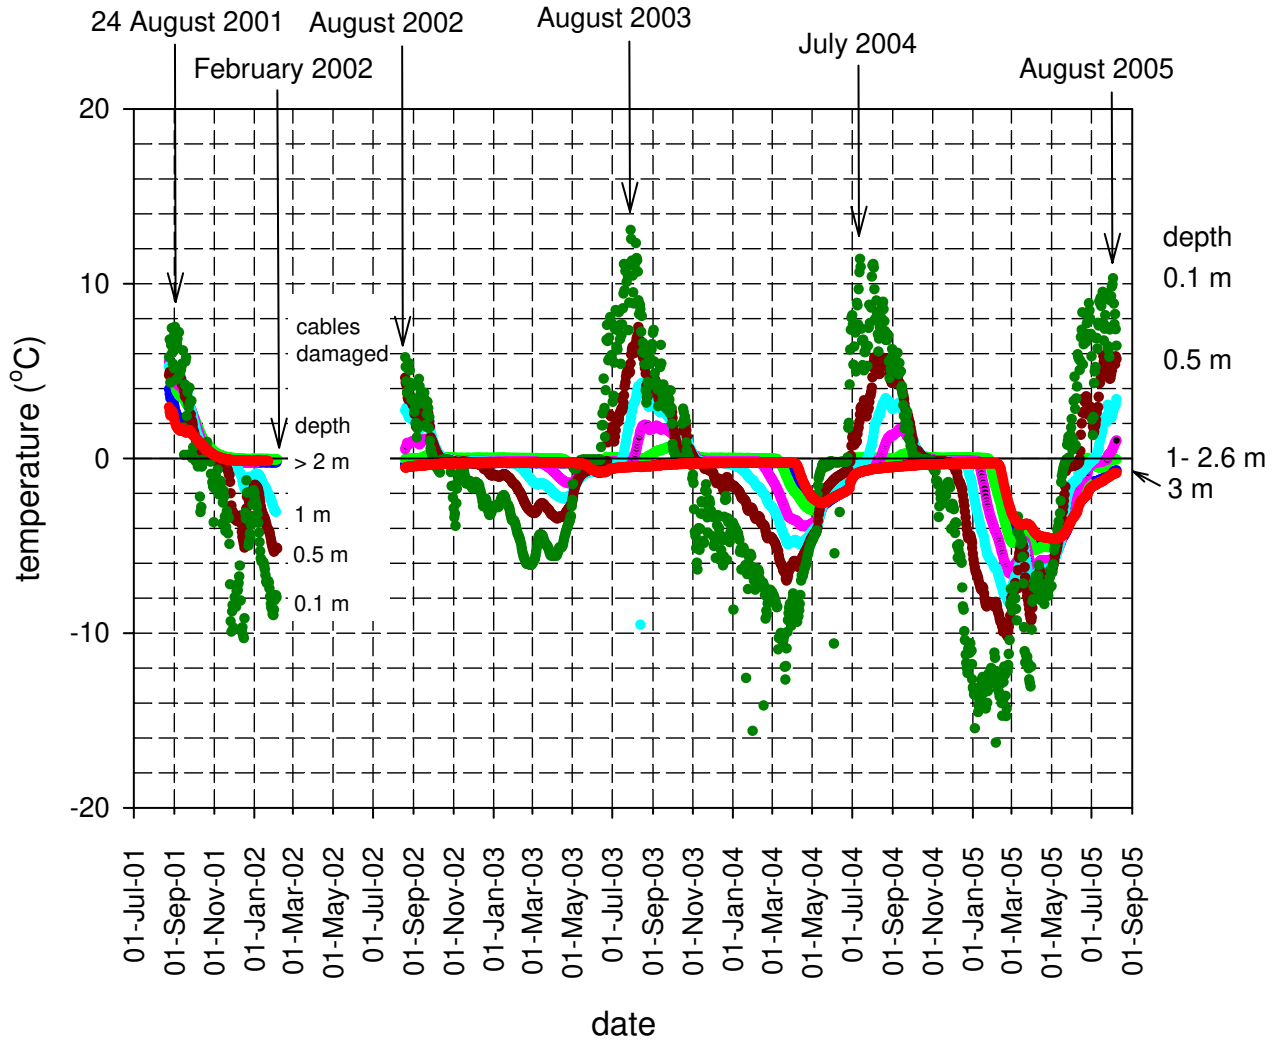
Figure 12. Example temperature-time histories from thermocouples located in Pipe 1 (upstream of barrier).

Temperature-time records from thermocouples placed in one of the instrumentation pipes immediately upstream of the barrier are shown in Figure 12. The gap in the records is due to severing of the cables by wildlife at the site in early 2002. The cables were repaired the following summer. Based on the data available, the ground temperatures at a given depth are lower in the winter of 2004-05 than the preceding winters. For monitoring points below a 2 m depth, temperatures are persistently below freezing based on the data available. This point is explored further by plotting temperature profiles from the same installation corresponding to the time of barrier installation and at selected times during the summers of 2003, 2004, and 2005 (Figure 13). The data show that freeze-back has occurred to an elevation well above the base of the original trench. The piezometers located close to the base of the barrier were frozen and hence measurement of the groundwater table behind the barrier was not recorded.
