Assessment of Stability Conditions of Ancient Underground Quarries using On-Site Monitoring and Numerical Modeling

ABSTRACT: *This work, carried out by members of the University of Parma's Department of Civil and Environmental Engineering and Architecture, analyzes the stability of the ancient underground quarries at Viggiù (Varese, Italy). The objective of the study was to verify the actual structural predisposition to instability phenomena in the ancient ornamental stone quarries for a historical and cultural valorization as well as the recovery of the Danzi and Beltrami quarries. Although completely abandoned, these sites could be used as a tourist attraction and/or as a teaching environment. They are a wonderful example of industrial architecture, presenting audacious compositions of filled-in trenches and room and pillar techniques (Hedley and Grant, 1972). With such objectives in mind, a monitoring system that aims to control the most significant joints and discontinuities of the site has been realized. A numerical model of the entire rock mass has been developed in order to analyze the stability of the underground openings. A route for visitors has also been identified.*

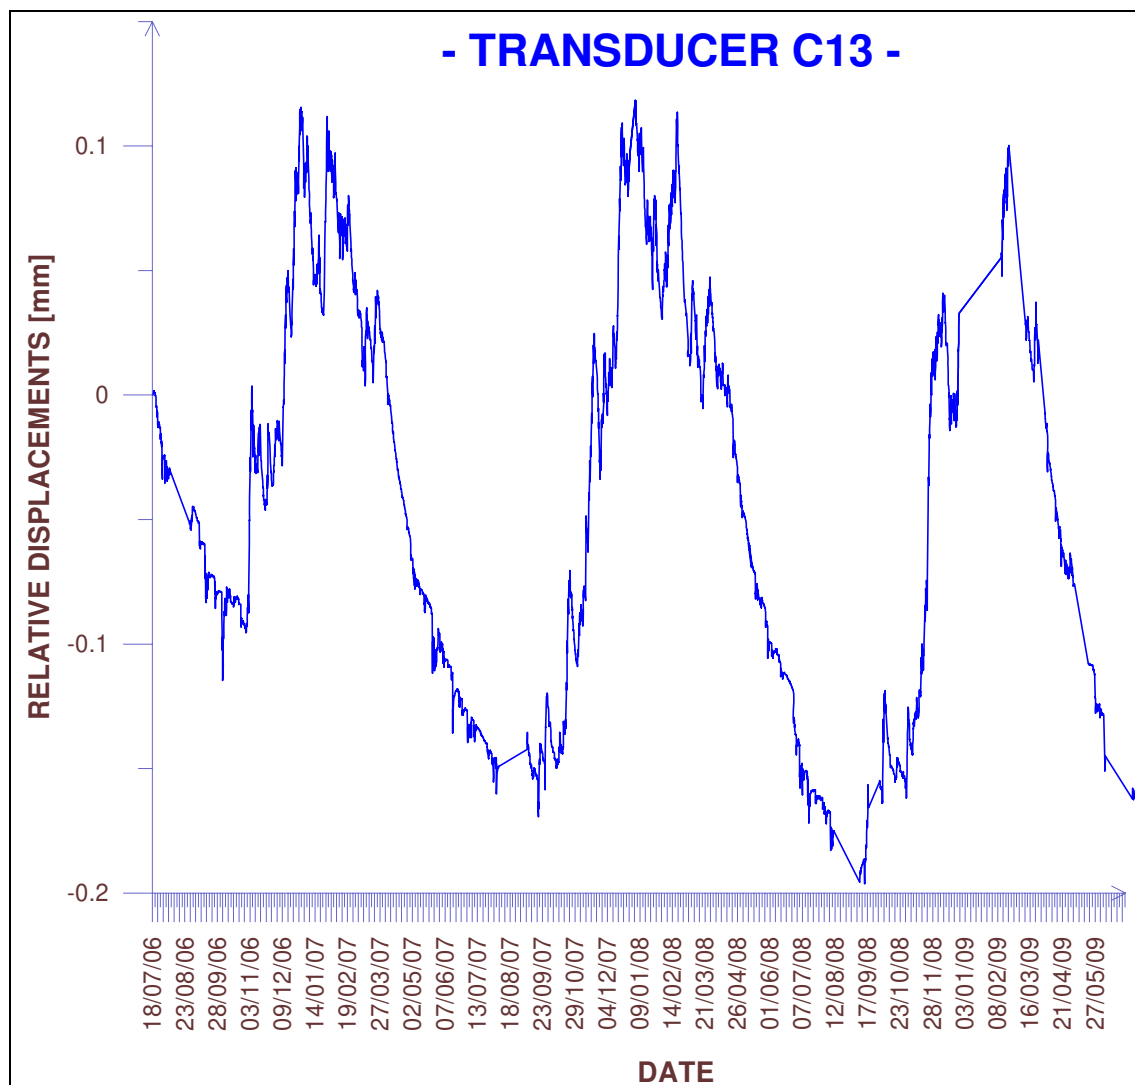
Figure 8. Readings from C13 transducer in period July 2006–May 2009.

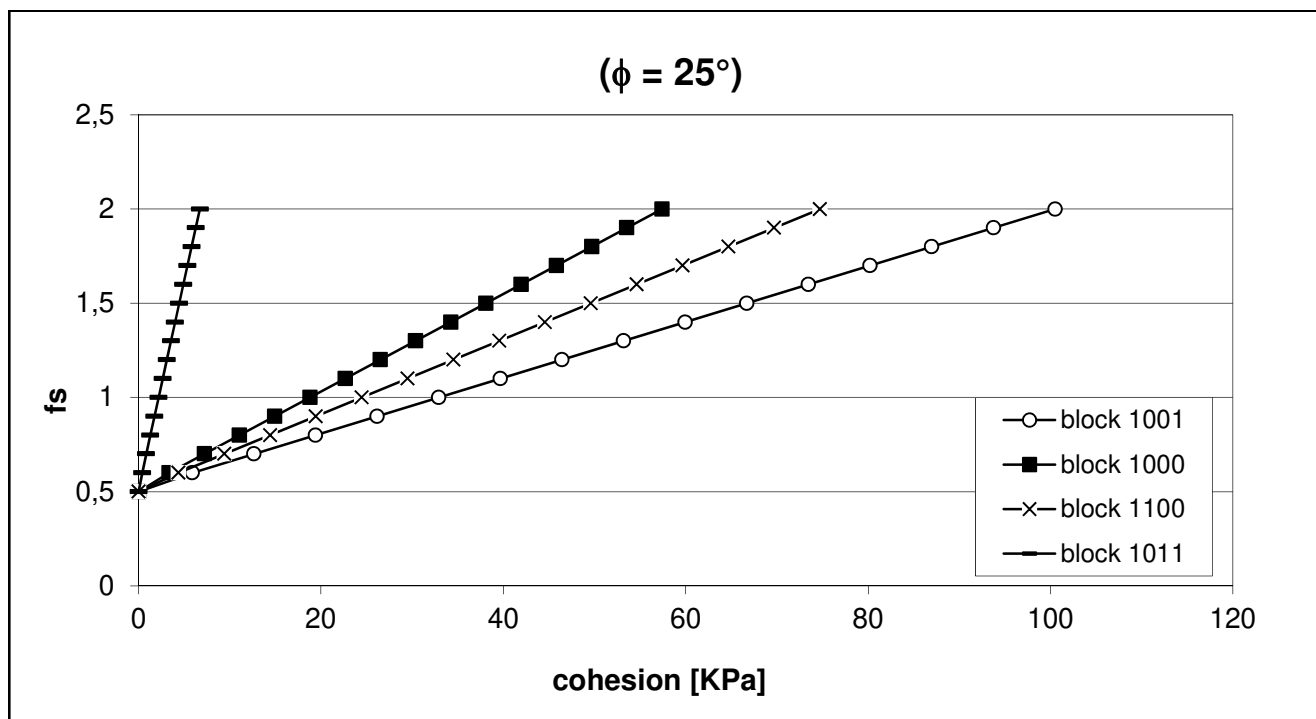
Figure 10a. Variation of SF with cohesion (friction angle = 25°).

The parametric analysis of the discontinuity shear strength has also been considered. Laboratory tests on discontinuities have shown shear friction angles of 51° and 41° , respectively, for peak and residual condition. However, in situ observations have outlined the presence of non-fully persistent discontinuity and weathering due to karst actions. These two effects caused the authors to take the cohesion value (due to rock bridges) and the low friction angles (due to karstic action) into account. The results obtained on the central entrance indicated that for friction angles below 44.5° , instability occurs for all finite and removable blocks. For friction in the range of 30.3° – 32.9° , the safety factor (SF) varies from 1–1.3 (see Figure 10).

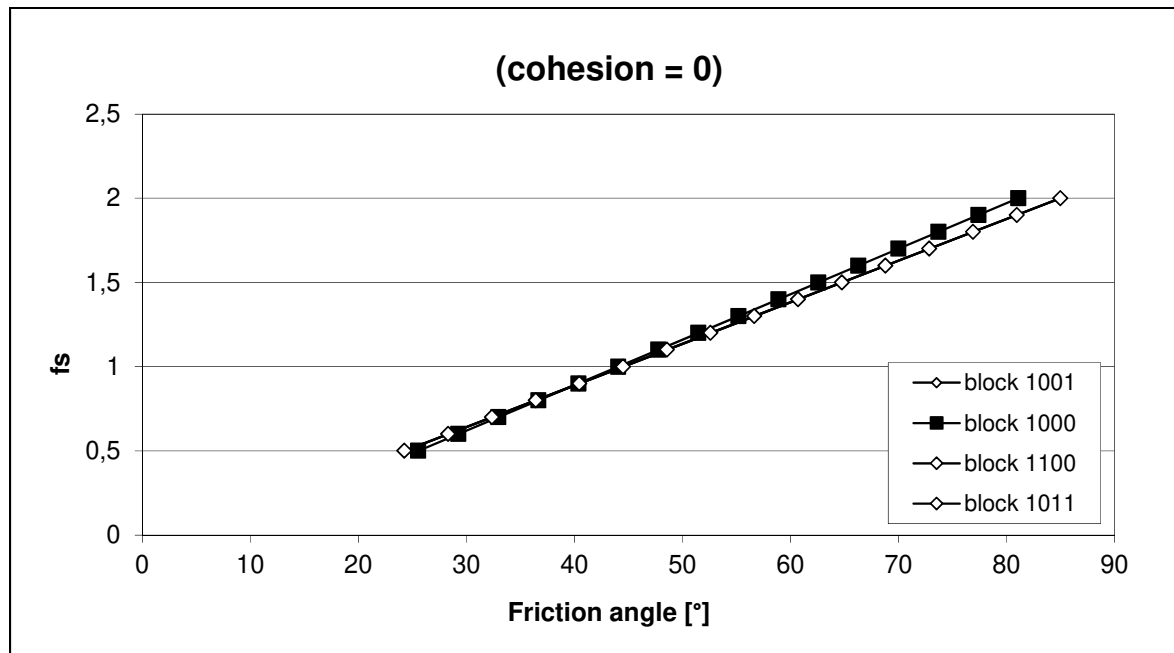
Figure 10b. Variation of safety factor (SF) with friction angle (cohesion = 0).

For friction angles above 56.6° , $SF > 1.3$. For the lower entrance, similar results have been obtained where instabilities occur at friction angles below 53.7° . All of the finite blocks are unstable at the upper entrance of the Danzi quarry. On the other hand, cohesion in the range of 20–30 kPa can guarantee stability for most blocks. Table 7 reports the results subdivided for each examined entrance area.
