Assessment of Stability Conditions of Ancient Underground Quarries using On-Site Monitoring and Numerical Modeling

ABSTRACT: This work, carried out by members of the University of Parma's Department of Civil and Environmental Engineering and Architecture, analyzes the stability of the ancient underground quarries at Viggù (Varese, Italy). The objective of the study was to verify the actual structural predisposition to instability phenomena in the ancient ornamental stone quarries for a historical and cultural valorization as well as the recovery of the Danzi and Beltrami quarries. Although completely abandoned, these sites could be used as a tourist attraction and/or as a teaching environment. They are a wonderful example of industrial architecture, presenting audacious compositions of filled-in trenches and room and pillar techniques (Hedley and Grant, 1972). With such objectives in mind, a monitoring system that aims to control the most significant joints and discontinuities of the site has been realized. A numerical model of the entire rock mass has been developed in order to analyze the stability of the underground openings. A route for visitors has also been identified.

Refe

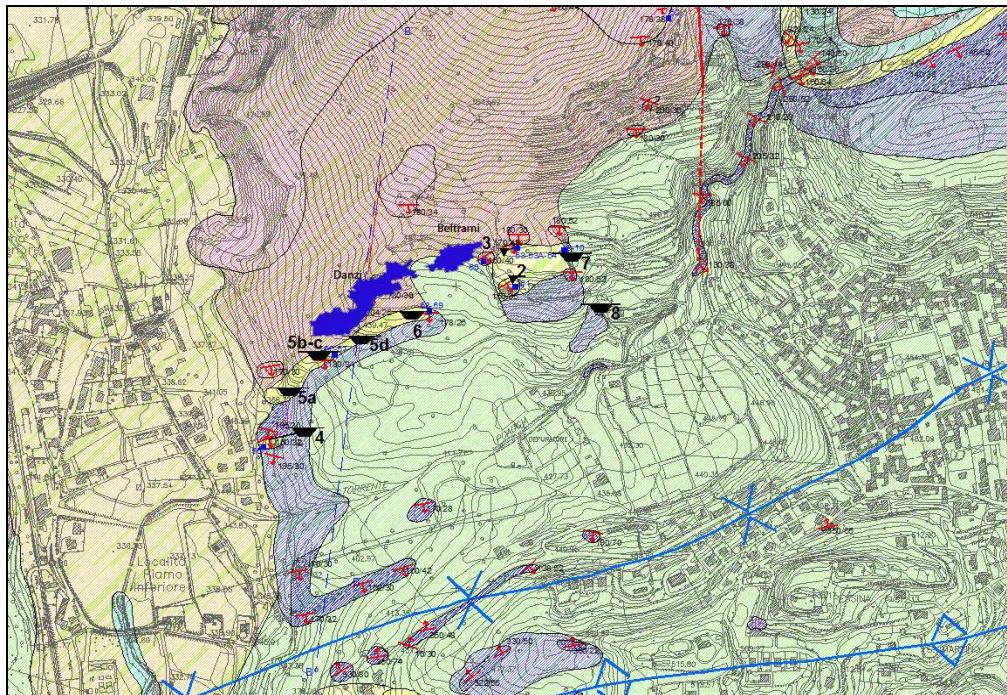
Figure 1. Geological map of area (reproduced from Scesi, 2000), with indication of section B-B' (see Figure 2) and area occupied by underground quarries (solid blue). See legend in Table 1.

The studied sector (see Figure 1) belongs, from geological point of view, to the Alpi Meridionali (Sudalpino) tectonic unit, more precisely located within the western portion of the Prealpi Lombarde (Scesi, 2000). The unit is formed by a series of tectonic flakes that, due to the compressive tectonic movements connected with the beginning of the closure of the Ligurian–Piedmont Basin, are partially overthrust one above the other. Their sliding planes dip irregularly toward the north, producing an apparent orientation to the south of the majority of the tectonic elements. The outcropping rocks that are of a sedimentary nature and have a prevailing carbonitic composition (limestones and dolomite) and siliceous suborder cover a timespan between the Superior Triassic (approx. 230 Million years ago.) and the Inferior Cretaceous periods.

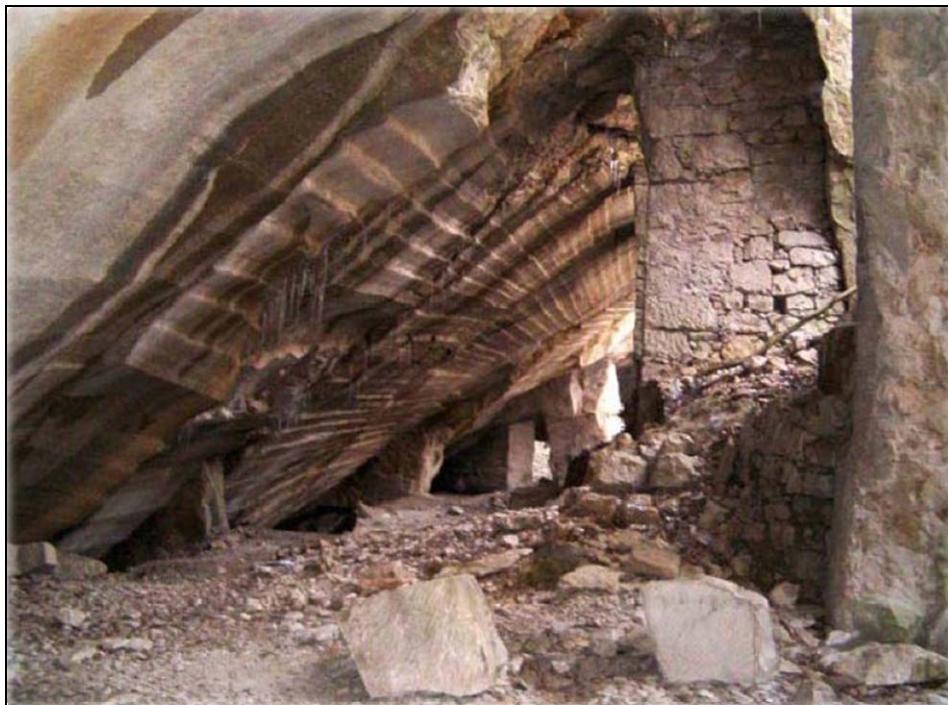
Figure 3. View of upper entrance of Danzi quarry.

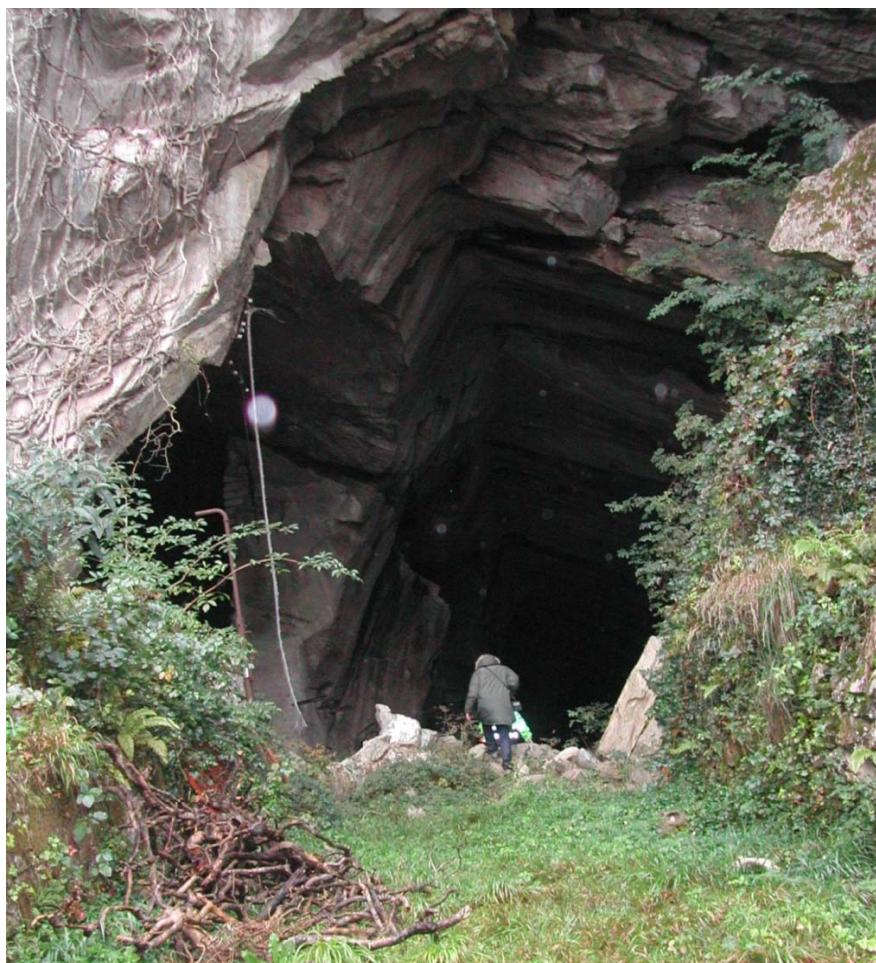
Figure 4. View of middle entrance of Beltrami quarry.

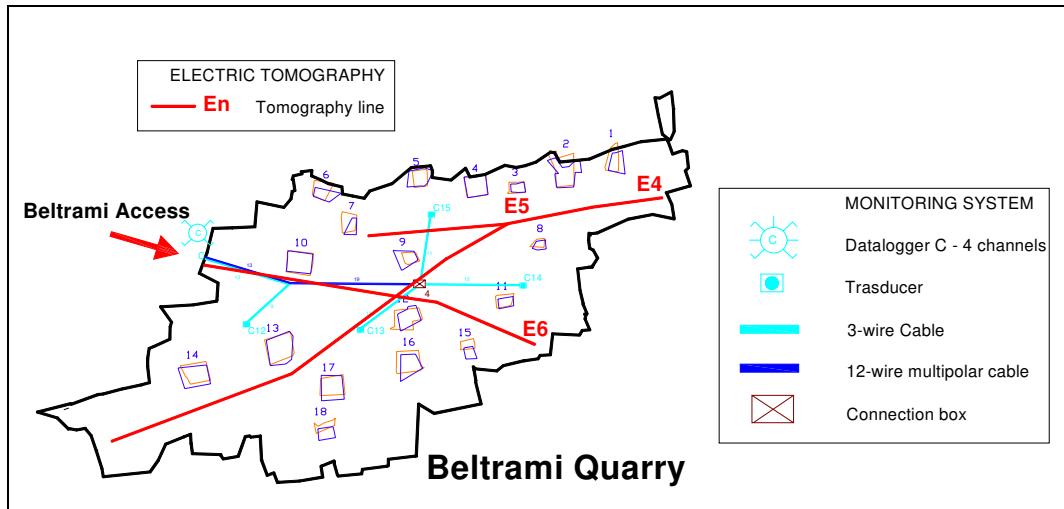
Figure 6. Map of Beltrami quarry showing roofs of pillars(blue) and base (green), monitoring system and tomography lines.

Figure 9. 3D tomographic section of quarry floor. See Figure 6 for positions of tomography lines.

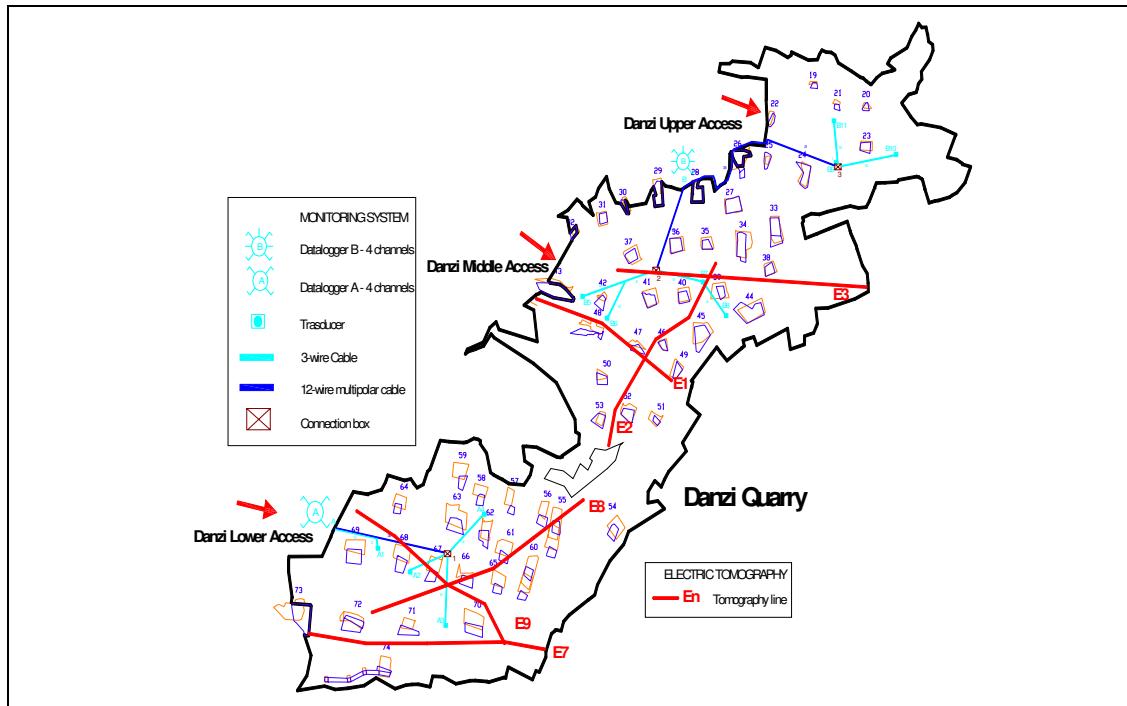
Figure 7. Map of Danzi quarry showing roofs of pillars (blue) and base (green), monitoring system and tomography lines.

Nine tests were performed on the pillars (see Figure 7 for location of the pillars) and the boundary walls by allowing the estimation of the acting state of stresses (see Table 6). These results were then used for the numerical model calibration.

The FEM analysis on pillar 23 (see Figure 7) returned a value of approximately 2.22 MPa for vertical stress in the area where the flat jack test was performed, which fits well with the experimental results that indicate a vertical stress of 2.14 MPa. The same conceptual procedure has been used for all of the pillars and walls that were tested with the flat jack. The mechanical features of the rock mass after the calibration procedure are reported in Table 9.

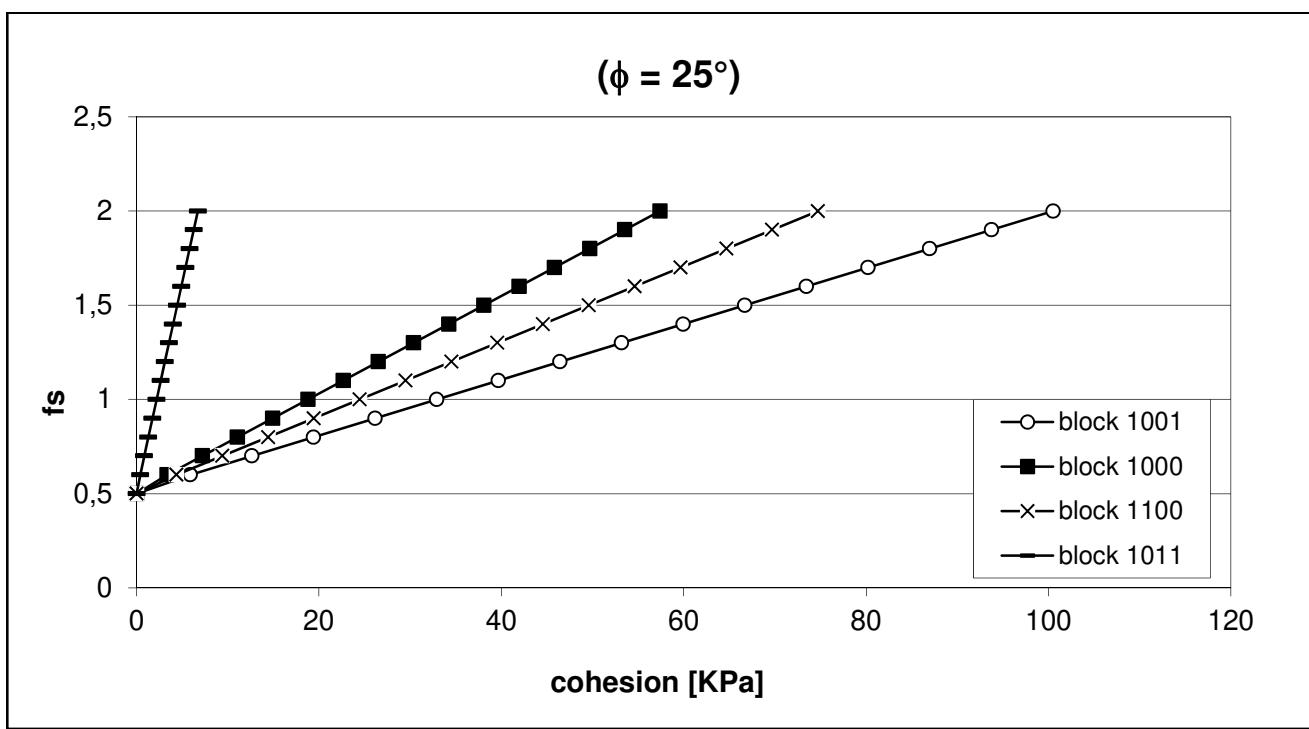
Figure 10a. Variation of SF with cohesion (friction angle = 25°).

The parametric analysis of the discontinuity shear strength has also been considered. Laboratory tests on discontinuities have shown shear friction angles of 51° and 41° , respectively, for peak and residual condition. However, in situ observations have outlined the presence of non-fully persistent discontinuity and weathering due to karst actions. These two effects caused the authors to take the cohesion value (due to rock bridges) and the low friction angles (due to karstic action) into account. The results obtained on the central entrance indicated that for friction angles below 44.5° , instability occurs for all finite and removable blocks. For friction in the range of 30.3° – 32.9° , the safety factor (SF) varies from 1–1.3 (see Figure 10).

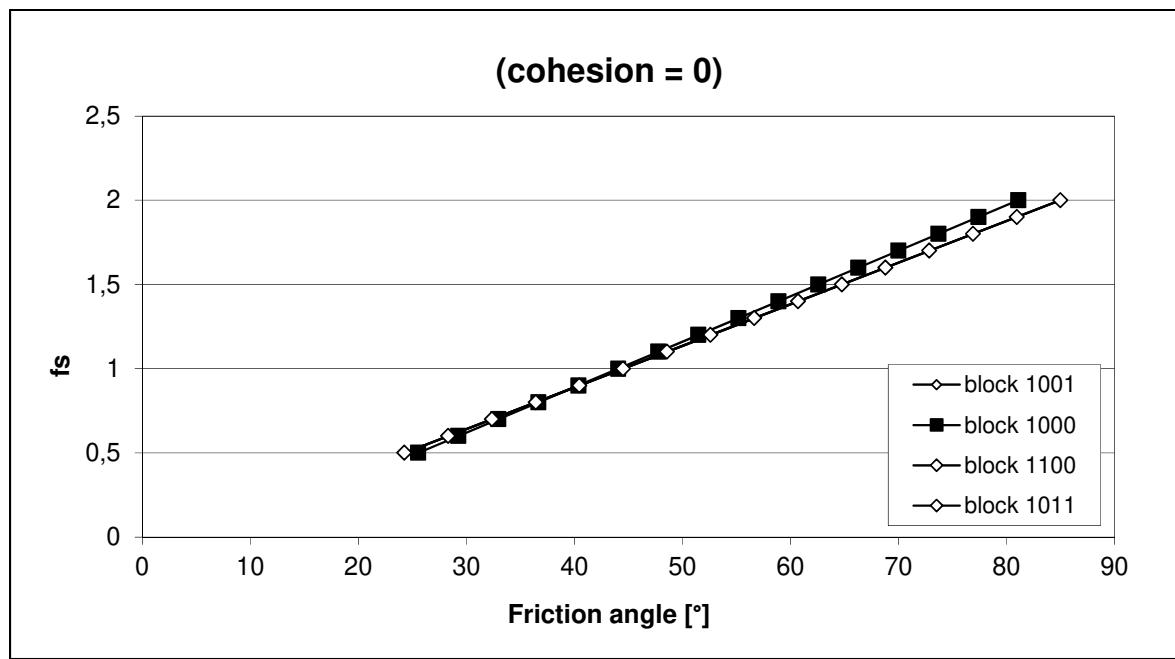
Figure 10b. Variation of safety factor (SF) with friction angle (cohesion = 0).

For friction angles above 56.6° , $SF > 1.3$. For the lower entrance, similar results have been obtained where instabilities occur at friction angles below 53.7° . All of the finite blocks are unstable at the upper entrance of the Danzi quarry. On the other hand, cohesion in the range of 20–30 kPa can guarantee stability for most blocks. Table 7 reports the results subdivided for each examined entrance area.

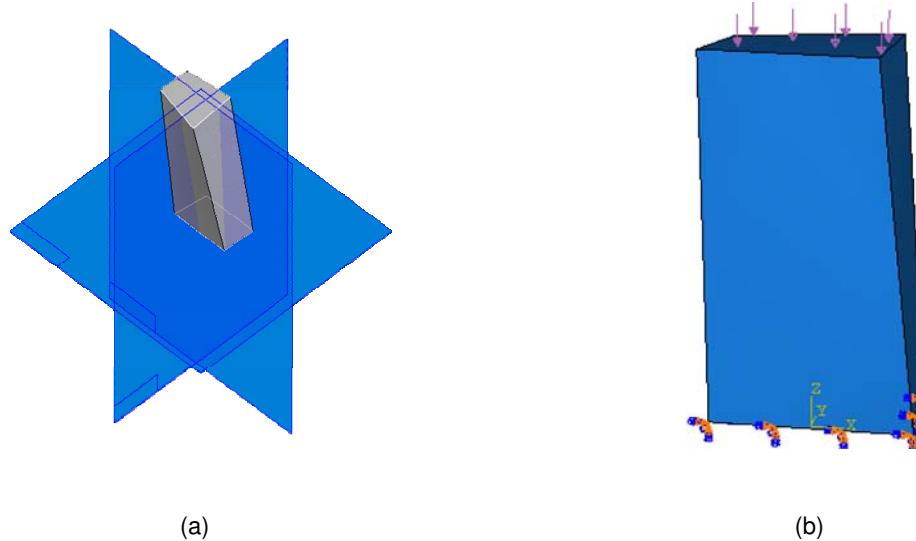
Figure 11. (a) View of pillar No. 23 (see Figure 7) as modeled with ABAQUS software (Hibbit, Karlsson and Sorensen, Inc., 1994); (b) different 3D view of same pillar with boundary conditions and applied loads.

The first analysis defined the most appropriate mechanical features of the rock mass using a back analysis procedure on the pillars where flat jack tests were performed. The comparison between numerical results and on-site outcomes allowed for an appropriate and reliable calibration of the numerical model and for use as a provisional tool. Particular care has been paid to the definition of the loading condition of the pillars. In a local model, such as the one reported in Figure 11, the correct definition of the loading condition is essential for a proper numerical calculation. The reported pillar is located inside the Beltrami quarry, has a height of approximately 7 m, is highly irregular and the rock overburden is around 13 m high. The area of influence of the pillar is around 200 m^2 . In order to calculate the load that should be applied to the pillar

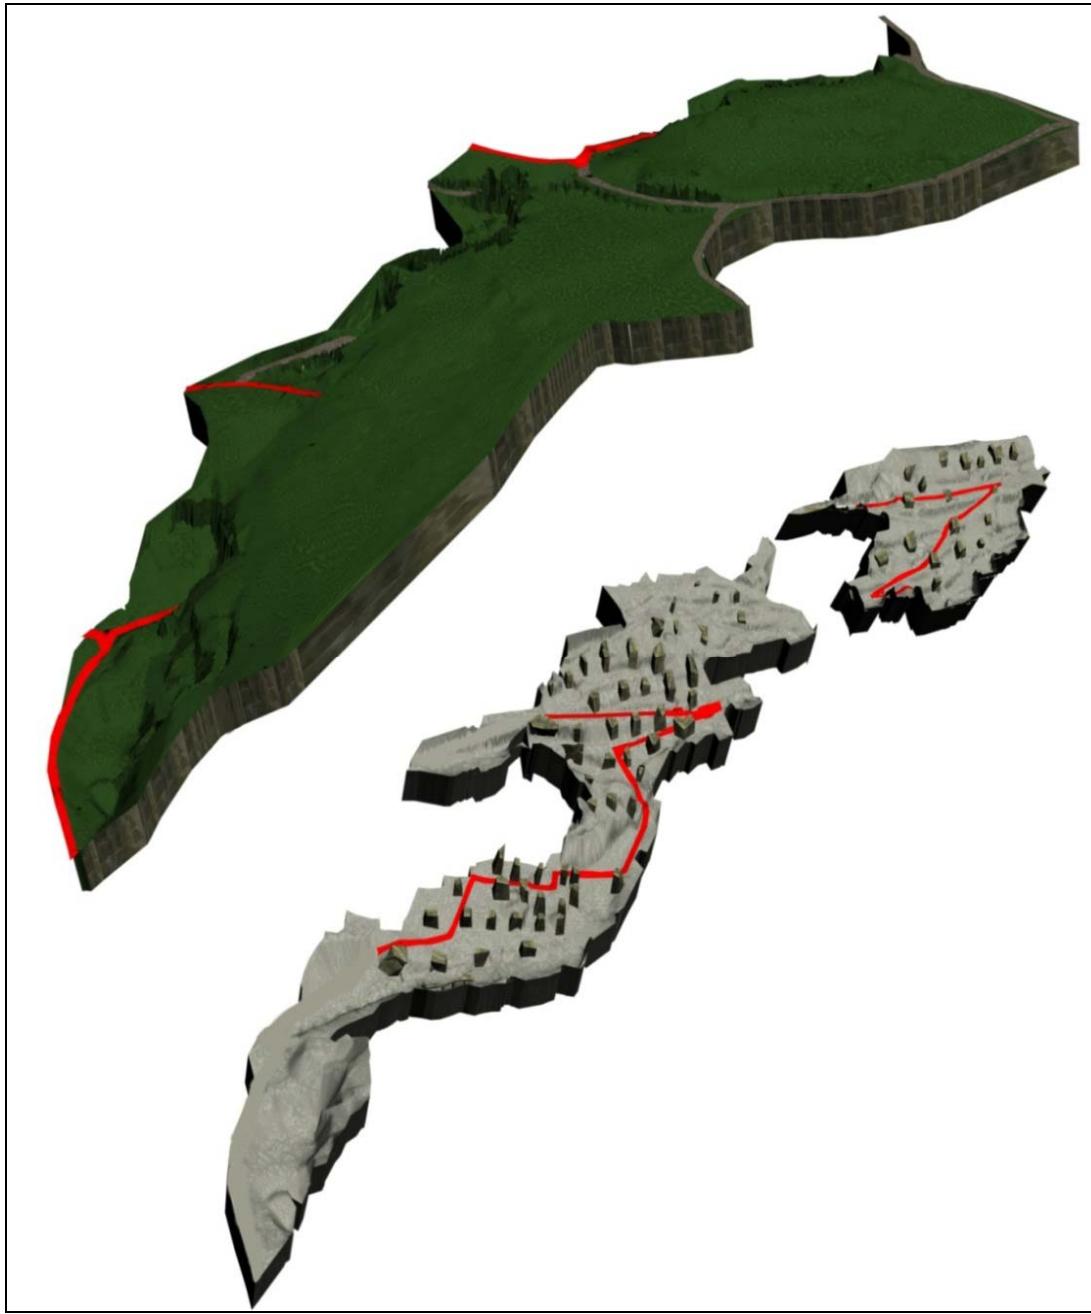
Figure 16. 3D rendering of route for visitors. External area (above) and underground path (below).

A short distance outside the quarries (see Figure 16), visitors walk between several ancient stone walls inside a well-kept forest and then reach the entrance to Beltrami quarry. This quarry is the oldest and was excavated using the manual hammer-and-chisel technique. Traces of such activity can be seen along the walls and on the sides of the pillars.
