# Expedient Mitigation of Collapsible Loess in Northern Afghanistan

**Christopher T. Senseney**, Assistant Professor, U.S. Air Force Academy, Colorado, 80840-6232, USA; email: [christopher.senseney@usafa.edu](mailto:christopher.senseney@usafa.edu)

Reference: Senseney, C. (2013). *Expedient Mitigation of Collapsible Loess in Northern Afghanistan*

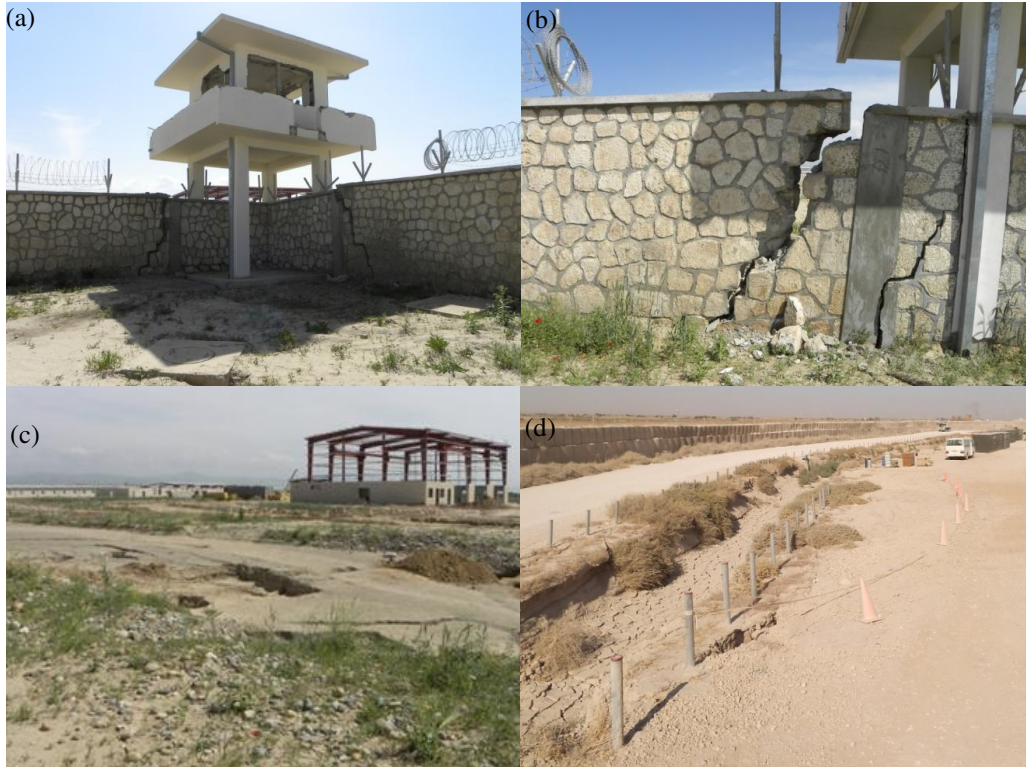
Figure 2. a. Damaged guardhouse and security wall in Kunduz, b. security wall damaged in Kunduz, c. settlement basin through a road in Kunduz, d. slope failure next to earthen drainage ditch in Mazar-e-Sharif as evidenced by coned off area.

The magnitude of collapse and resulting damage to infrastructure and facilities is primarily dependent on the amount of wetting. In low lying areas where water pools or flows after heavy rains, soil collapse often manifests itself in settlement basins or slope failure. Settlement basins typically occur near the perimeter of a facility beneath downspouts or on the edge of roads near drainage ditches. The facilities, in turn, experience differential settlement and structural damage, as evidenced by building settlements up to 10 cm (4 in) around Mazar-e-Sharif and Kunduz (Meier et al. 2009, SIGAR 2010). Settlement basins also cause failure to security walls (Fig. 2a-b) and damage roads (Fig. 2c). Slope failures damage the drainage system and render limited real estate unusable (Fig. 2d). Repairing damage wastes valuable resources that could be better utilized elsewhere.

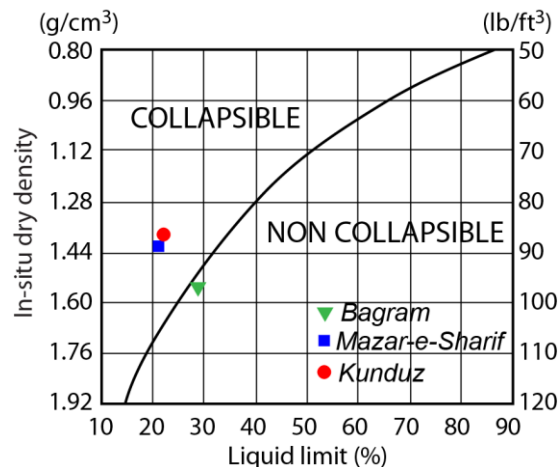
Figure 3. Gibbs and Bara (1962) criteria for determining collapsibility.

Of the methods to identify collapsible soil, two of the most common are the dry density and liquid limit graph (Gibbs and Bara 1962) and the one-dimensional compression test using an oedometer (Lutenegger and Saber 1988). By studying alluvial fan deposits in California with low dry density, Gibbs and Bara (1962) showed that when the saturated moisture content exceeds the liquid limit, the soil will likely collapse. Using this relationship, they developed the dry density versus liquid limit criteria in Fig. 3. The Gibbs and Bara approach is most applicable to clayey sands and sandy clays (NAVFAC 1986), but in the absence of a collapse test, it is a reasonable preliminary assessment for loess soils. Lutenegger and Saber (1988) introduced a collapse test that applies a vertical stress to a laterally confined, undisturbed sample of loess at its natural water content, and then introducing water to the specimen. A decrease in volume at a constant vertical stress is an indication of the collapse potential of the soil.

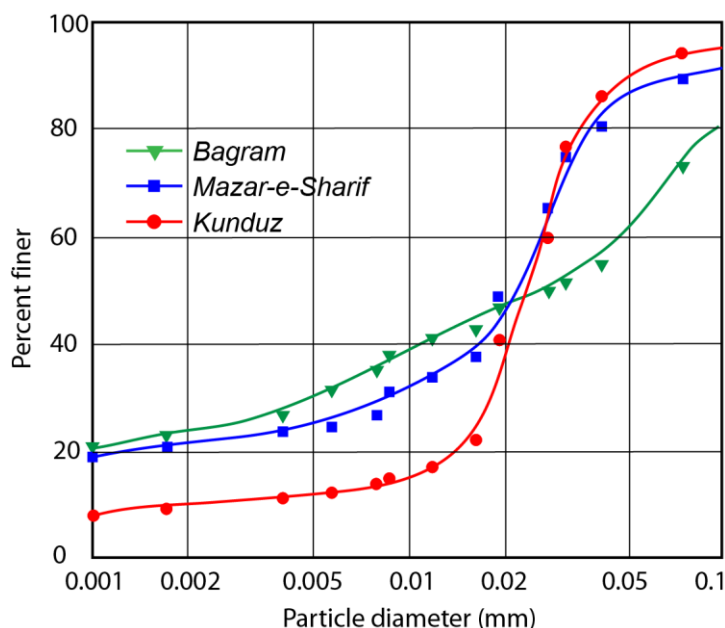
Figure 4. Particle size distributions of Kunduz, Mazar-e-Sharif and Bagram soil.

Soils from Afghanistan military bases in Kunduz, Mazar-e-Sharif and Bagram were evaluated for collapse using Gibbs and Bara's criteria and Handy's criteria. Sand cone tests were conducted and disturbed soil samples were collected at a depth of 0.5 m (20 in). Three sand cone tests and three samples were obtained from Kunduz and two sand cone tests and two samples each were obtained from Mazar-e-Sharif and Bagram. An average of the soil properties are given in Table 1 and an average of the particle size distributions in Fig. 4, where fine content less than 0.075 mm was determined using a hydrometer apparatus (ASTM 2007). The Kunduz and Mazar-e-Sharif soil exhibit a uniform distribution with particles concentrated in the range 0.01 to 0.06 mm, indicating the soils are loessial and will not compact well. On the contrary, the Bagram soil exhibits a more well-graded distribution, indicating the soil is not loessial and has higher potential for compaction. According to Gibbs and Bara's criteria, the Kunduz and Mazar-e-Sharif soil is collapsible, while the Bagram soil would fall just inside the non-collapsible region (see Fig. 3). According to Handy's criteria, the Kunduz soil has high probability of collapse, the Mazar-e-Sharif soil will probably collapse, and the Bagram soil has less than 50% probability. These results match what military forces have observed. As many as 48 sites in and around the Kunduz Airfield show signs of collapsed soil (SIGAR 2010) and an earthen drainage ditch near the Mazar-e-Sharif Airfield experienced slope failure from collapsible soil. No evidence of collapse has been observed at Bagram. Lutenegeger and Saber's collapse test or other collapse tests were not used in this study because the equipment to obtain undisturbed samples and equipment to conduct necessary laboratory tests are not available in Afghanistan.

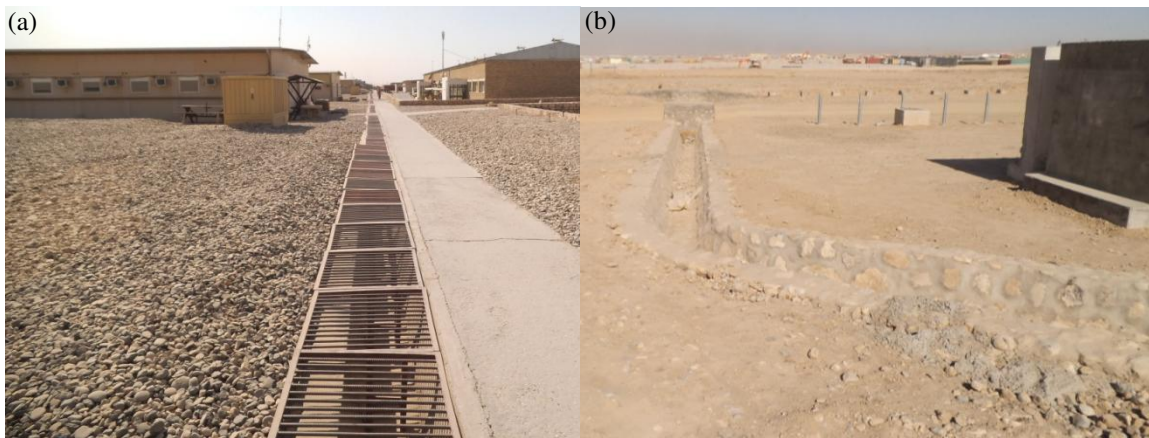
Figure 5.a. Cast in place concrete trench drain and gravel cover over the ground surface, b. grouted stone channel constructed with locally available cobble stones.

A suitable drainage design at expedient military bases is open channel drains and a gravel cover over the ground surface. Cast in place concrete trench drains (as shown in Fig. 5a) should be trapezoidal or rectangular with depths generally ranging from 0.15-1.0 m (0.5-3.3 ft), depending on local hydrological conditions. The drain bottom and side walls must be reinforced to withstand earth pressure and anticipated loads. Grouted stone channels (see Fig. 5b) are also acceptable. Such channels are common in Afghanistan given the abundance of naturally occurring cobble stone deposits in river beds. Downspouts from buildings should feed into the drains. UngROUTED riprap-lined channels or earthen drainage ditches (see Fig. 2d) are not recommended because water infiltration may cause collapse and/or slope failure.
