Reclamation and Safety of High Cantilever Strong Box Pipe Pile Seawall in Marine Clay

ABSTRACT: A high cantilever seawall was constructed in soft clay of 15 m to 32 m thickness and the enclosed water between the shoreline and the seawall was reclaimed. The area was 7 hectare and the reclamation height ranged from 10 m to 20 m. The reclamation methods were controlled and not intended to cause additional incremental deflection to the already high design deflection of -385 mm or 0.89% of H ($H = 44$ m is defined as rotating and not cantilever height). However the different methods of reclamation had a significant influence on the slurry clay flows and thus caused additional incremental deflection. The slurry clay flows pushed the deflection of seawall to an additional maximum magnitude of -353 mm or 0.80% of H. The maximum seawall deflection of -526 mm or 1.20% of H was based on inclinometer IW1903 readings. At such high seawall movement, the inclinometer deflection profiles indicate safety in the design and the long term deflection is stable. This reclamation experience indicates that it is difficult to control slurry clay flows in future high reclamation filling of 10 m to 20 m hei

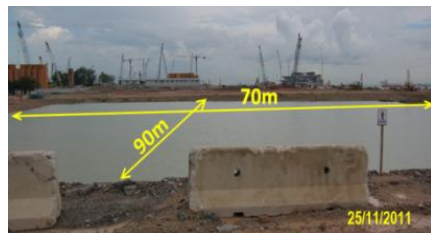
(a) Photograph of pond A (90 m x 70 m x 5.5 m) with slurry clay heaved from RL94.5 m to RL100 m.

The clay slurry ponds B and C were observed on 25 Nov 2011 as shown in Figure 13, when the clay slurry was pushed sideways and upward to the pond water level RL102.0 m. Pond A was still submerged in water and the clay slurry thickness was determined by chain sounding.

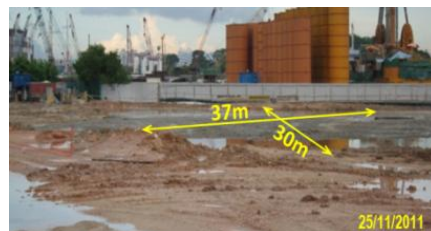
(c) Photograph of pond C. (37 m x 30 m x 7.5 m) with slurry clay heaved from RL94.5 m to RL102 m.
