Reclamation and Safety of High Cantilever Strong Box Pipe Pile Seawall in Marine Clay

ABSTRACT: A high cantilever seawall was constructed in soft clay of 15 m to 32 m thickness and the enclosed water between the shoreline and the seawall was reclaimed. The area was 7 hectare and the reclamation height ranged from 10 m to 20 m. The reclamation methods were controlled and not intended to cause additional incremental deflection to the already high design deflection of -385 mm or 0.89% of H ($H = 44$ m is defined as rotating and not cantilever height). However the different methods of reclamation had a significant influence on the slurry clay flows and thus caused additional incremental deflection. The slurry clay flows pushed the deflection of seawall to an additional maximum magnitude of -353 mm or 0.80% of H. The maximum seawall deflection of -526 mm or 1.20% of H was based on inclinometer IW1903 readings. At such high seawall movement, the inclinometer deflection profiles indicate safety in the design and the long term deflection is stable. This reclamation experience indicates that it is difficult to control slurry clay flows in future high reclamation filling of 10 m to 20 m hei

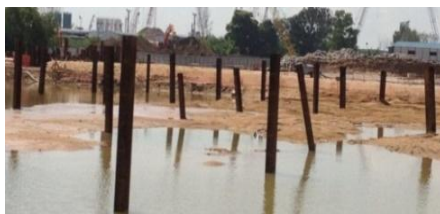
Pond A
Controlled filling layout with kingposts in progression of 0.5 m thick sand layer at every 10 m x 10 m grid.

Figure 12. Photograph showing controlled filling method C for stage 3 reclamation.

Reclamation by controlled filling method C for filling into ponds B, A and C is shown in Figure 12. This controlled filling of 0.5 m thickness with Grade A material was enforced for the clay slurry ponds A, B and C. For pond A, a grid pattern of 10 m x 10 m was set up for the filling that was carried out in progression. At each step of progression, the fill thickness was

not exceeding 0.5 m. Even with such stringent control filling, some of the kingposts were noted to tilt. The method of reclamation was extremely slow and may cause clay squeezing of thickness less than 0.5 m. Similar layering reclamation filling in 0.5 m thickness was carried out for ponds B and C.
