Geotechnical and Structural Challenges over an Active Landslide

ABSTRACT: The construction of the steel arched Tsakona Bridge, designed to overpass an active landslide, required several temporary projects. Auxiliary steel towers were used for the erection and welding of the arch segments. Most of them had to be founded in the body of the sliding mass. An automated instrumentation and monitoring system was installed on site providing early warning to the engineers in charge in case large displacements were measured. The real-time recording data provided valuable information about the landslide movements. These monitoring results defined the geotechnical and structural design criteria for the deep foundation of the temporary towers. Several 2D and 3D geotechnical and structural models were created to evaluate the sliding effect on the foundation components, finalize their dimensioning and calculate the required reinforcement. The procedure followed for the design of the temporary deep foundation is described based on the criteria devised using the monitoring system, emphasizing on the continuous feedback between the geotechnical and structural design teams. Several key structural de

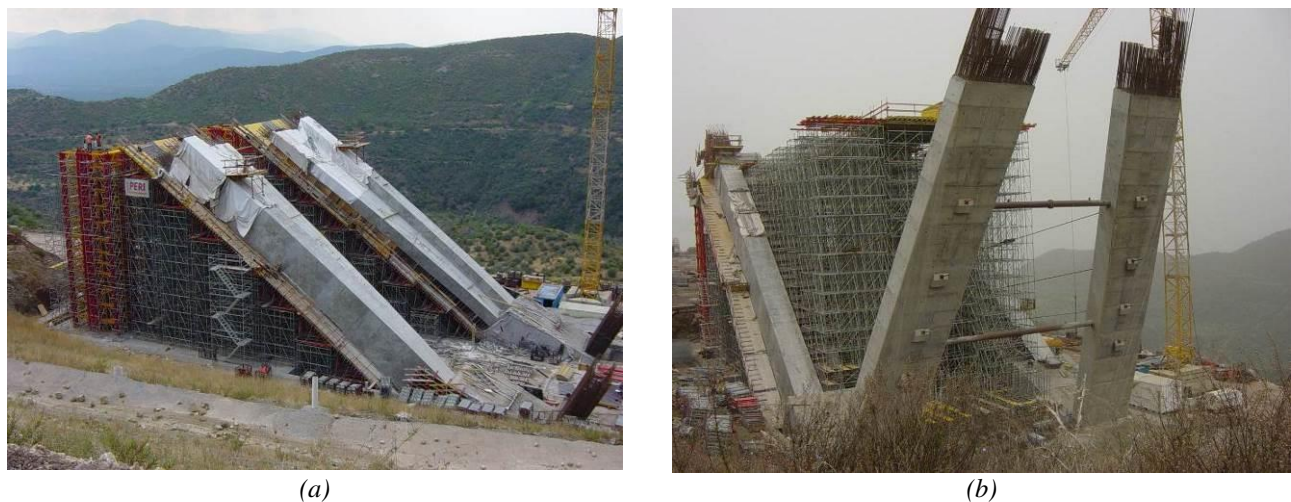
Figure 9. Construction of the (a) curved struts and (b) straight struts of the bridge pier.

The main body of the V-shaped pier consisted of two pairs of supporting struts. The southern struts were curved, following the parabolic geometry of the arch. The northern ones were designed as straight elements on the same inclined plane, converging towards each other. For the construction of the curved struts, scaffolding towers were used, anchored on slabs on the ground. For the straight struts a self-climbing formwork system was mobilized. Temporary horizontal bracings along the transverse direction kept the straight struts in place. At the same time, temporary tendons were utilized to suspend these struts from the completed curved ones, providing the necessary stability to the unfinished V-shaped pier (Figure 9). Before the construction of the curved struts, the two MT towers were installed to support their top ends. They were designed to provide bearing capacity of 12000 kN and 16500 kN each, under static and seismic load combination, respectively. Their foundation consisted of pile-groups penetrating the stable bedrock, connected with pile caps. Ground anchors were also foreseen, as mitigation measure to be activated in case large movements were observed during construction (Figure 10). A special arrangement was provided on the top of the MT towers to compensate any contingency movement within the loose soil above the bedrock as well as the elastic deformations of the auxiliary towers and the deformation due to temperature fluctuations. This arrangement included two (2) elastomeric bearings and four (4) lifting jacks for each tower. Continuous accurate surveying of the level of the bearings and vertical adjustments through the jacks were ensuring the fixed vertical position of the support during construction, until the complete functionality of the arch was achieved.

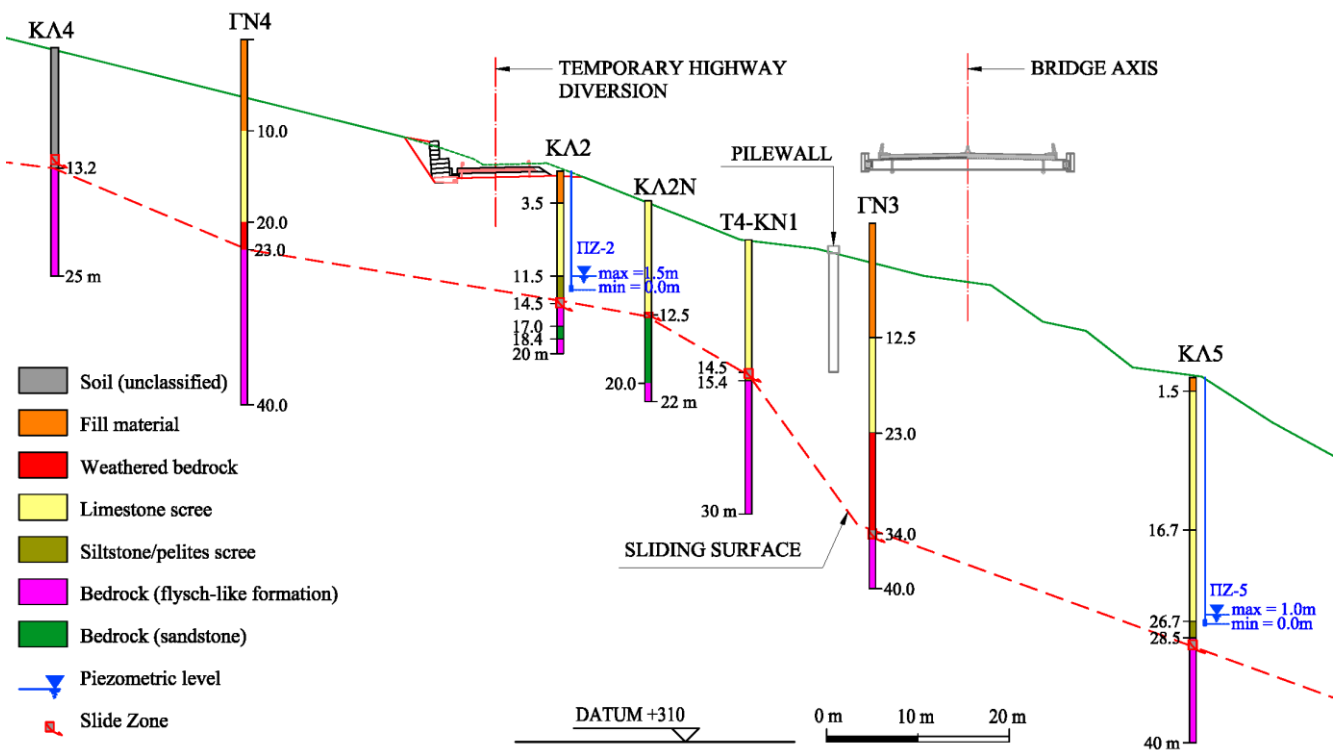
Figure 16. Section in between Piers Ii2 and Ii3 showing the position of the geotechnical instruments with respect to the bedrock surface.

In order to explore and deal with an active landslide, which presented very small margins of safety against failure, a network of geotechnical instruments that recorded the movements of the sliding mass and water levels was installed in the 2001-2012 period, comprising optical targets, inclinometers and piezometers. In January 2013, in view of the forthcoming high-risk construction works, a complementary fully automated instrumentation scheme was designed and implemented that continuously recorded, monitored and updated a database (Seferoglou and Chrysohoidis 2016). The instruments were located at key depths within the sliding mass and at positions near structural elements. The new instrumentation system consisted of four (4) in-place inclinometer chains in boreholes KA2, KA3, KA4 and KA5 (later relocated to KA2N, KA3N and KA5N), three (3) electrical piezometers (ΠΖ-2, ΠΖ-3 και ΠΖ-5) close to the boreholes KA2, KA3 and KA5 and a rain gauge (pluviometer). These instruments, along with the conventional ones, provided all the necessary information about the movement of the sliding mass and its impact on the structures. The arrangement of all instruments in plan-view is illustrated in Figure 15, while a characteristic section between piers Π2 and Π3 is shown in Figure 16, pointing out the position of the geotechnical instruments with respect to the bedrock surface.

shown in Figures 6 through 8 and 16. The scope of this procedure aimed at defining the geotechnical parameters that would feed the final structural design of each pier. These parameters were the coefficients of the earth pressure produced by landslide slippage and the constants of the equivalent elastic supports that would be applied as springs at the bottom of each pile of the structural models, simulating the soil-structure interaction. The constant of equivalent vertical spring of each pile of the piers was expressed as $K=P/v_z$, where $P=1000$ kN was a single load applied on the top of the corresponding pile and v_z was the calculating settlement. For the piles of the left branch a mean value derived from the analyses of all piers and a spring constant of 140,000 kN/m was adopted, while for the right branch the calculated values varied within a range of 120,000 kN/m – 1,000,000 kN/m. These results were in accordance with the ones derived from loading tests of non-functional piles. Regarding the earth pressure evolved at the upslope piles of the right branch piers $\Pi 2\Delta$ - $\Pi 4\Delta$, presenting the maximum free height and being founded in the sliding body, the horizontal and vertical stresses were calculated under static loads, resulting in equivalent pressure coefficient equal to $K_0=0.50$. The same value was obtained for the imposed movement, since the floating piles moved along with the sliding mass, as also demonstrated by the 3D geotechnical analyses and confirmed by the monitoring data.
