Geotechnical and Structural Challenges over an Active Landslide

ABSTRACT: The construction of the steel arched Tsakona Bridge, designed to overpass an active landslide, required several temporary projects. Auxiliary steel towers were used for the erection and welding of the arch segments. Most of them had to be founded in the body of the sliding mass. An automated instrumentation and monitoring system was installed on site providing early warning to the engineers in charge in case large displacements were measured. The real-time recording data provided valuable information about the landslide movements. These monitoring results defined the geotechnical and structural design criteria for the deep foundation of the temporary towers. Several 2D and 3D geotechnical and structural models were created to evaluate the sliding effect on the foundation components, finalize their dimensioning and calculate the required reinforcement. The procedure followed for the design of the temporary deep foundation is described based on the criteria devised using the monitoring system, emphasizing on the continuous feedback between the geotechnical and structural design teams. Several key structural de

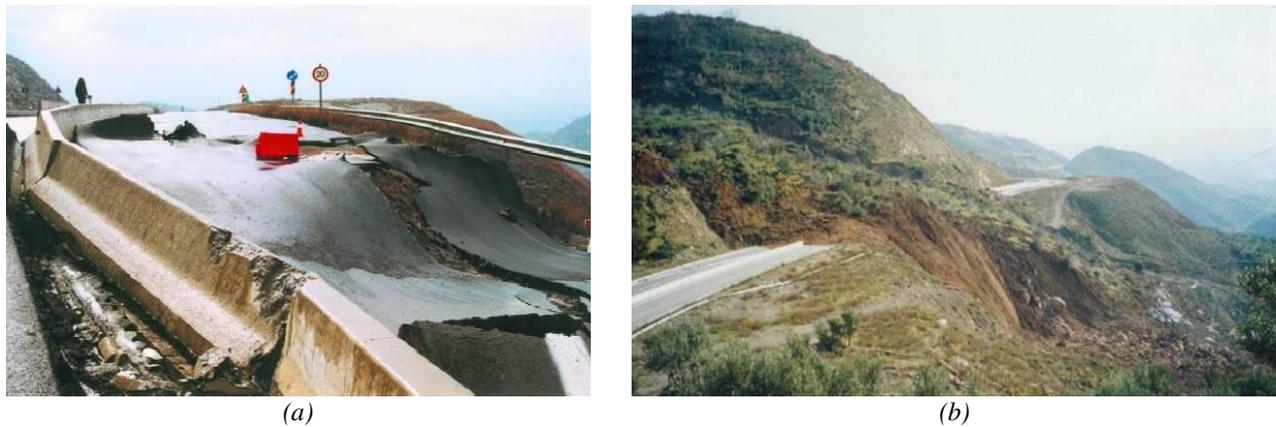
Figure 1. The Tsakona landslide (February 2003) (EMEK S.A (2015)) (a) large settlements on the road pavement (b) massive soil movement (Fikiris et al. (2001)).

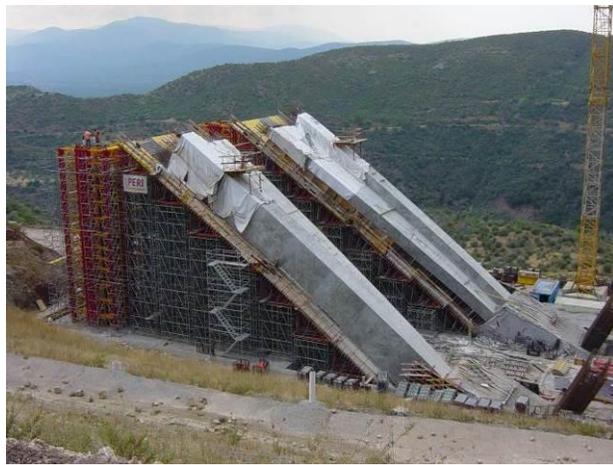
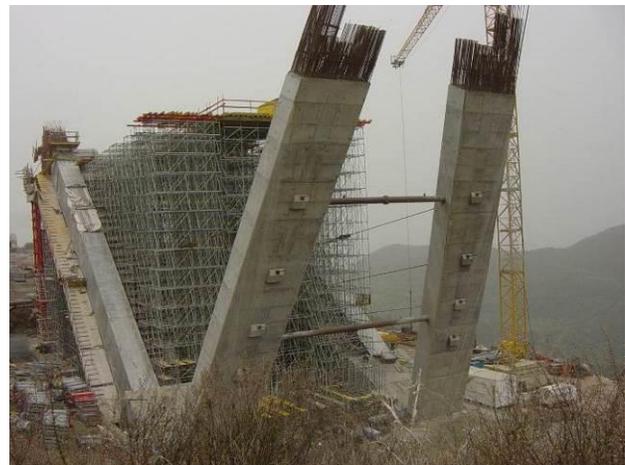
Figure 9. Construction of the (a) curved struts and (b) straight struts of the bridge pier.

The main body of the V-shaped pier consisted of two pairs of supporting struts. The southern struts were curved, following the parabolic geometry of the arch. The northern ones were designed as straight elements on the same inclined plane, converging towards each other. For the construction of the curved struts, scaffolding towers were used, anchored on slabs on the ground. For the straight struts a self-climbing formwork system was mobilized. Temporary horizontal bracings along the transverse direction kept the straight struts in place. At the same time, temporary tendons were utilized to suspend these struts from the completed curved ones, providing the necessary stability to the unfinished V-shaped pier (Figure 9). Before the construction of the curved struts, the two MT towers were installed to support their top ends. They were designed to provide bearing capacity of 12000 kN and 16500 kN each, under static and seismic load combination, respectively. Their foundation consisted of pile-groups penetrating the stable bedrock, connected with pile caps. Ground anchors were also foreseen, as mitigation measure to be activated in case large movements were observed during construction (Figure 10). A special arrangement was provided on the top of the MT towers to compensate any contingency movement within the loose soil above the bedrock as well as the elastic deformations of the auxiliary towers and the deformation due to temperature fluctuations. This arrangement included two (2) elastomeric bearings and four (4) lifting jacks for each tower. Continuous accurate surveying of the level of the bearings and vertical adjustments through the jacks were ensuring the fixed vertical position of the support during construction, until the complete functionality of the arch was achieved.

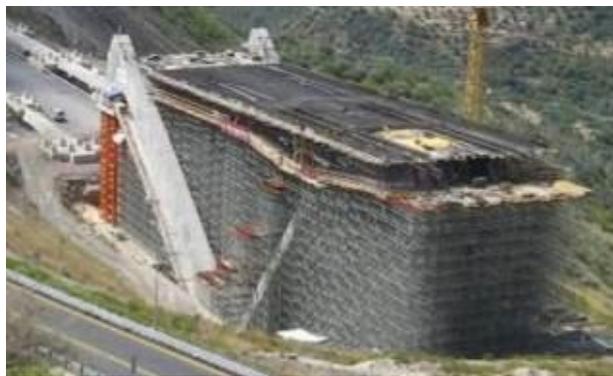
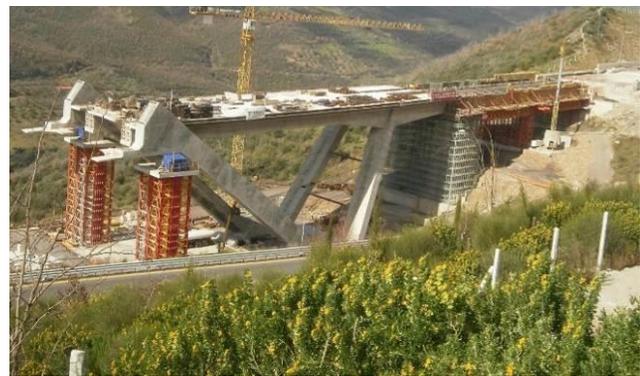
Figure 11. Construction of (a) the 55 m and (b) the 75 m access parts of the bridge prestressed concrete deck.

The 130 m prestressed concrete part of the bridge consisted of two parts, one 55 m long closing the V shape of the bridge pier and the other 75 m long between the straight struts of the pier and the northern abutment, as shown in Figure 11. The first part was poured on scaffolding anchored on the struts of the pier and ground slabs, while for the second one heavy duty bridge-type scaffolding was used, founded with piles on adverse surface morphology conditions, but on a stable ground (Figure 11). The construction of the bridge was completed with the steel arch part. The arch system with a span of 260 m and a rise of 45 m, consisted of two vertical steel arches, one for each branch of the Highway, connected with K-type bracings, all pre-fabricated. Segments of 12 m long were assembled and welded on the ground slabs or the bridge corridors, creating larger pieces of 36 m, which were in turn lifted to position with the heavy lifting system mounted on the temporary steel towers and welded at height. Shelter booths were seated at the top of the towers providing protection from the wind and the rain for the welding procedure of the arch segments (Figure 12a). The bridge was completed with the erection of the composite deck (Figure 12b), which was fully suspended from the arches with the use of hangers (Stathopoulos et al. 2014a, 2014b).

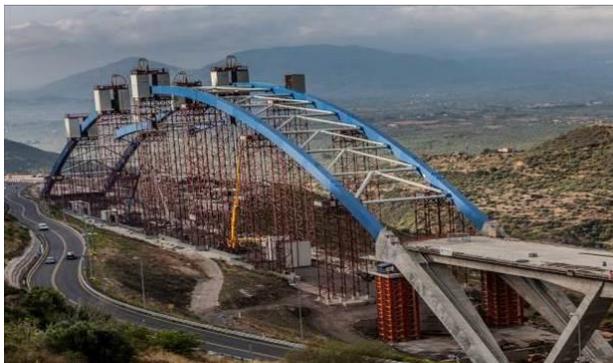
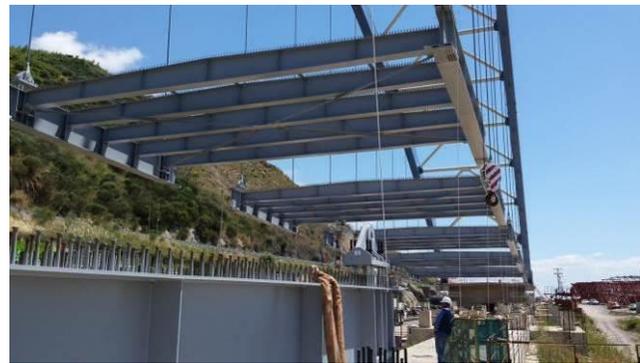
Figure 12. Assembling, erection and welding of (a) the arch segments using the auxiliary steel towers and (b) the composite deck segments.

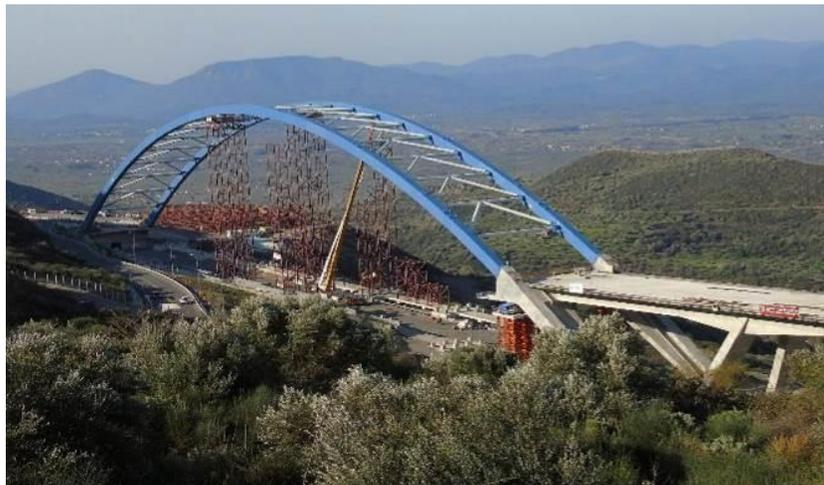
Figure 14. Removal of the temporary towers.

Other crucial issues were related with gradual removal of the arch supporting towers (Figure 14), as well as the total release of the bridge and the removal of the last supporting structure, the MT towers.

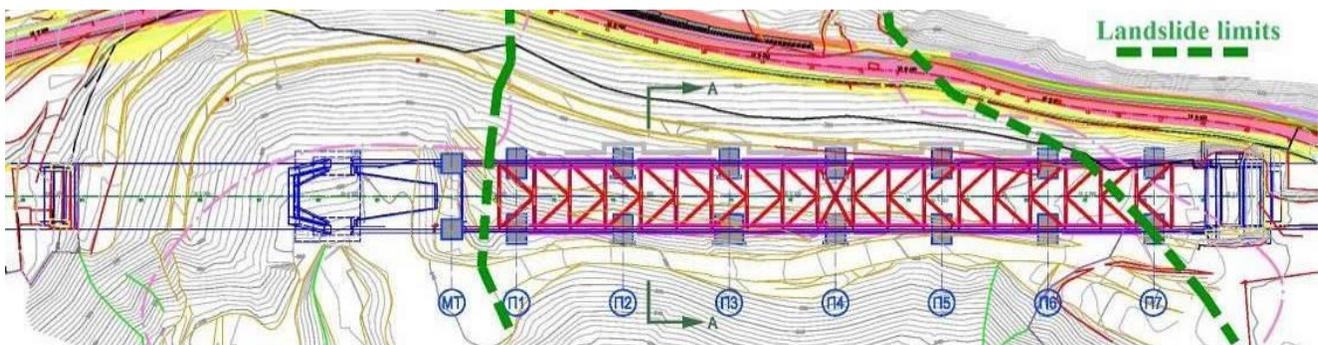
Figure 24. Location in plan view of the characteristic transverse view A-A.
