Masonry Arch Bridges with Reinforced Soil Spandrel Walls

Reference: Jones, C.J.F.P. and Doulala-Rigby, C. (2022). Masonry Arch Bridges with Reinforced Soil Spandrel Walls. International Journal of Geoengineering Case Histories, Volume 7, Issue 2, pp. 72-82, doi: 10.4417/IJGCH-07-02-06

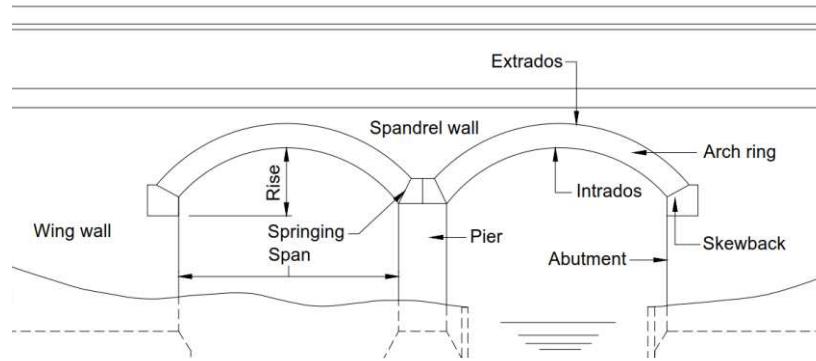
Figure 4. Long section of an arch bridge (Highway England, 2020).

Masonry arch bridges are simple structures with a stone or brick arch supporting outer spandrel walls infilled with soil or granular material, as shown in Figure 4. Originally built to carry horse and cart traffic, they have proved capable of supporting modern traffic loadings, although constant traffic can lead to the spread and even collapse of the spandrel walls due to distortion of the fill. The general maintenance cost of masonry bridges has proved to be lower than most modern structures. Where appropriate, the construction of new masonry arch bridges is encouraged in the United Kingdom with the development of a new code of practice for their design and construction (Highways England, 2020).

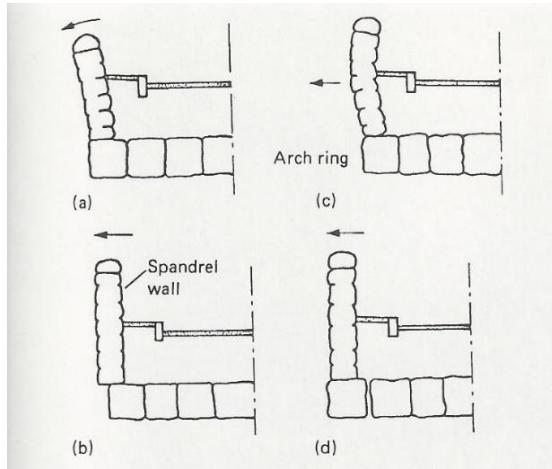
Figure 5. Movement of spandrel walls: (a) outward rotation; (b) sliding; (c) bulging; and (d) outward and cracked arch (Sowden and Jones, 1990).

Spandrel walls are an example of an *externally* stabilized method. The movement of spandrel walls may take the form of tilting, bulging, or sliding over the extrados of the vault, possibly accompanied by horizontal shearing at different levels or a fracture through the end of the arch barrel may open, as depicted in Figure 5. There are various potential causes for this movement. Vertical live loading on the arch may initiate separation between its extrados and the stiffer spandrel wall and parapet acting together as a beam, or it may lead to longitudinal fracture near the end of the vault. Lateral forces tending to push the spandrel wall outwards may be exerted by the fill, especially if it becomes saturated and freezes or if the road/rail track levels are raised appreciably. The forces may be due to traffic: either vertical live loads generating horizontal pressures from a “Poisson ratio” effect on the fill, or centrifugal forces on curves being transmitted through the fill. The position of traffic relative to the spandrel wall is often significant.

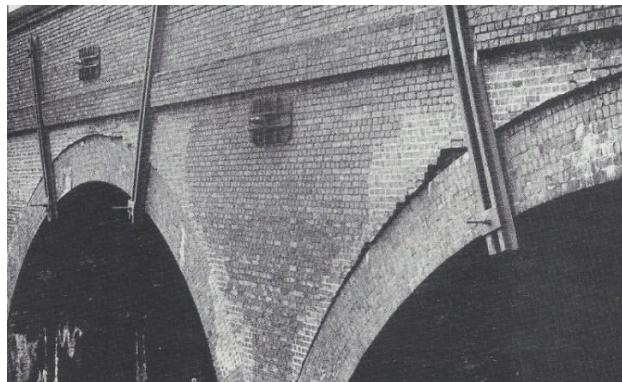
Figure 6. Tie-bars and spreader beams used to stabilize spandrel walls (Sowden and Jones, 1990).

The traditional method of increasing the resistance of spandrel walls to outward movement involves the use of tie-bars with appropriate methods of distributing the stabilizing effect; the results are reasonably effective if inelegant, as shown in Figure 6.

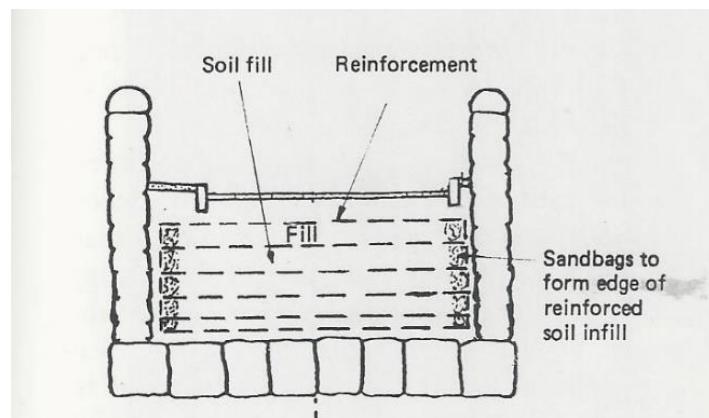
Figure 7. Reinforced soil infill used to relieve lateral pressure on spandrel walls.

The development of polymeric geogrid reinforcement introduced the concept of stabilizing spandrel walls using reinforced soil as the infill between the walls, shown in Figure 7. The advantages of this technique are twofold: total relief is provided to the walls; and the method is economical since the primary construction material is soil, which is compatible for long-term use with polymeric geogrid, which is non-metallic and hence not susceptible to corrosion.

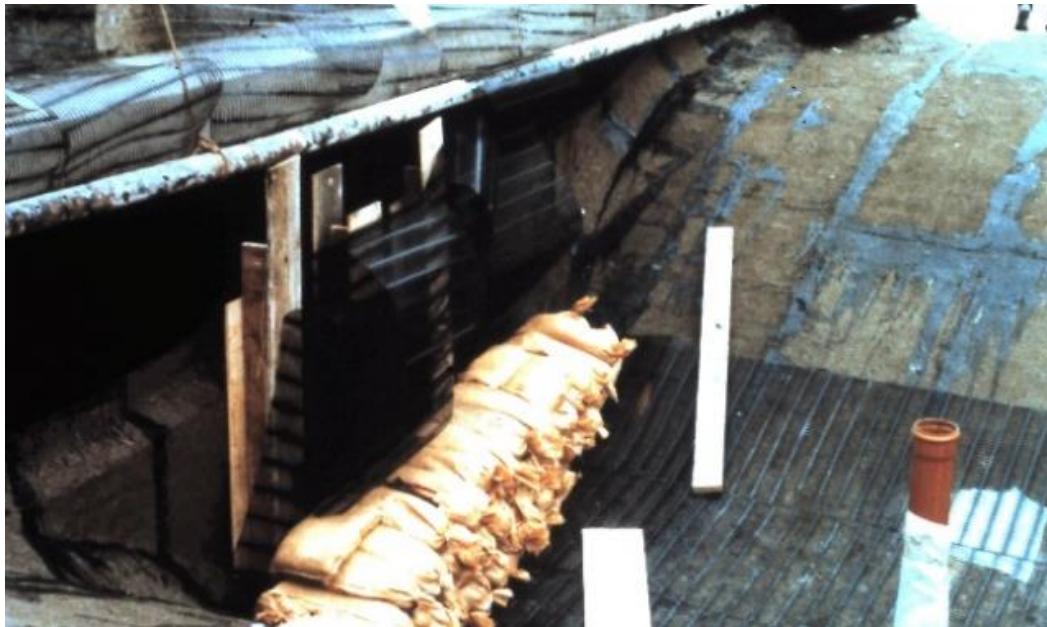
Figure 10. Construction of geogrid reinforced infill to spandrel walls, Kettlewell New Bridge, 1984.

In 1984, the spandrel wall on one side of the bridge failed due to bulging and lateral sliding, though the infill soil remained intact (see Figure 9). Repair was undertaken with geogrid reinforced fill between the spandrel walls, designed in accordance with United Kingdom Memorandum BE 3/78, using the concertina method of construction of reinforced soil, seen in Figure 10. Lateral loading from the reinforced fill onto the reconstructed spandrel walls was eliminated by forming a small permanent gap between the reinforced fill and the back of the spandrel walls, shown in Figure 7. The Concertina Method of construction accommodates difficult geometries particularly if the face is formed by wrapping geogrid reinforcement over sandbags. The 3D shape of the void above the arch results in the shape of the facing changing and the vertical spacing of the reinforcement varying. This is easily accommodated during construction by hammering the sandbags into the desired shape using a wooden mallet.

The required vertical spacing of the reinforcement is at a maximum at the springing of the arch; thus, if this section is stable in accordance with the design Memorandum BE 3/78, no other sections need to be checked. Construction in the confined space over the arch between the spandrel walls is possible, as construction is primary by hand using minimum construction equipment. The geogrid used in the repair of Kettlewell Bridge was the newly developed 1-meter-wide high-density polyethylene (HDPE) uniaxially oriented geogrid with a tensile strength of 80 kN/m identified as SR1. The spacing of the reinforcement at the springing of the arch was 400 mm. The original soil fill removed to undertake the repair was reused (if in suitable condition, e.g., unsaturated). As part of the repair, a waterproof membrane was applied to the extrados of the arch with a positive drain provided at the springing.
