# MSE Wall Behavior during Large Truck Impact at High Speed against Barrier on Top of Wall

**Reference:** Briaud J.-L., Bligh R., and Maddah L. (2024). *MSE Wall Behavior during Large Truck Impact at High Speed against Barrier on Top of Wall*. International Journal of Geoengineering Case Histories, Vol. 8, Issue 1, p.1-24. doi: 10.4417/IJGCH-08-01-01

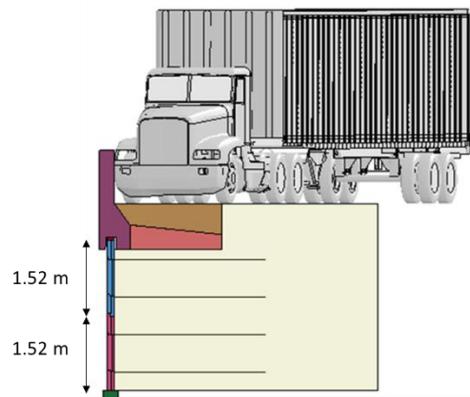
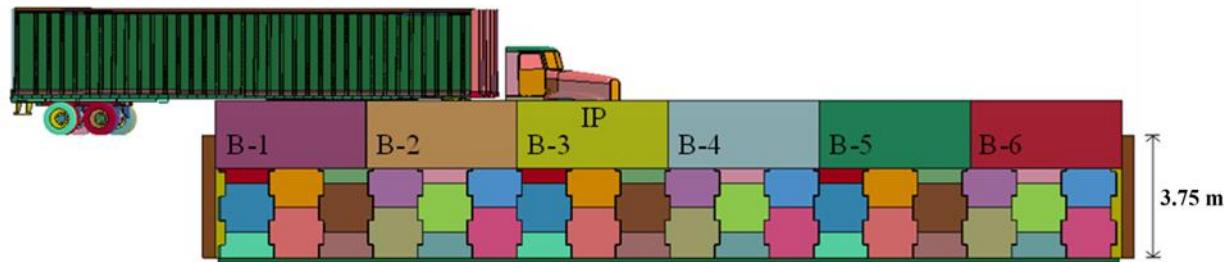
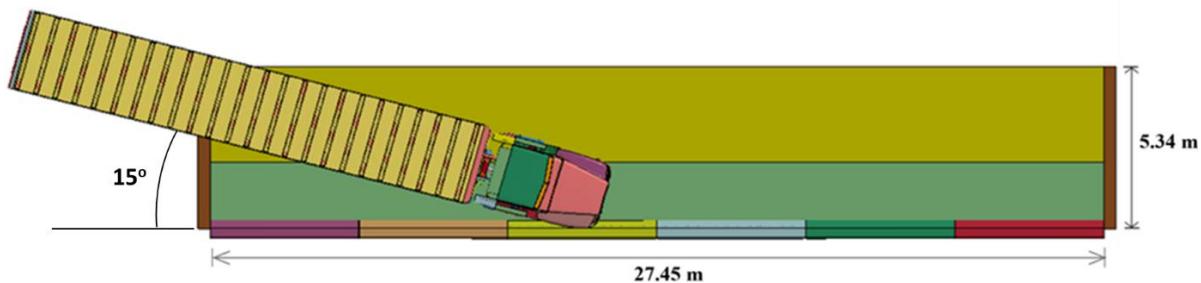
(a) Cross section of barrier-moment slab-MSE wall assembly with truck.

(b) Front view of the barrier-moment slab-MSE wall assembly with truck.

(c) Plan view of the barrier-moment slab-MSE wall assembly with truck.

**Figure 1.** Finite element mesh for simulation of barrier-moment slab-MSE wall assembly with truck: (a) cross section of barrier-moment slab-MSE wall assembly with truck, (b) front view of the barrier-moment slab-MSE wall assembly with truck, and (c) plan view of the barrier-moment slab-MSE wall assembly with truck.

The software used for the simulations was LS-DYNA (Hallquist, 2007). The Finite Element Method (FEM) models included the tractor-trailer truck, the L shape barrier and moment slab, and the MSE wall with soil and reinforcement strips (Figure 1).

The dimensions of the model (Figure 1) were 27.45 m in length, 3.75 m in height, and 5.34 m in width. The barrier height from the pavement surface to the top of the barrier was 1.07 m and the width of the moment slab was varied but finally chosen as 2.13 m, measured from the back of the MSE wall panel to the end of the moment slab. The bottom of the moment slab was 1.02 m deep below the pavement surface, and the length of the reinforcement strips was 3.05 m. Referring to Figure 1, the boundary conditions were as follows: all boundaries were free of any constraints except for the vertical boundary at the back of the wall, at the bottom of the wall and on the side-ends of the wall.

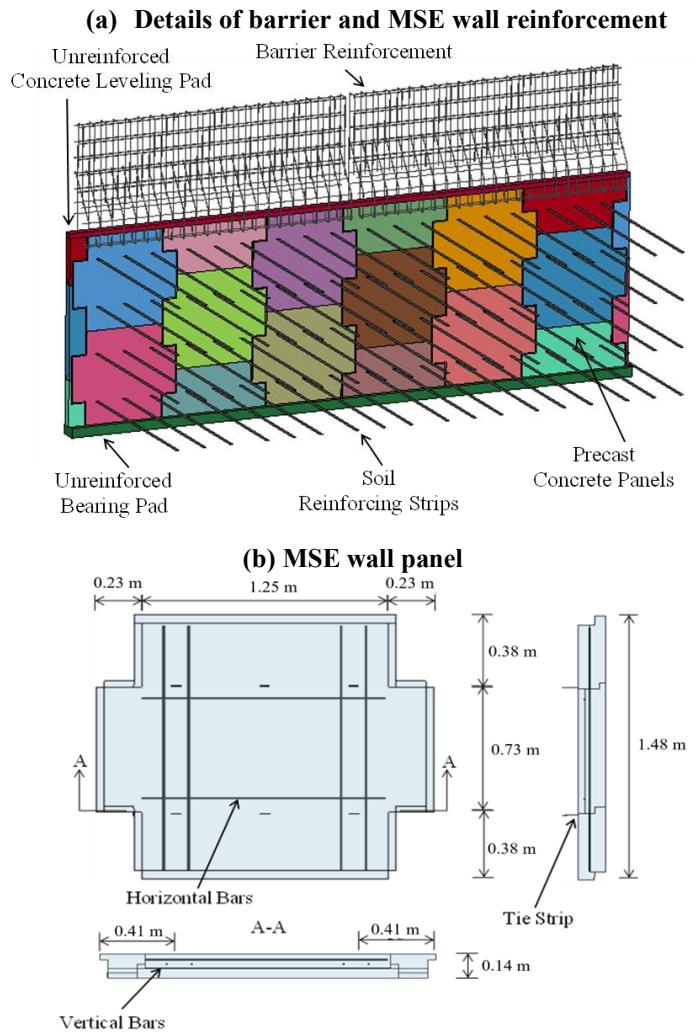
**Figure 2.** Barrier-moment slab and MSE wall model: (a) details of barrier and MSE wall reinforcement, and (b) MSE wall panel.

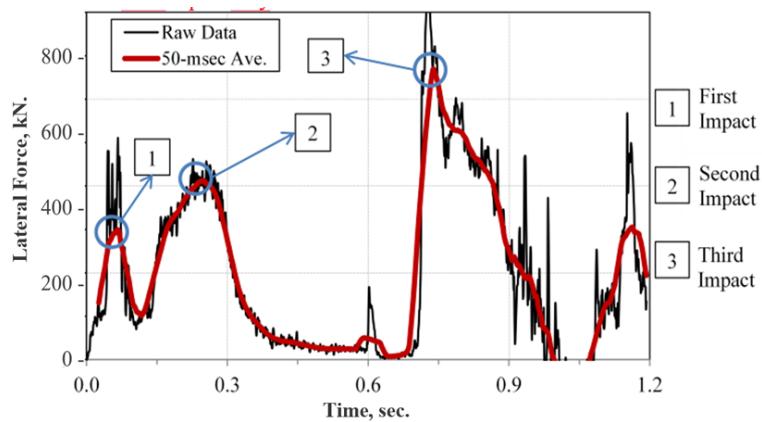
**Figure 3.** Horizontal impact force as a function of time in FEM simulation.

The impact horizontal force on the barrier as a function of time is shown in Figure 3. Two lines can be seen: one shows rapid variations in the load which is the actual measured response, and the other shows a smoother variation. The smoother line corresponds to the 50-millisecond average of the signal, which is common practice in roadside safety data analysis. The 50-ms signal identifies three distinct impacts associated with the front axle of the tractor at a peak dynamic force of 332 kN, the rear axle of the tractor (458.8 kN), and the rear axle of the trailer also known as the back slap (744.9 kN). Figure 4 shows the displacement at the top and at the bottom of the barrier. The main part of the impact lasted one second.

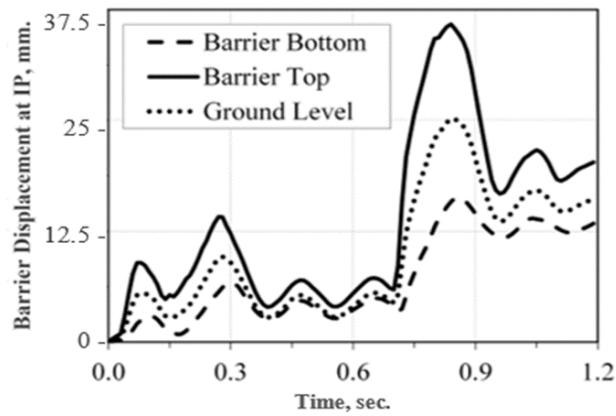
Figure 4. Barrier displacement during impact in FEM simulation.

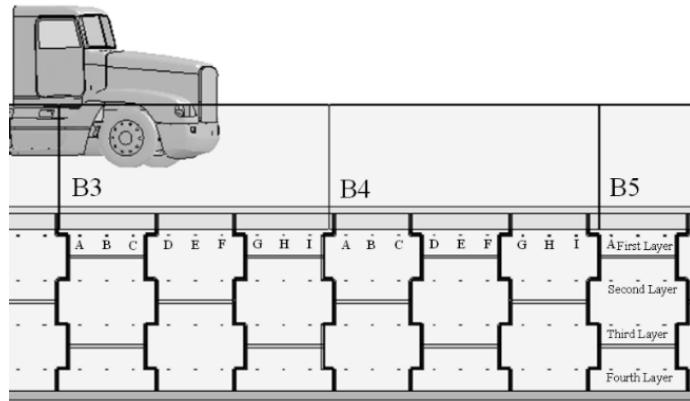
Figure 5. Reference designation for the strips in the wall.

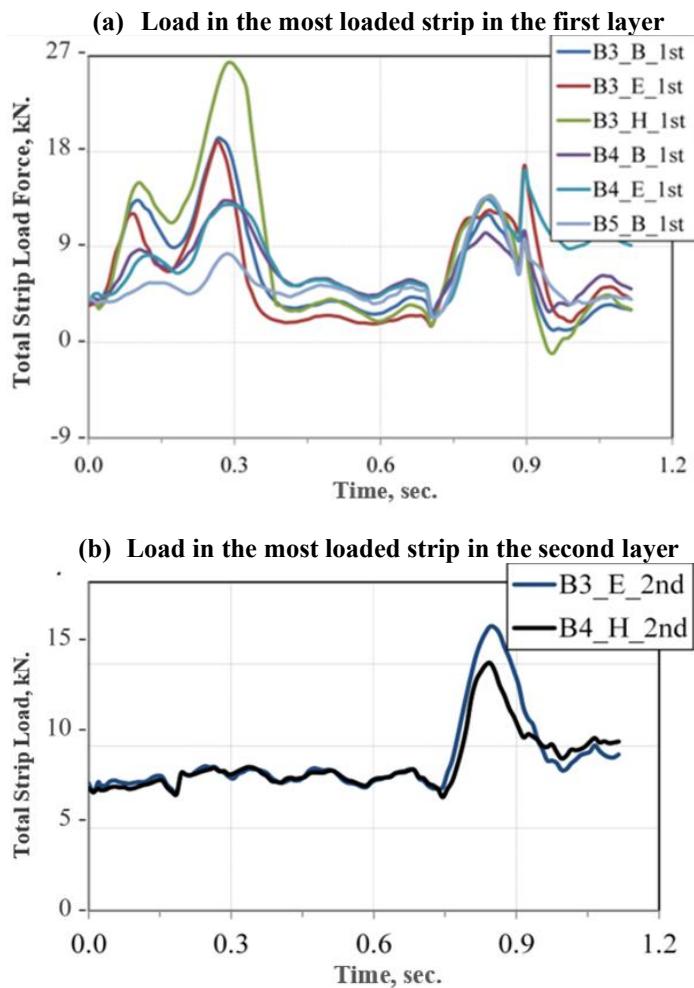
**Figure 6.** Total load in the most loaded strip for the first and second rows of strips in FEM simulation:  
(a) load in the most loaded strip in the first layer, and (b) load in the most loaded strip in the second layer.

The total load in the MSE wall strips is the addition of the static load due to the earth pressure in the wall and the dynamic load due to the TL5 impact. The designation of the strips in the wall is given in Figure 5. For example, B3\_B\_1<sup>st</sup> refers to barrier segment B3, strip B in the first layer of strips. The top or first layer of strips is the one that is most severely influenced by the dynamic impact. The total load in the most heavily loaded individual strip in the first layer of strips during the impact and the dynamic component are shown in Figure 6a. The peak total load is 26.03 kN with a peak dynamic component of 22.02 kN. In the second layer of strips (Figure 6b), the corresponding peak total load and peak dynamic load were 15.4 and 8.5 kN respectively. The calculated maximum pullout resistance of the strips according to AASHTO LRFD (2014) was 10.14 kN for strips in the first layer and 15.57 kN for strips in the second layer. Therefore, according to the numerical simulation, the reinforcing strips of the first layer reached pull-out failure during the impact. The pull-out displacement of the strips is shown in Figure 7 and indicates a maximum displacement of 10 mm. Laboratory tests conducted on strips in a pressurized sand box showed displacements to failure of about 5 mm. This is consistent with the numerical simulations indicating that the reinforcement strips were at failure during the impact. The dynamic and permanent displacement of the wall panels are shown in Figure 8; the permanent displacement of the panels is limited to 7 mm, indicating that the wall could likely be reused without repair.

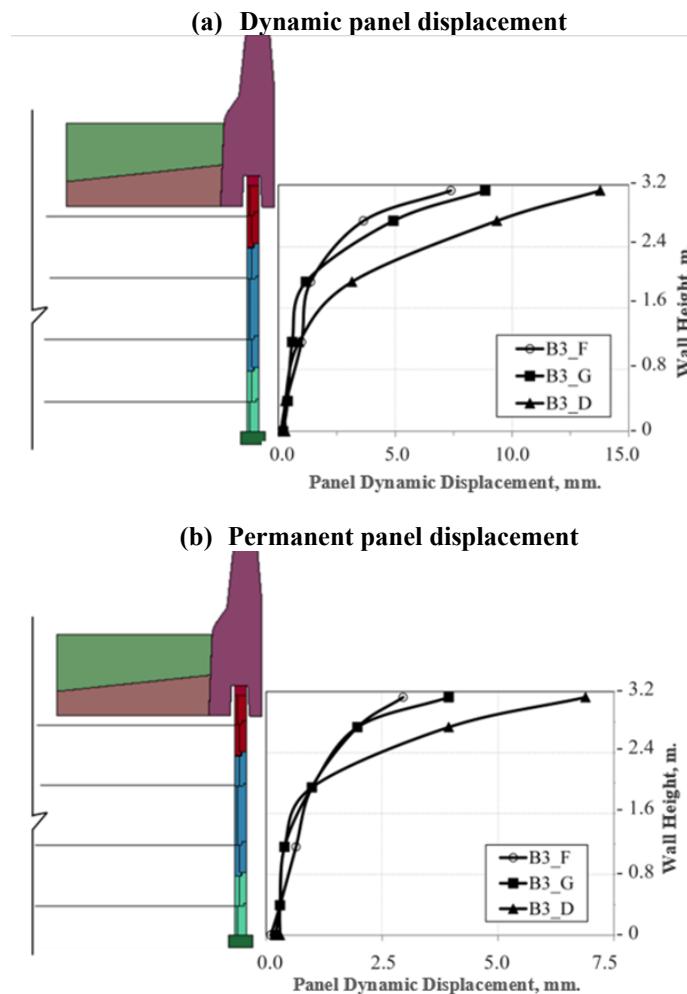
**Figure 8.** Displacement of the MSE wall panel in FEM simulation:  
(a) dynamic panel displacement, and (b) permanent panel displacement.

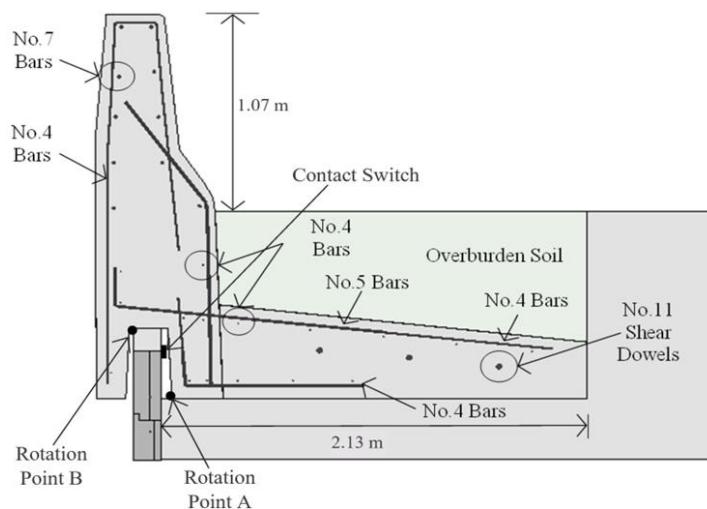
**Figure 9.** The TL5 barrier and moment slab as placed on the MSE wall.

3. The point of rotation of the barrier can be point A or B, as shown in Figure 9. Point A should be selected for overturning design if the top of the wall panel is not in contact with the coping. Point B should be used if there is direct bearing between the bottom of the coping and the top of the wall panel or level-up concrete.

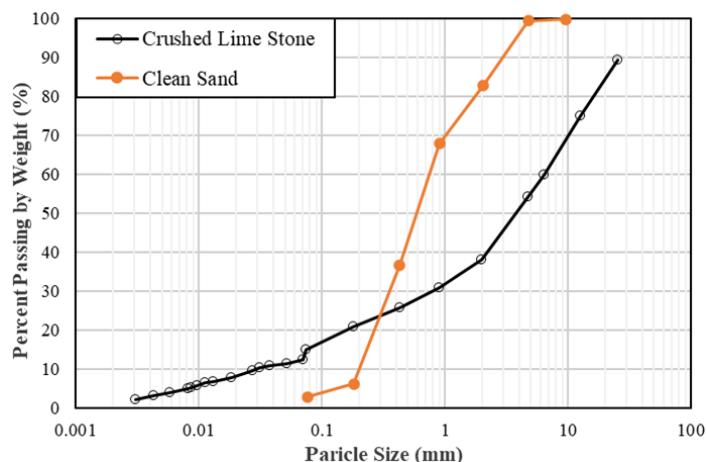
**Figure 10.** Particle size distribution curves for the clean sand and the crushed limestone rock.

The backfill consisted of two soils: the clean sand used to build the wall from the bottom of the excavation to the bottom of the moment slab (1.98 m), and the crushed limestone from the bottom of the moment slab to the pavement surface (1.02 m). The clean sand was a poorly graded sand (SP) with a  $D_{50}$  of 0.51 mm, a coefficient of uniformity of 3.85, a coefficient of curvature of 0.84, and 3.1% passing sieve No. 200 (Figure 10a). The modulus of the sand was 14.8 MPa as measured with the BCD (Briaud et al., 2006), and the direct shear test friction angle was 34 degrees. The crushed limestone rock (also called road base) was a silty gravel with a  $D_{50}$  of 4 mm, a coefficient of uniformity of 216.7, a coefficient of curvature of 3.28, and 15.0 % passing sieve No. 200 (Figure 10b). The modulus of the crushed limestone was 55.2 MPa as measured with the BCD, and a large triaxial cell test gave a friction angle of 45 degrees. The sand was compacted in 150 mm thick lifts to a dry density of 17.4 kN/m<sup>3</sup> (95% of maximum dry density) and 3.03% water content, while the crushed limestone was compacted in lifts of 250 mm to a dry density of 20.1 kN/m<sup>3</sup> (95% of maximum dry density) and 5.81% water content.

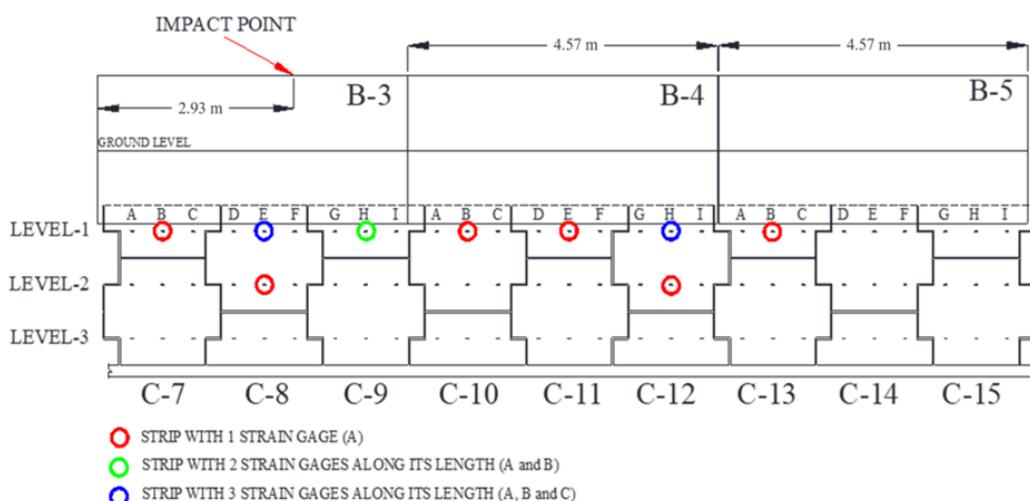
**Figure 11.** Location of the instrumented reinforcing strips.

The location of the MSE wall reinforcing strips that were instrumented is shown in Figure 11. The total load in a strip in this project is defined as the addition of the static load due to the internal stability of the wall under gravity active pressure and the dynamic load induced by the truck impact. The load in the strips was measured 0.178 m behind the strip connection to the panel, and the dynamic load vs. time is shown in Figure 13. The maximum dynamic component of the loads in the strips is listed in Table 1 and the total load in Table 2. The dynamic load in the strips was maximum near the strip-to-panel connection point. As can be seen, the measured static loads are close to those calculated by AASHTO. The sum of the dynamic load and the static load is defined as the total load in the first layer of strips; the total load reaches the calculated ultimate resistance of the strip closest to the impact.

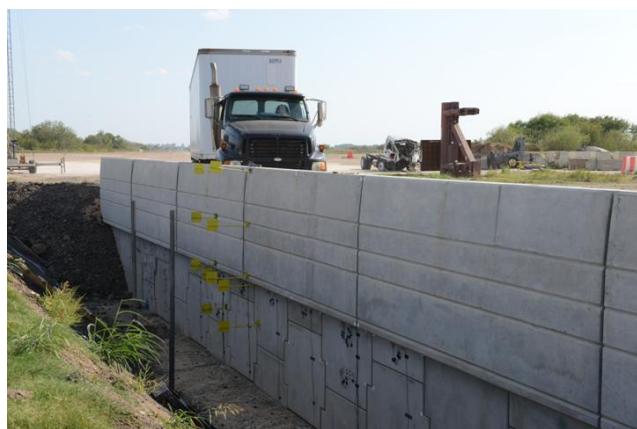
**Figure 12.** Test set up just before impact test.

The TL5 test, also called MASH test 5-12, was conducted on 26 September 2012 under a clear sky and a temperature of 31.7°C (Figure 12). The tractor was a 2000 Sterling TF with a 1997 Stri 14.63 m long trailer. The tractor-trailer assembly weighed 352 kN and hit the barrier at 79.5 kph and at a 15° angle. The vehicle was directed into the test installation under power using a cable guidance system and was released to be free-wheeling and unrestrained just prior to impact. The tractor impacted the barrier 11.28 m from the upstream end of the barrier. At 0.070 sec after impact, the tire of the front axle of the tractor contacted the barrier and the tractor started to redirect. At 0.190 sec, the tire of the rear tandem of the tractor contacted the barrier, and at 0.757 sec the rear axle of the trailer contacted the barrier and created the highest dynamic horizontal load. The tractor-trailer rode off the end of the barrier and came to rest 53.8 m downstream of impact. The brakes on the vehicle were not applied.

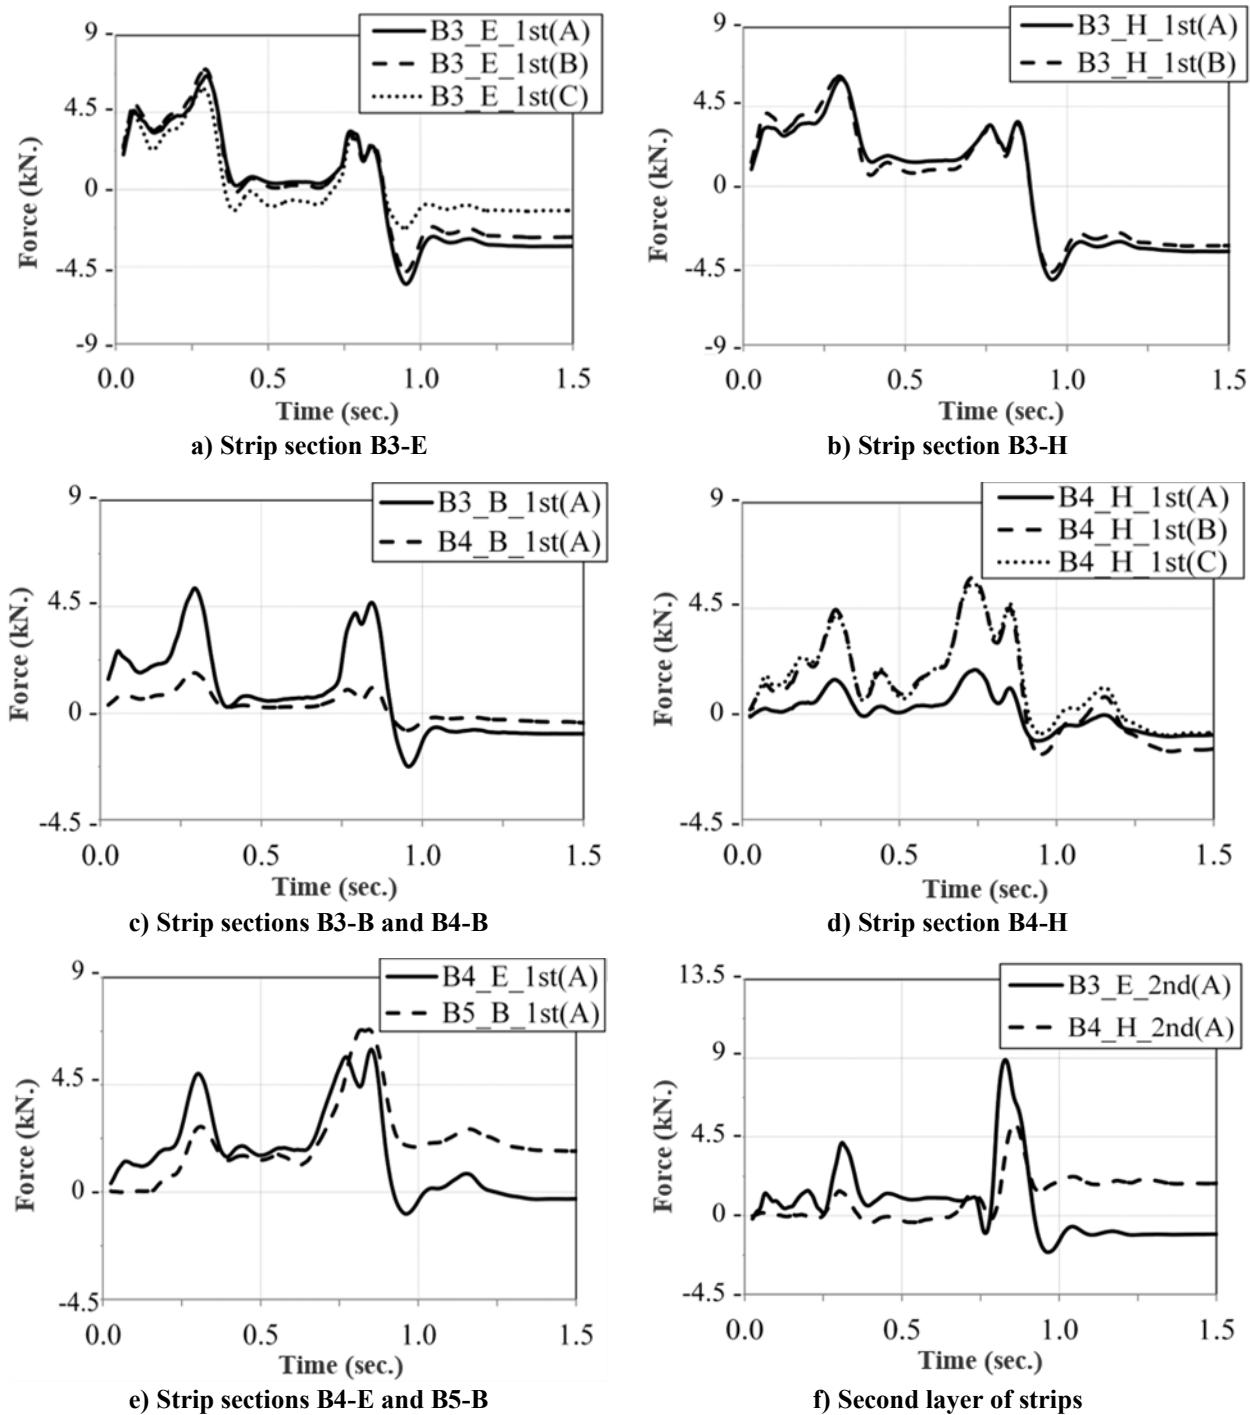
**Figure 13.** Dynamic load in the wall reinforcing strips during the impact (50 msec average): (a) strip section B3-E, (b) strip section B3-H, (c) strip sections B3-B and B4-B, (d) strip section B4-H, (e) strip sections B4-E and B5-B, and (f) second layer of strips.

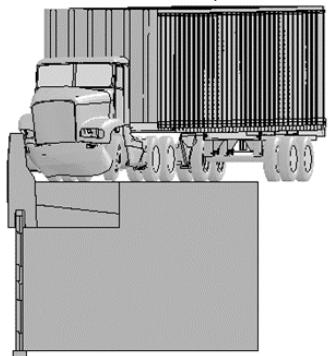
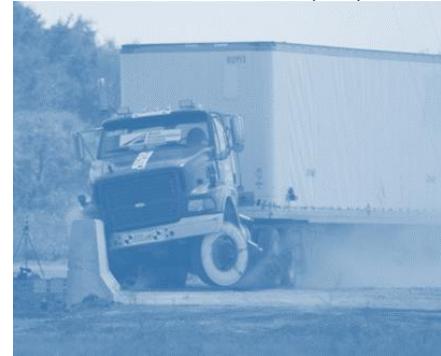
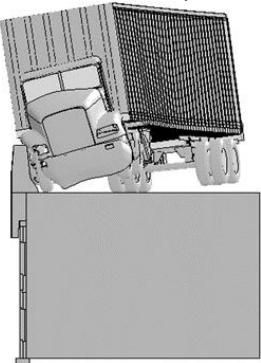
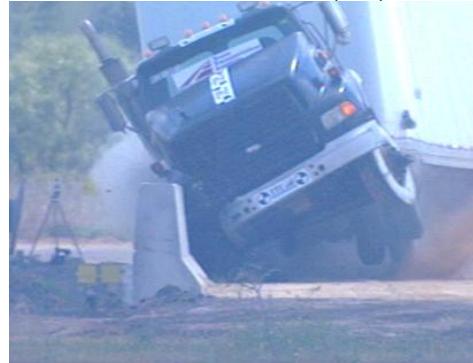
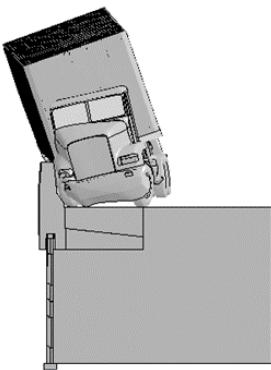
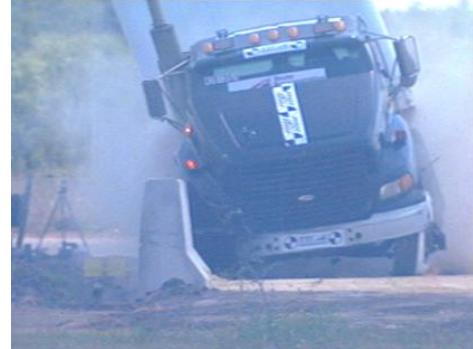
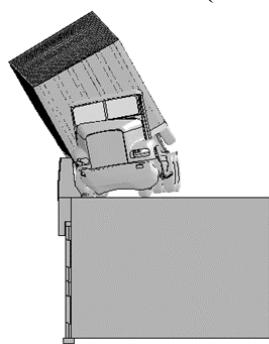
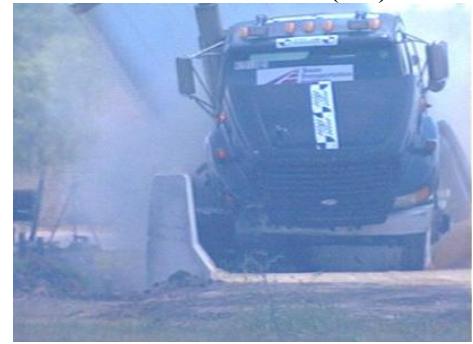
**Figure 14.** Comparison between simulation and test of sequential views of the impact.

Qualitatively, the sequential views of the impact from the simulation and the test compare well, as seen in Figure 14. Quantitatively, the acceleration results were closer for the rear axle of the trailer, which corresponds to the highest load in the impact than for the rear axle of the tractor. Indeed, for the trailer, the longitudinal and lateral accelerations were -2.7 g's and -11.6 g's for the model, and -3.4 g's and -10.8 g's for the test; for the tractor, they were -2.1 g's and -5.3 g's for the longitudinal

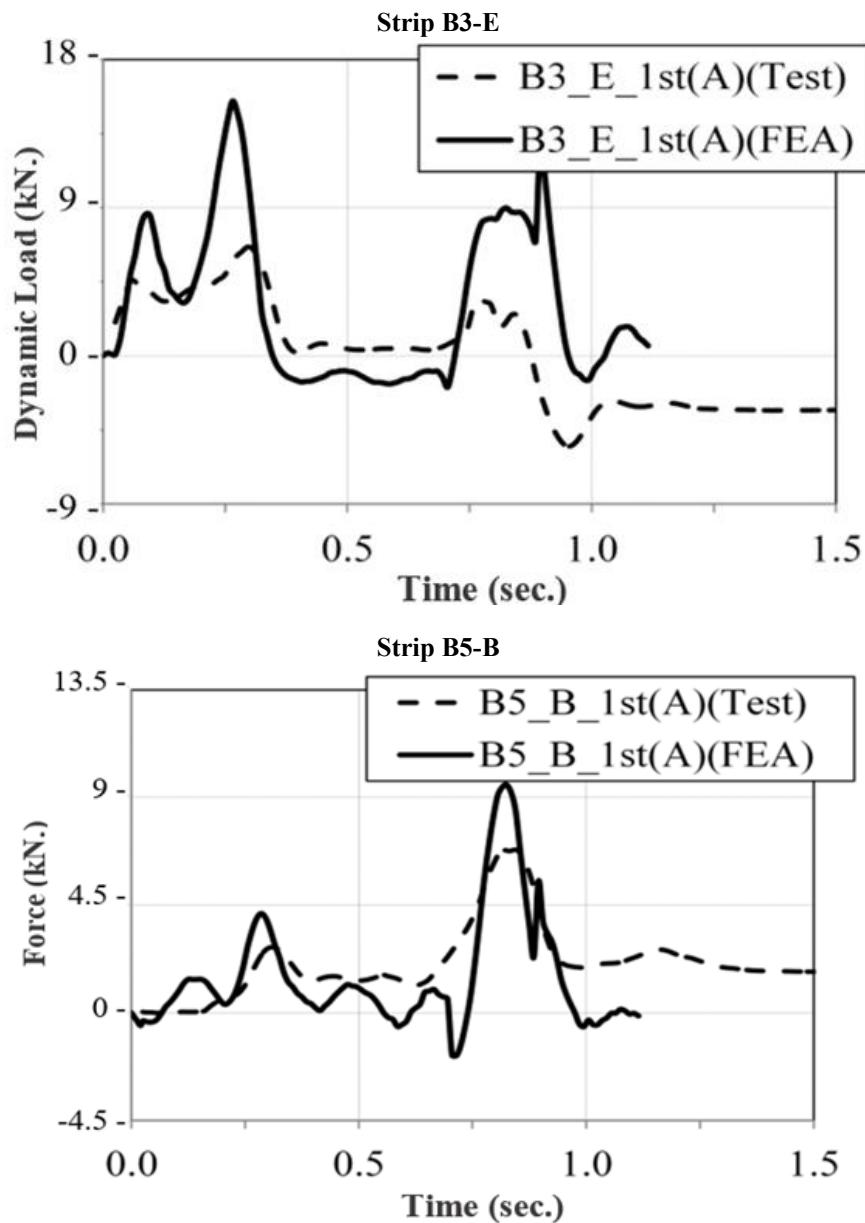
Figure 15. Comparison of the dynamic component of the strips' loads in the uppermost layer of soil reinforcement.

and lateral acceleration in the model, and -1.4 g's and -4.4 g's for the test. These acceleration values are 50 msec averages. The simulation predicted reasonably well the permanent displacement of the barrier, as shown in Table 3. The dynamic displacements of the wall panels during the test could not be measured due to problems in the instrumentation. The measured lateral permanent deflections of the wall panels after the test ranged from 0.25 mm to 13.72 mm. The dynamic and permanent deflection determined from the simulation ranged from 0.25 mm to 14.73 mm and from 0.25 mm to 7.11 mm, respectively. The simulation under-predicted the permanent displacement in some wall panels but predicted others reasonably well. In addition, the simulation predicted high bending stresses of the panels located underneath the impact point and, after the test, hairline cracks were observed at those locations. The simulation overpredicted the tension load in the top strips near the point of impact but did better at other locations (Figure 15), particularly in the second row of strips.

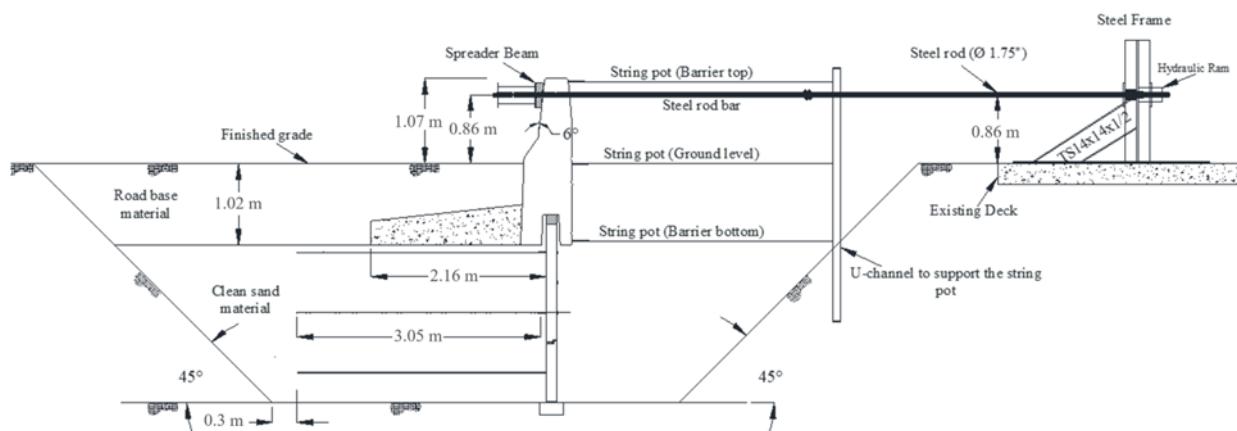
Figure 16. Set up for the horizontal static load test on the barrier.

After the full-scale impact test, a horizontal static load test was performed on the barrier moment slab system on top of the MSE wall (Figure 16). The objective was to assess the ultimate horizontal load of the system as an equivalent static load to the maximum horizontal dynamic load in the impact test. The section of barrier selected was one that had received minor loading from the impact of the truck (B5). The horizontal load was applied at a height of 0.864 m through a 3.05 m long spreader bar to engage a 9.15 m length of barrier and a 9.15 m length of moment slab in the load test. The load was applied in 22.25 kN increments lasting one minute each. The horizontal displacement of the top and the bottom of the barrier were recorded, as well as the horizontal displacement of the coping. The horizontal load-horizontal displacement curve for the load test is shown on Figure 17(a) along with the numerical simulation results. Figure 17(b) shows the displacements at different heights of the barrier. During the static load test, the load in the strip right below the loading point (B5\_B\_1<sup>st</sup>(A)) was recorded (Figure 18). The figure indicates that the load started to increase rapidly in the strip when the static load on the barrier exceeded 356 kN, which is assumed to be the point at which sliding of the barrier was prominently engaged. Because the barrier moment slab redirected the truck properly and without major repair needed, the static load considered to be equivalent to the maximum dynamic load on the barrier was the maximum load applied to the barrier in the horizontal static load test before the nonlinear behavior started, or 356 kN.

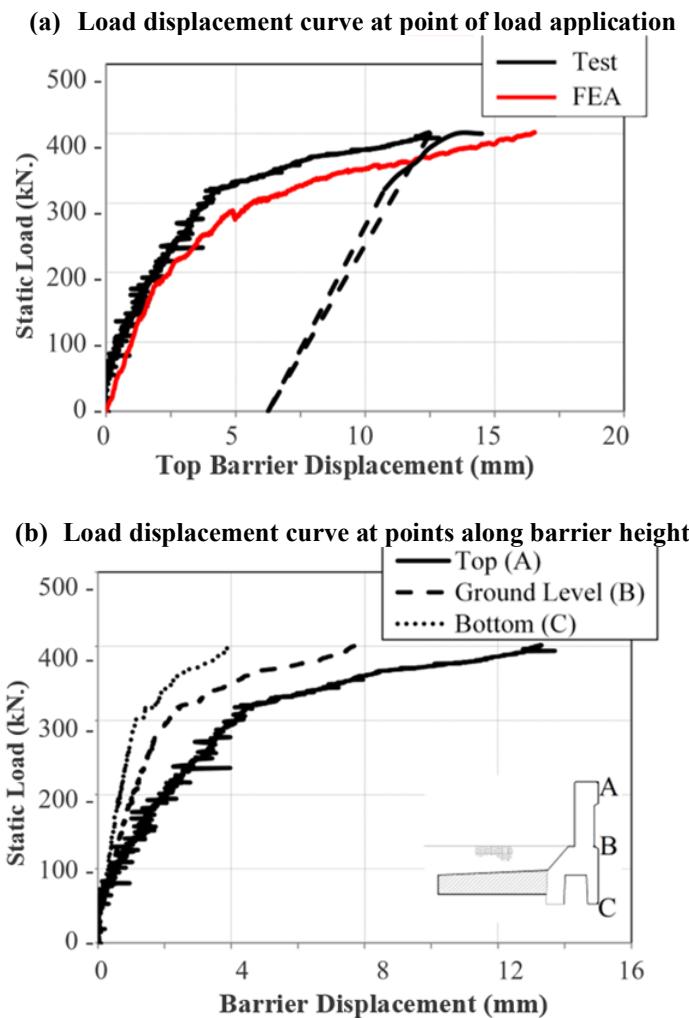
**Figure 17.** Horizontal load vs. horizontal displacement of the barrier: measurements and simulation: (a) load displacement curve at point of load application, and (b) load displacement curve at points along barrier height.

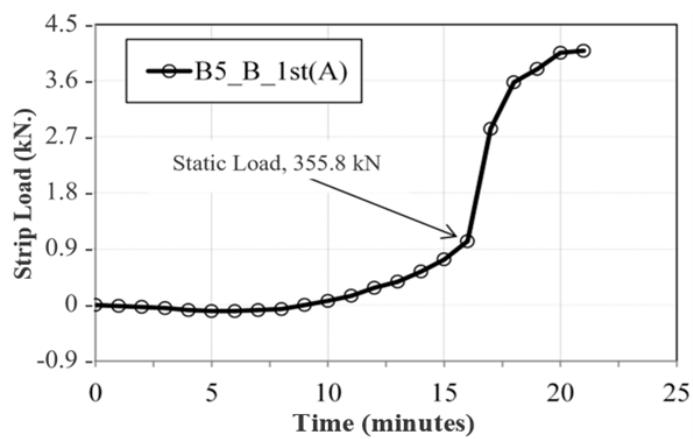
**Figure 18.** Load in top strip below barrier loading point.

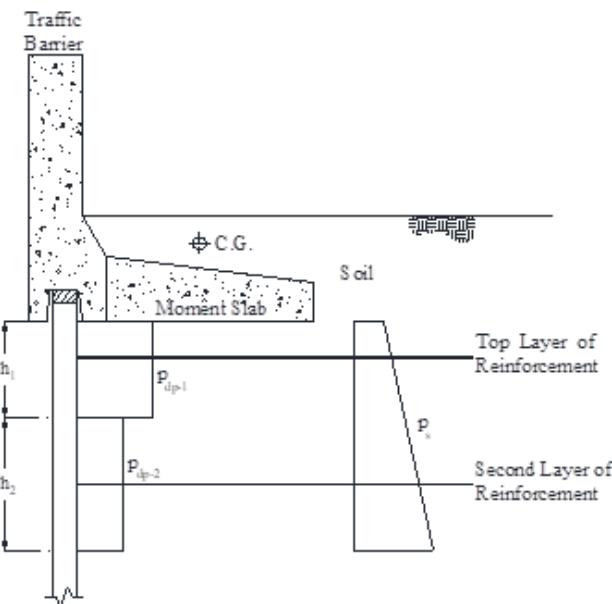
**Figure 19.** Pressure diagram for static and dynamic components to design MSE wall strips for TL5 impact loading.

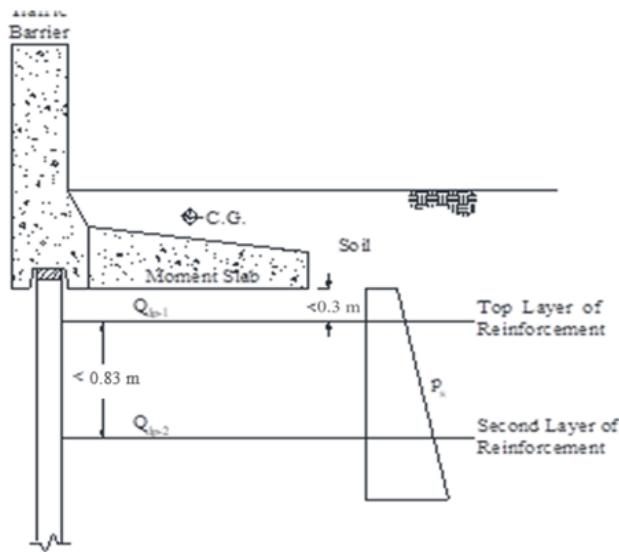
**Figure 20.** Line load diagram for static and dynamic components to design MSE wall strips for TL5 impact loading.
