MSE Wall Behavior during Large Truck Impact at High Speed against Barrier on Top of Wall

Reference: Briaud J.-L., Bligh R., and Maddah L. (2024). *MSE Wall Behavior during Large Truck Impact at High Speed against Barrier on Top of Wall*. International Journal of Geoengineering Case Histories, Vol. 8, Issue 1, p.1-24. doi: 10.4417/IJGCH-08-01-01

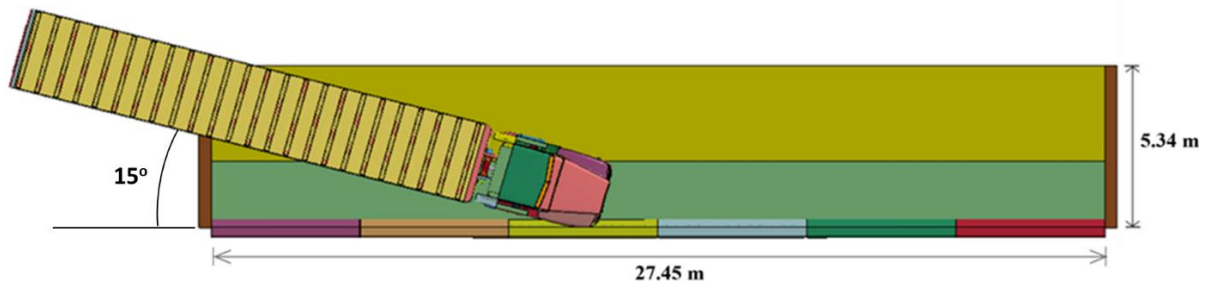
Figure 1. Finite element mesh for simulation of barrier-moment slab-MSE wall assembly with truck: (a) cross section of barrier-moment slab-MSE wall assembly with truck, (b) front view of the barrier-moment slab-MSE wall assembly with truck, and (c) plan view of the barrier-moment slab-MSE wall assembly with truck.

The software used for the simulations was LS-DYNA (Hallquist, 2007). The Finite Element Method (FEM) models included the tractor-trailer truck, the L shape barrier and moment slab, and the MSE wall with soil and reinforcement strips (Figure 1).

The dimensions of the model (Figure 1) were 27.45 m in length, 3.75 m in height, and 5.34 m in width. The barrier height from the pavement surface to the top of the barrier was 1.07 m and the width of the moment slab was varied but finally chosen as 2.13 m, measured from the back of the MSE wall panel to the end of the moment slab. The bottom of the moment slab was 1.02 m deep below the pavement surface, and the length of the reinforcement strips was 3.05 m. Referring to Figure 1, the boundary conditions were as follows: all boundaries were free of any constraints except for the vertical boundary at the back of the wall, at the bottom of the wall and on the side-ends of the wall.

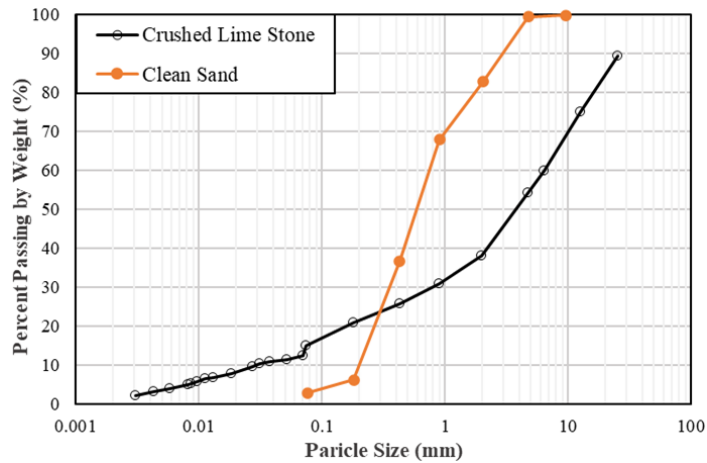
Figure 10. Particle size distribution curves for the clean sand and the crushed limestone rock.

The backfill consisted of two soils: the clean sand used to build the wall from the bottom of the excavation to the bottom of the moment slab (1.98 m), and the crushed limestone from the bottom of the moment slab to the pavement surface (1.02 m). The clean sand was a poorly graded sand (SP) with a D_{50} of 0.51 mm, a coefficient of uniformity of 3.85, a coefficient of curvature of 0.84, and 3.1% passing sieve No. 200 (Figure 10a). The modulus of the sand was 14.8 MPa as measured with the BCD (Briaud et al., 2006), and the direct shear test friction angle was 34 degrees. The crushed limestone rock (also called road base) was a silty gravel with a D_{50} of 4 mm, a coefficient of uniformity of 216.7, a coefficient of curvature of 3.28, and 15.0 % passing sieve No. 200 (Figure 10b). The modulus of the crushed limestone was 55.2 MPa as measured with the BCD, and a large triaxial cell test gave a friction angle of 45 degrees. The sand was compacted in 150 mm thick lifts to a dry density of 17.4 kN/m^3 (95% of maximum dry density) and 3.03% water content, while the crushed limestone was compacted in lifts of 250 mm to a dry density of 20.1 kN/m^3 (95% of maximum dry density) and 5.81% water content.

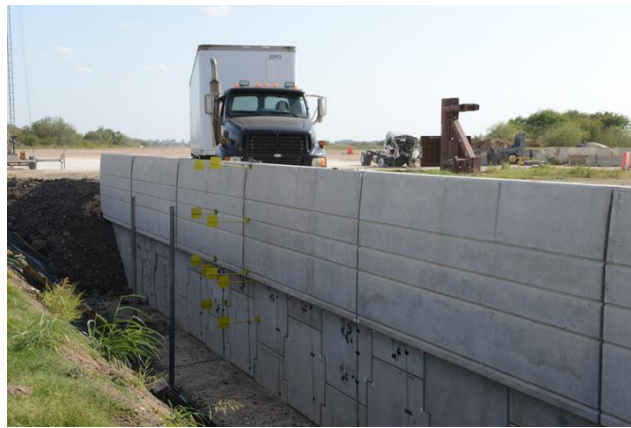
Figure 12. Test set up just before impact test.

The TL5 test, also called MASH test 5-12, was conducted on 26 September 2012 under a clear sky and a temperature of 31.7°C (Figure 12). The tractor was a 2000 Sterling TF with a 1997 Stri 14.63 m long trailer. The tractor-trailer assembly weighed 352 kN and hit the barrier at 79.5 kph and at a 15° angle. The vehicle was directed into the test installation under power using a cable guidance system and was released to be free-wheeling and unrestrained just prior to impact. The tractor impacted the barrier 11.28 m from the upstream end of the barrier. At 0.070 sec after impact, the tire of the front axle of the tractor contacted the barrier and the tractor started to redirect. At 0.190 sec, the tire of the rear tandem of the tractor contacted the barrier, and at 0.757 sec the rear axle of the trailer contacted the barrier and created the highest dynamic horizontal load. The tractor-trailer rode off the end of the barrier and came to rest 53.8 m downstream of impact. The brakes on the vehicle were not applied.

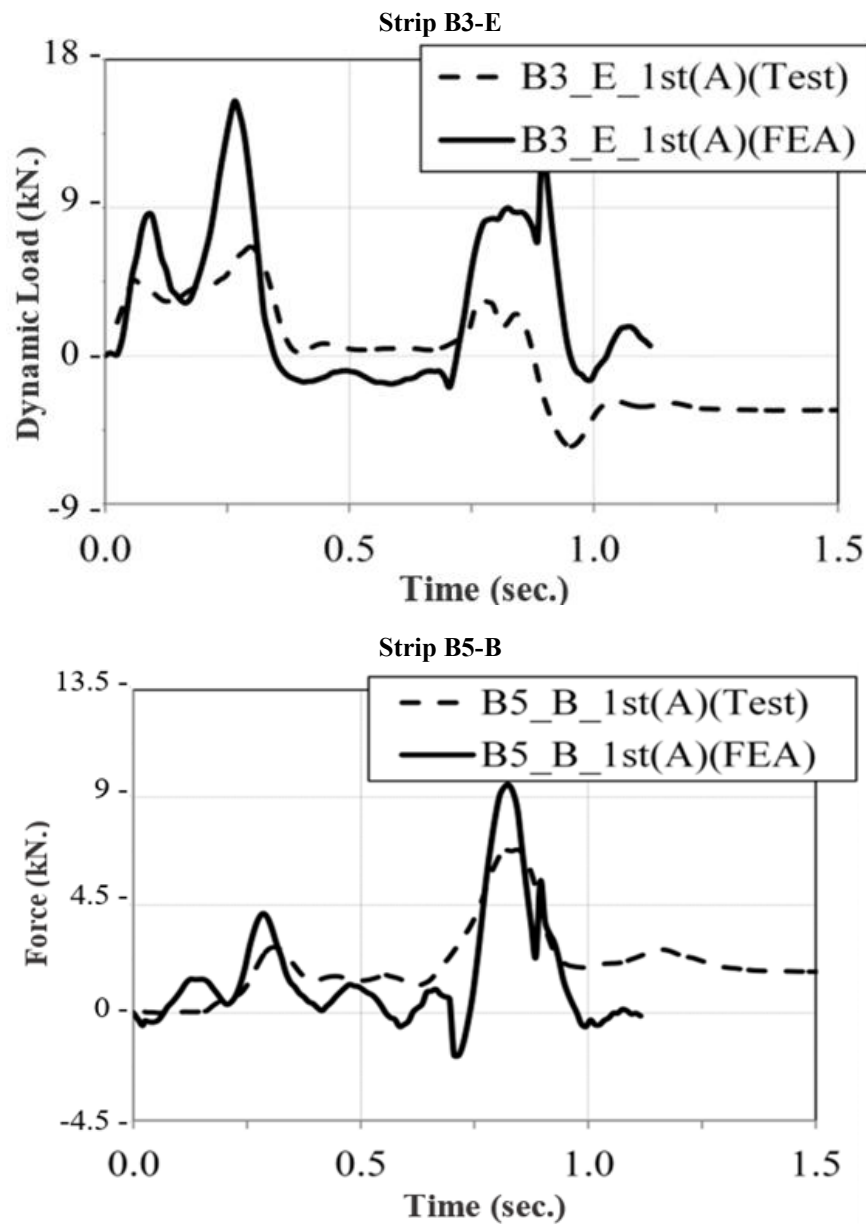
Figure 15. Comparison of the dynamic component of the strips' loads in the uppermost layer of soil reinforcement.

and lateral acceleration in the model, and $-1.4\text{ g}'\text{s}$ and $-4.4\text{ g}'\text{s}$ for the test. These acceleration values are 50 msec averages. The simulation predicted reasonably well the permanent displacement of the barrier, as shown in Table 3. The dynamic displacements of the wall panels during the test could not be measured due to problems in the instrumentation. The measured lateral permanent deflections of the wall panels after the test ranged from 0.25 mm to 13.72 mm. The dynamic and permanent deflection determined from the simulation ranged from 0.25 mm to 14.73 mm and from 0.25 mm to 7.11 mm, respectively. The simulation under-predicted the permanent displacement in some wall panels but predicted others reasonably well. In addition, the simulation predicted high bending stresses of the panels located underneath the impact point and, after the test, hairline cracks were observed at those locations. The simulation overpredicted the tension load in the top strips near the point of impact but did better at other locations (Figure 15), particularly in the second row of strips.
