# MSE Wall Behavior during Large Truck Impact at High Speed against Barrier on Top of Wall

**Reference:** Briaud J.-L., Bligh R., and Maddah L. (2024). *MSE Wall Behavior during Large Truck Impact at High Speed against Barrier on Top of Wall*. International Journal of Geoengineering Case Histories, Vol. 8, Issue 1, p.1-24. doi: 10.4417/IJGCH-08-01-01

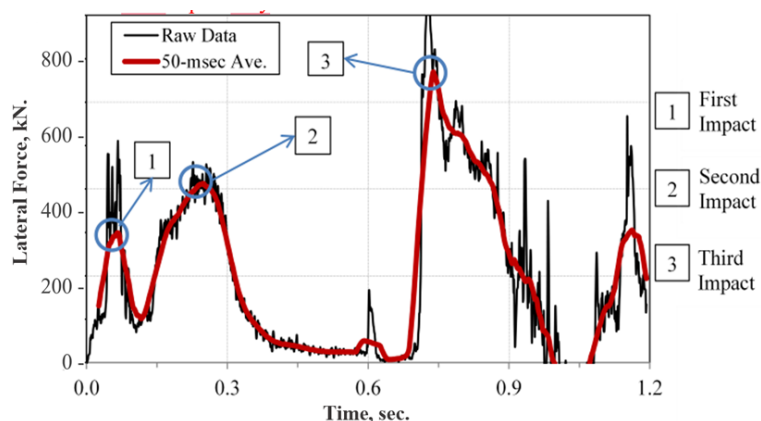
**Figure 3.** Horizontal impact force as a function of time in FEM simulation.

The impact horizontal force on the barrier as a function of time is shown in Figure 3. Two lines can be seen: one shows rapid variations in the load which is the actual measured response, and the other shows a smoother variation. The smoother line corresponds to the 50-millisecond average of the signal, which is common practice in roadside safety data analysis. The 50-ms signal identifies three distinct impacts associated with the front axle of the tractor at a peak dynamic force of 332 kN, the rear axle of the tractor (458.8 kN), and the rear axle of the trailer also known as the back slap (744.9 kN). Figure 4 shows the displacement at the top and at the bottom of the barrier. The main part of the impact lasted one second.
