MSE Wall Behavior during Large Truck Impact at High Speed against Barrier on Top of Wall

Reference: Briaud J.-L., Bligh R., and Maddah L. (2024). *MSE Wall Behavior during Large Truck Impact at High Speed against Barrier on Top of Wall*. International Journal of Geoengineering Case Histories, Vol. 8, Issue 1, p.1-24. doi: 10.4417/IJGCH-08-01-01

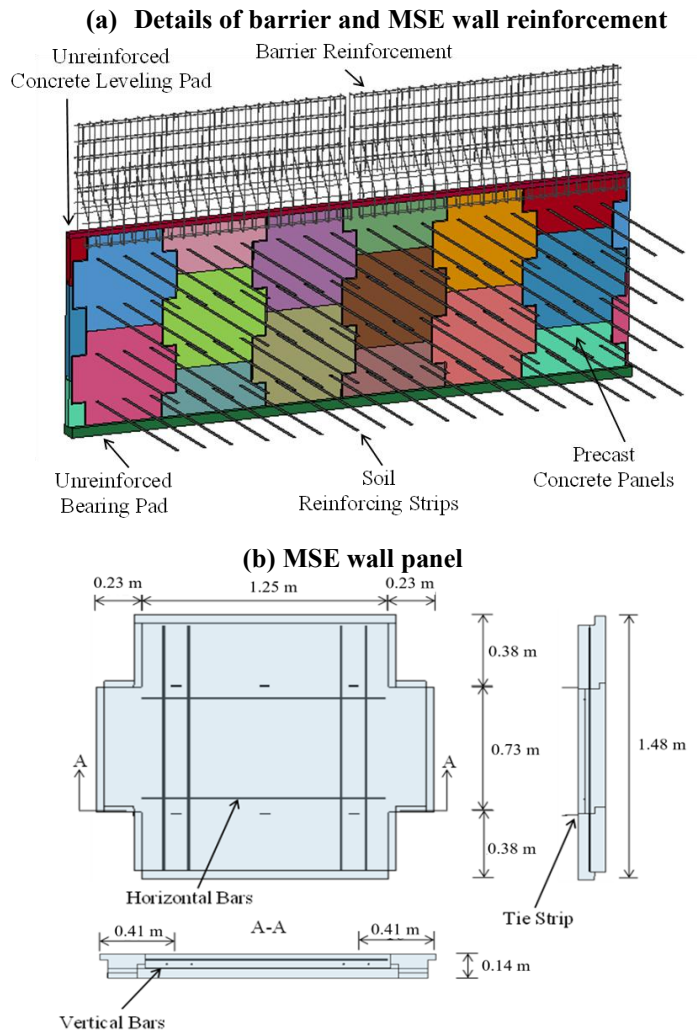
Figure 2. Barrier-moment slab and MSE wall model: (a) details of barrier and MSE wall reinforcement, and (b) MSE wall panel.

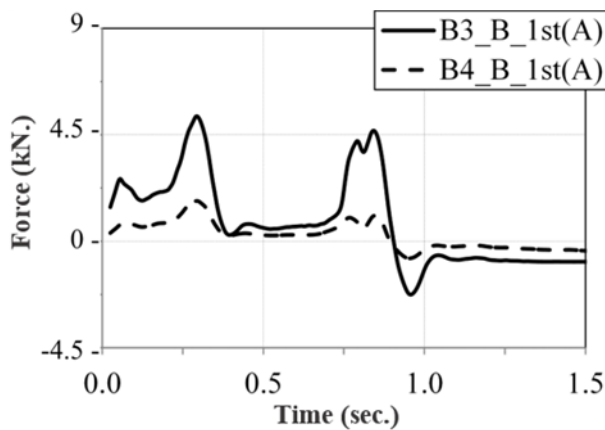
a) Strip section B3-E

b) Strip section B3-H

c) Strip sections B3-B and B4-B

d) Strip section B4-H

e) Strip sections B4-E and B5-B

f) Second layer of strips

Figure 13. Dynamic load in the wall reinforcing strips during the impact (50 msec average): (a) strip section B3-E, (b) strip section B3-H, (c) strip sections B3-B and B4-B, (d) strip section B4-H, (e) strip sections B4-E and B5-B, and (f) second layer of strips.
