# MSE Wall Behavior during Large Truck Impact at High Speed against Barrier on Top of Wall

**Reference:** Briaud J.-L., Bligh R., and Maddah L. (2024). *MSE Wall Behavior during Large Truck Impact at High Speed against Barrier on Top of Wall*. International Journal of Geoengineering Case Histories, Vol. 8, Issue 1, p.1-24. doi: 10.4417/IJGCH-08-01-01

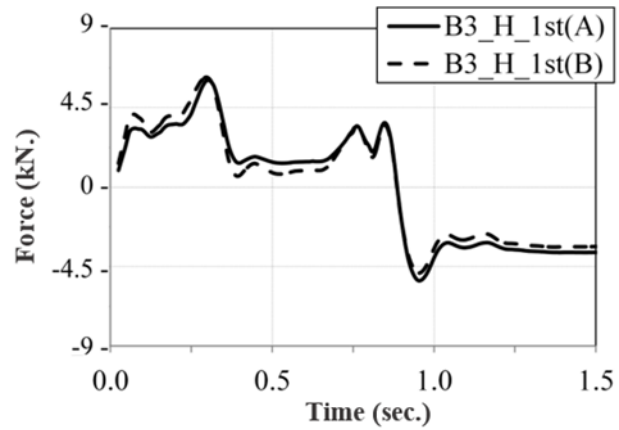
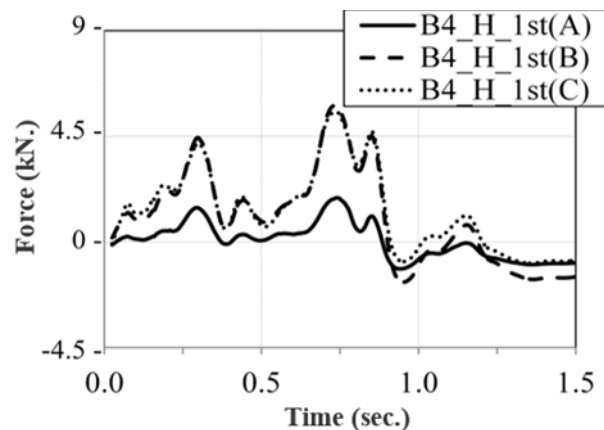
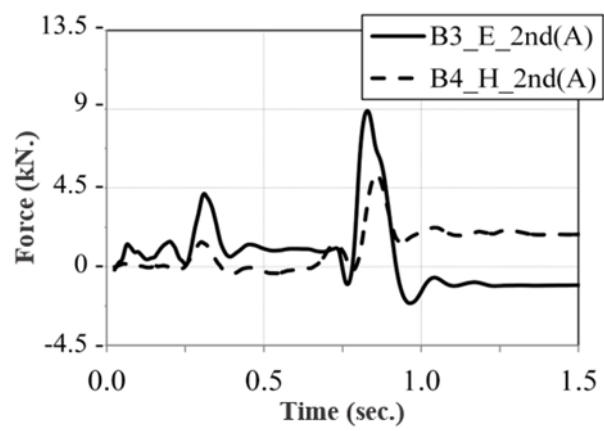
**Figure 13.** Dynamic load in the wall reinforcing strips during the impact (50 msec average): (a) strip section B3-E, (b) strip section B3-H, (c) strip sections B3-B and B4-B, (d) strip section B4-H, (e) strip sections B4-E and B5-B, and (f) second layer of strips.

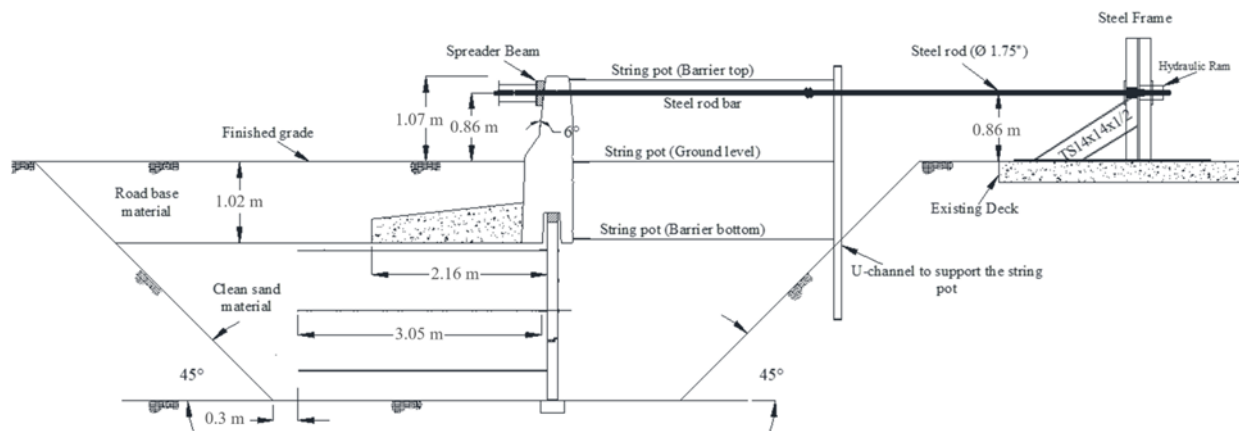
**Figure 16.** Set up for the horizontal static load test on the barrier.

After the full-scale impact test, a horizontal static load test was performed on the barrier moment slab system on top of the MSE wall (Figure 16). The objective was to assess the ultimate horizontal load of the system as an equivalent static load to the maximum horizontal dynamic load in the impact test. The section of barrier selected was one that had received minor loading from the impact of the truck (B5). The horizontal load was applied at a height of 0.864 m through a 3.05 m long spreader bar to engage a 9.15 m length of barrier and a 9.15 m length of moment slab in the load test. The load was applied in 22.25 kN increments lasting one minute each. The horizontal displacement of the top and the bottom of the barrier were recorded, as well as the horizontal displacement of the coping. The horizontal load-horizontal displacement curve for the load test is shown on Figure 17(a) along with the numerical simulation results. Figure 17(b) shows the displacements at different heights of the barrier. During the static load test, the load in the strip right below the loading point (B5\_B\_1<sup>st</sup>(A)) was recorded (Figure 18). The figure indicates that the load started to increase rapidly in the strip when the static load on the barrier exceeded 356 kN, which is assumed to be the point at which sliding of the barrier was prominently engaged. Because the barrier moment slab redirected the truck properly and without major repair needed, the static load considered to be equivalent to the maximum dynamic load on the barrier was the maximum load applied to the barrier in the horizontal static load test before the nonlinear behavior started, or 356 kN.
