A geocomposite barrier for hydrocarbon containment in the Arctic

ABSTRACT: *The paper describes the background and remediation steps that were taken to contain migration of a subsurface hydrocarbon contaminant plume at a site in the Canadian Arctic. A composite liner consisting of a novel fluorine surface-treated high-density polyethylene geomembrane and a geosynthetic clay liner was selected as the short-term (several years) barrier solution. The paper describes the design details, the selection criteria, and the challenges that were overcome to install the barrier system. A complimentary program of site monitoring is underway together with a parallel program of laboratory testing investigating the long-term effects of freeze-thaw, low temperatures, and contact with jet fuel on specimens of the barrier components. Results from site monitoring show that the barrier system is performing as planned three years after installation. Laboratory tests completed to date show that the geosynthetic barrier materials can be expected to maintain acceptably low rates of hydrocarbon diffusion and advection well beyond the original 3-year design life of the barrier system.*

Bathurst, R. J., Row

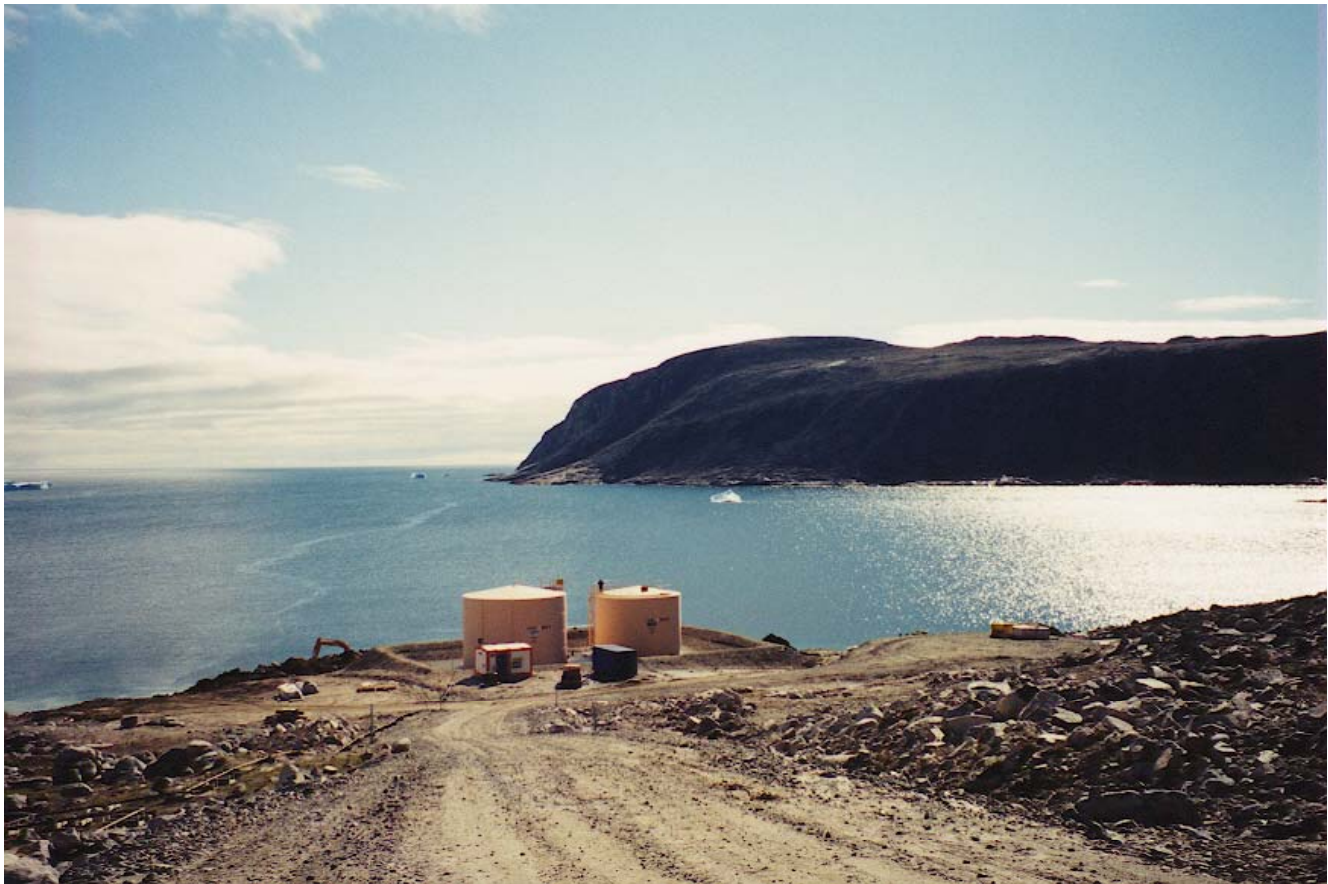
Figure 2. View looking toward ocean showing existing fuel tanks.

In 1998, during the initial site assessment of BAF-3, visual inspection of the beach area confirmed the presence of two large petroleum, oil and lubricants (POL) tanks situated within a lined berm area approximately 75 m north of the ocean (Figures 2 and 3). Given that the existing POL tanks had replaced older tanks dating back from the original Brevoort Relay Station (RES-X-1; a DEW Line Rearward Communications Site), the potential for fuel leaked from corroded tanks or spilled during deconstruction activities was investigated. At that time, the collection and analyses of limited soil samples revealed the presence of Arctic diesel (jet fuel) in the sloped area between the tanks and the ocean at levels up to 14,000 ppm total petroleum hydrocarbons (TPH).

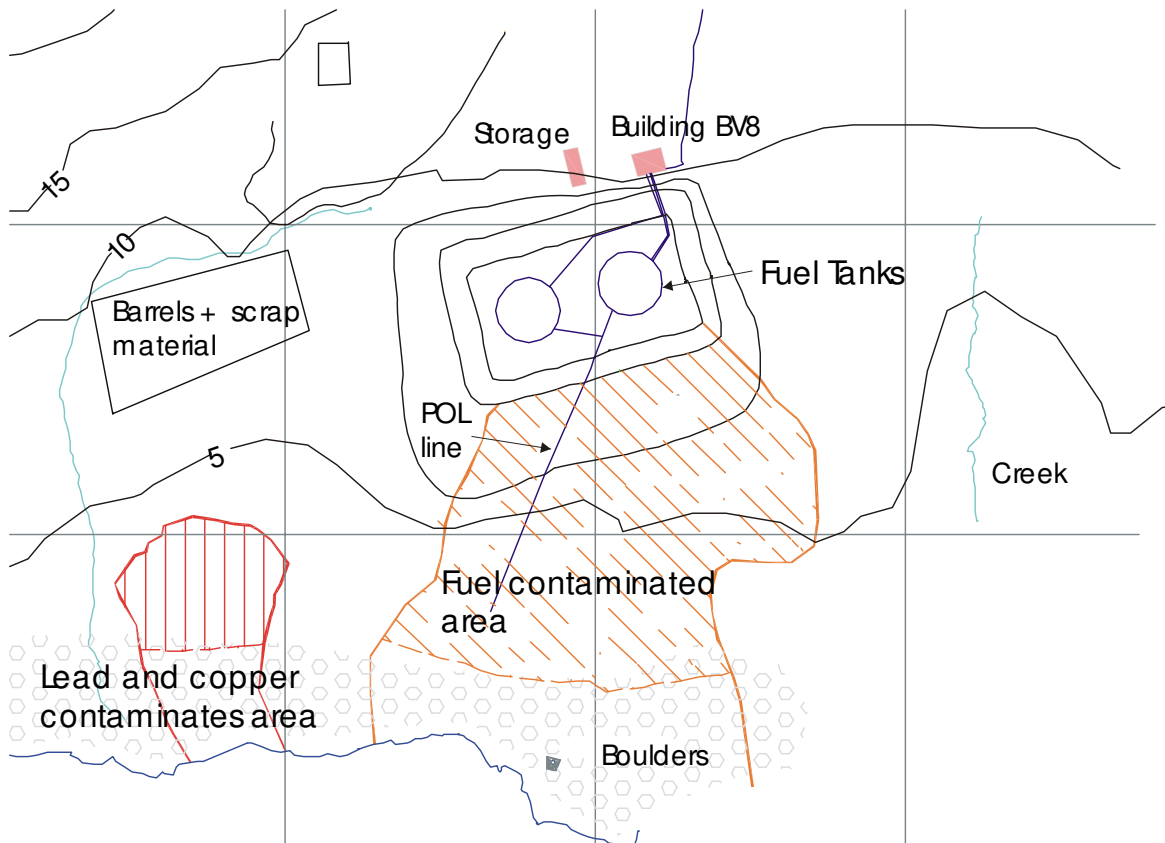
Figure 3. Plan view of fuel contaminated area.

Complications were imposed by the predominance of large boulders; hence an opportunistic sampling strategy was adopted whereby samples were collected wherever conditions allowed given the available equipment. A small backhoe was used to dig test pits to a maximum depth of 1.8 m (depth dependent upon reaching permafrost or bedrock). Ultimately, a total of 21 test pits (providing 74 samples) were excavated, with coverage extending to within ~20 m of the ocean (i.e. to the beginning of the boulder field). Laboratory analysis indicated that although many surface soil samples were uncontaminated, most of those collected at depth had TPH levels exceeding acceptable criteria. It became apparent that fuel spilled or leaked at the tank source had migrated down-slope towards the ocean. Whether contamination had reached the bay was questionable, as the difficulty of sampling beneath the boulder field immediately adjacent to the water was impossible to overcome. The area extent of the HC-contaminated zone below and down-slope of the existing POL tank farm is illustrated in Figure 3.

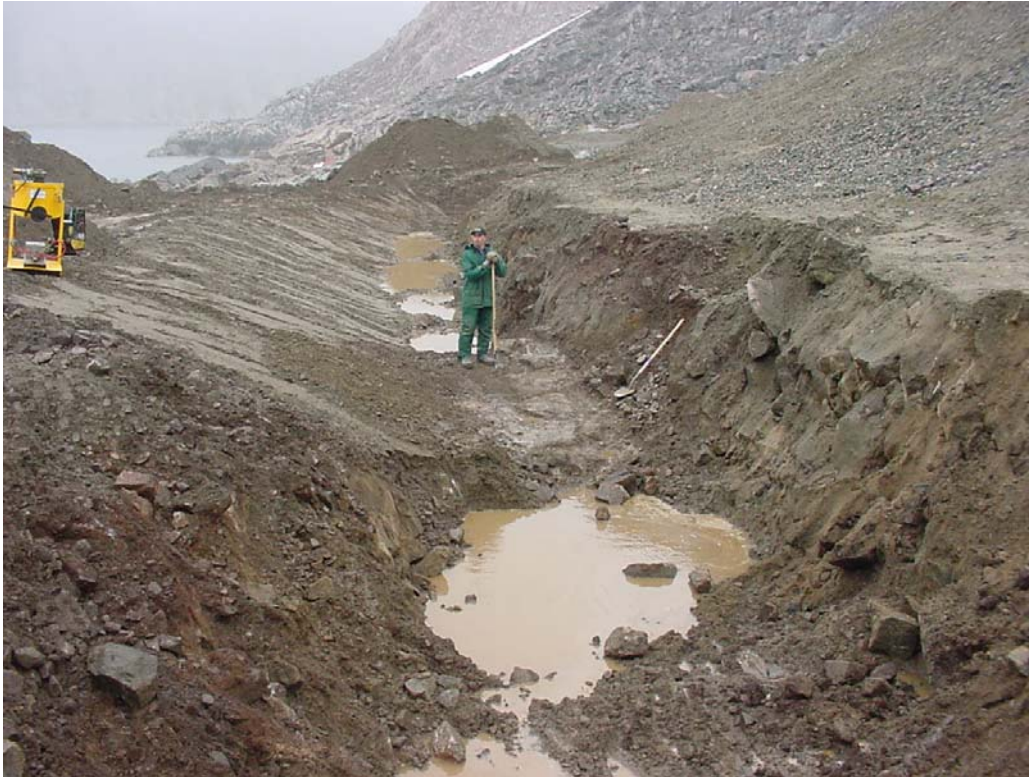
Figure 5. Photograph of trench excavation illustrating bedrock encountered at trench bottom.

The barrier system was designed to be placed on the down-slope side of the excavated trench. The decision for a sloped installation was largely dictated by factors such as available manpower and ease of construction. It was recognized that this approach would require more geosynthetic barrier material and excavation than an alternative vertical wall system. However, a vertical trench was not possible because of the presence of large boulders and the possibility of intercepting the groundwater table that could lead to trench wall instability. Photographs of trench excavation illustrating ground conditions at the site are shown in Figures 4 and 5. The groundwater table was not observed during excavation of the trench nor was there visual evidence of free product LNAPL. The ponded water on the permafrost layer in Figure 5 was the result of rainfall runoff.

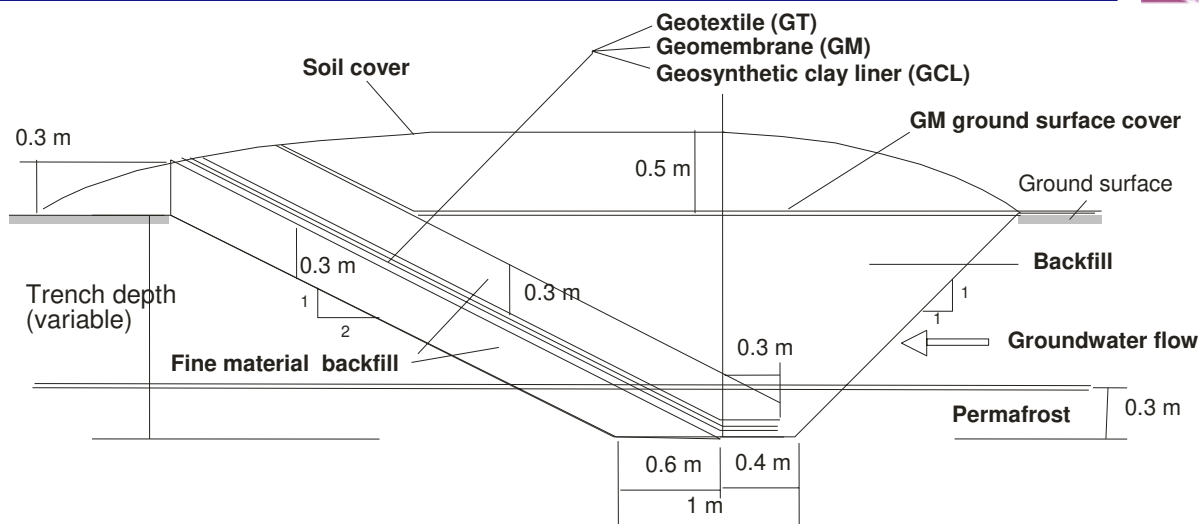
Figure 6. Installation of geosynthetic barrier system anchored in permafrost (Case 1).

The trench excavation geometry of the sloped barrier method is illustrated in Figures 6 and 7. The two trench cross-sections are the same with the exception of the anchorage detail at the bottom of the trench (i.e. anchorage in soil or attachment to bedrock). The trench was excavated with the downstream side at about 1:2 (vertical: horizontal) slope prior to installation of the geosynthetic barrier.

Figure 6 shows the geosynthetic barrier system for the case where the bottom of the barrier is anchored in permafrost soil (Case 1) to a depth of 0.3 m. The primary barrier is an HDPE geomembrane sheet with fluorination pre-treatment supplied by Fluoro-Seal Inc. (Sangam et al. 2001; Sangam and Rowe 2005).

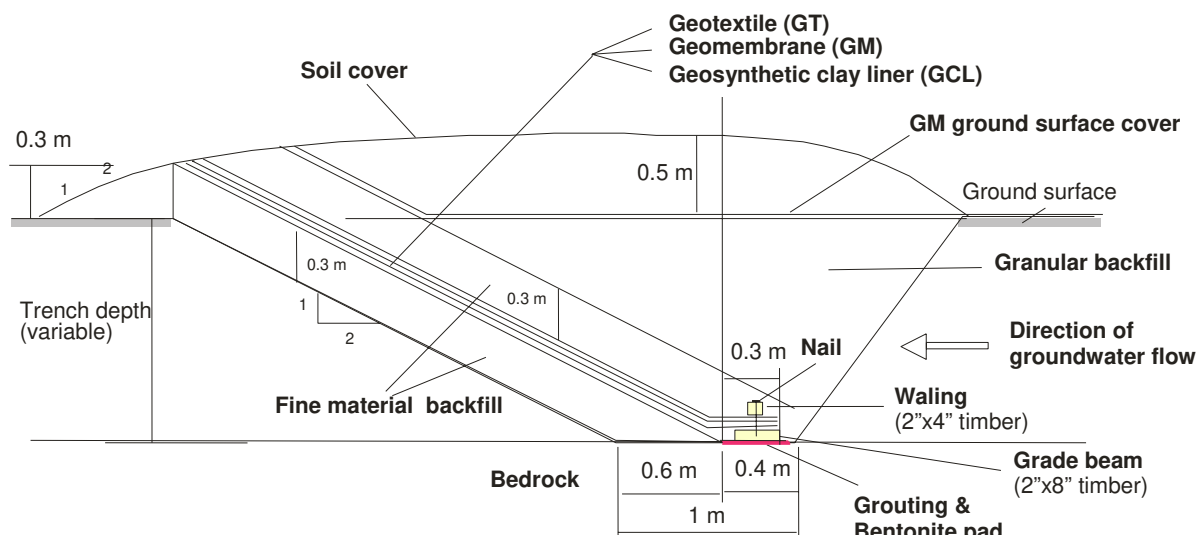
Figure 7. Installation of geosynthetic barrier system anchored to bedrock (Case 2).

The composite system was extended below the permafrost table where practicable. At locations where the excavation trench is located on bedrock, the installation scheme identified as Case 2 was used (Figure 7). The bedrock was cleaned by power washing before using bentonite powder and grout (Sika Arctic Grout) to fill rock surface voids or cracks and to seat a timber grade beam at the bedrock surface. The installation of the geocomposite liner was similar to that shown in Figure 6. Once the two liners were in place, the construction method called for a timber waling to be placed over the geocomposite liner and nailed through to the timber grade beam to secure the bottom end of the barrier. Once buried, water

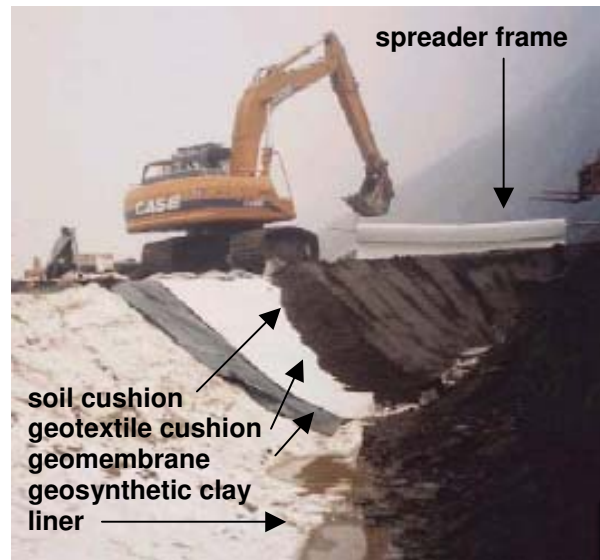
Figure 8. Photograph showing installation and arrangement of liner system components.

The upstream side of the HDPE is protected from the granular backfill by a needle-punched nonwoven geotextile (550 g/m²) cushion. The down-stream side of the barrier is a needle-punched nonwoven geosynthetic clay liner (GCL). The GCL product (Bentofix Thermal Lock “NWL”) has a bentonite mass of 3.66 kg/m², hydraulic conductivity of 5×10^{-11} m/sec, and internal shear strength of 24 kPa (typical peak value for specimen hydrated for 24 hours and sheared under 10 kPa normal stress in accordance with ASTM D6243). The swell index of bentonite is 24 ml/2g minimum following ASTM D5890. Loose granular bentonite was placed between panels at a rate of about 400 g per linear m of seam and overlapped by 150 mm. The HDPE and GCL panels were placed using a spreader frame (Figure 8).

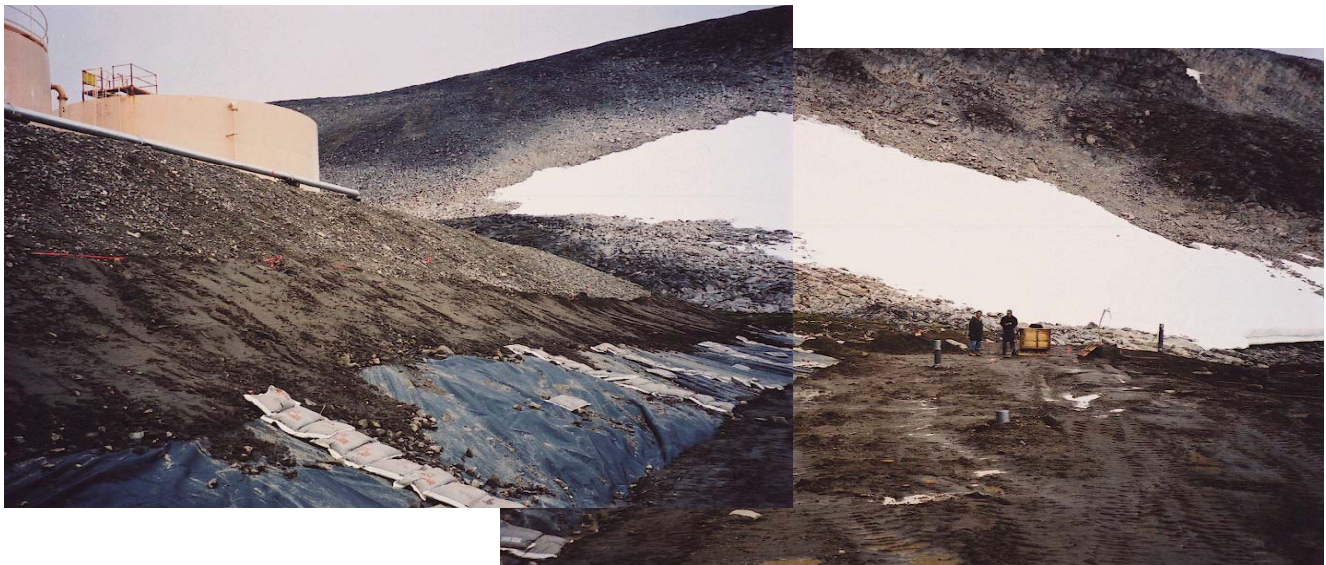
Figure 9. Photograph showing geomembrane cover sheet placed over and upstream of the geocomposite barrier.

After the geosynthetic barrier was in place, the liner system was then covered with a 0.3 m-thick layer of minus 50 mm gravel. This construction stage is illustrated in the photograph in Figure 8. Next, the trench was backfilled using the excavated materials and the ground surface graded and covered by a low weight pre-seamed scrim-reinforced polyethylene geomembrane (Layfield RPE 25) with a thickness of 0.51 mm and a tensile strength of 1,510 N. The boundaries of the cover sheet were anchored into a 1 to 1.5 m-deep trench and ballasted using on-site backfill and sand bags to prevent wind uplift (Figure 9). The cover sheet extended to the downstream side beyond the excavation and below the backfill mound covering the barrier installation. The cover sheet was intended to minimize infiltration from rainfall and snowmelt into the contaminated zone upgradient of the barrier system.

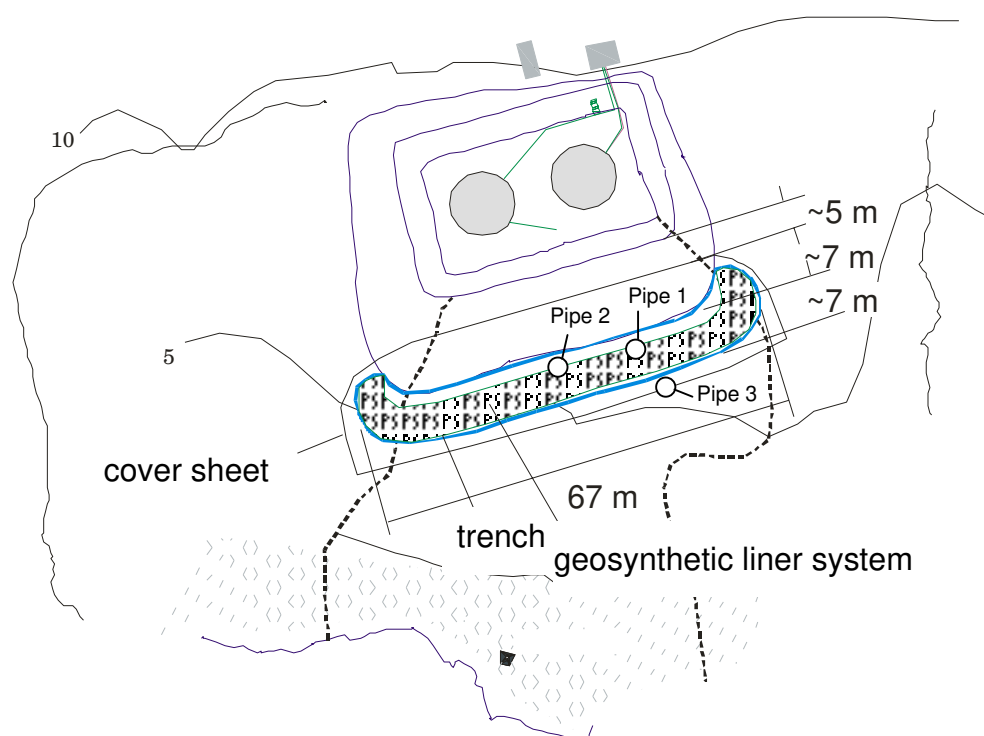
Figure 10. Plan view of containment barrier system location and instrumentation pipe locations.

The final trench was excavated in a single straight length about 67 m long with shorter curved sections at each end to bring the barrier trench into contact with the tank farm berms. The location of the trench was dictated by ground conditions that prevented the barrier system from being placed in the boulder field identified in Figure 3. The final alignment is shown in Figure 10. The consequences of the lack of geotechnical data available at the design stage of this project became apparent at the beginning of construction. The depth to permafrost was discovered to be up to 2.6 m deep, significantly greater than the average 1.5 m assumed at the time of the design. The increased depth is believed to be due to the proximity of the trench to the ocean and the large depth of fill that had been placed at the site during site leveling to accommodate the new tank farm. The deeper excavation led to a 73% increase in the amount of the geosynthetic materials required. The demand for minus 50 mm gravel (cushion) was also greatly increased. Shortening of the original trench length and careful management of the quantity of construction materials was required to ensure that there were sufficient geosynthetic materials to build the barrier system.

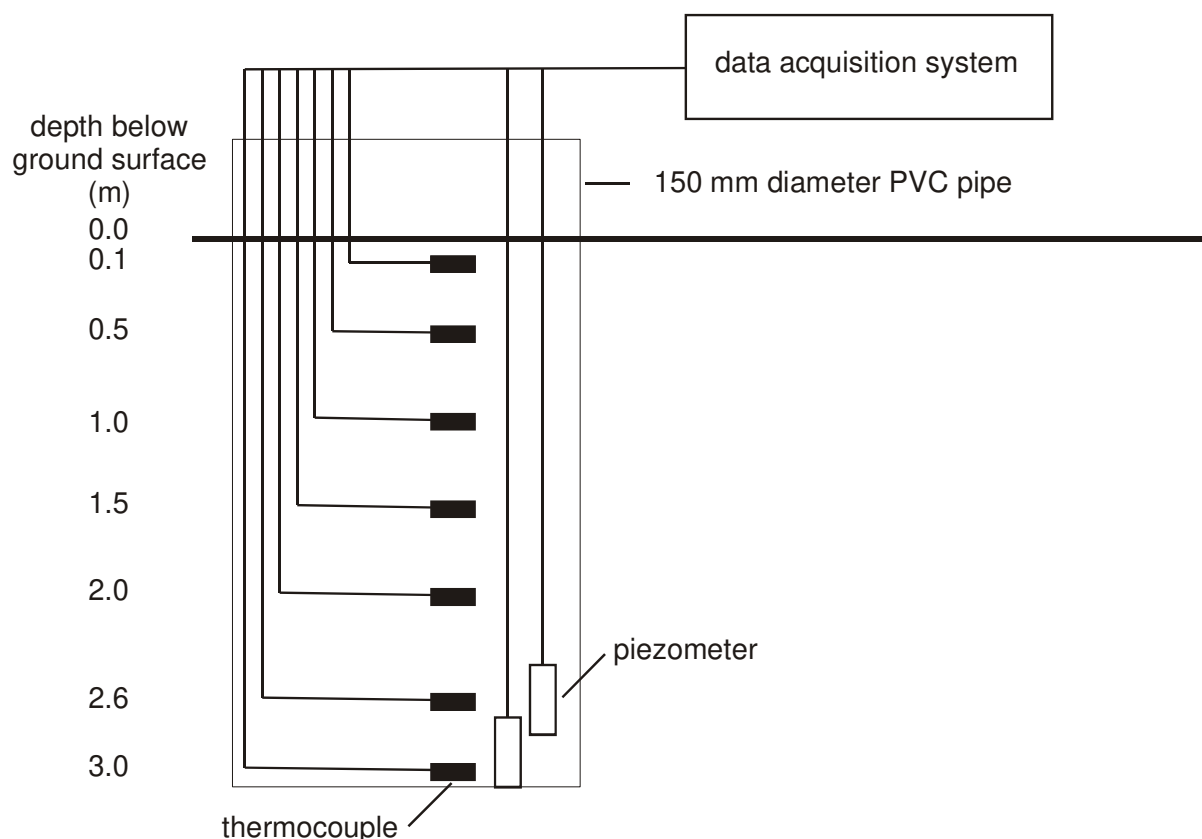
Figure 11. Example thermocouple and piezometer installation (Pipe 1 – upstream of geocomposite barrier).

In order to assess the thermal and groundwater regimes at the site, 16 thermocouples and 6 piezometers were installed in three 150 mm-diameter PVC pipes extending to the bottom of the trench excavation. Two pipes were installed immediately upstream of the barrier system and one immediately downstream. The pipes were placed while the excavation was open. An example installation is illustrated in Figure 11. The data acquisition system (Campbell Scientific) was specially designed for harsh environments and consists of a memory module that can be swapped out at intervals and the data downloaded. The module can store up to one year of data. A battery supply connected to a solar panel is used to power the system.

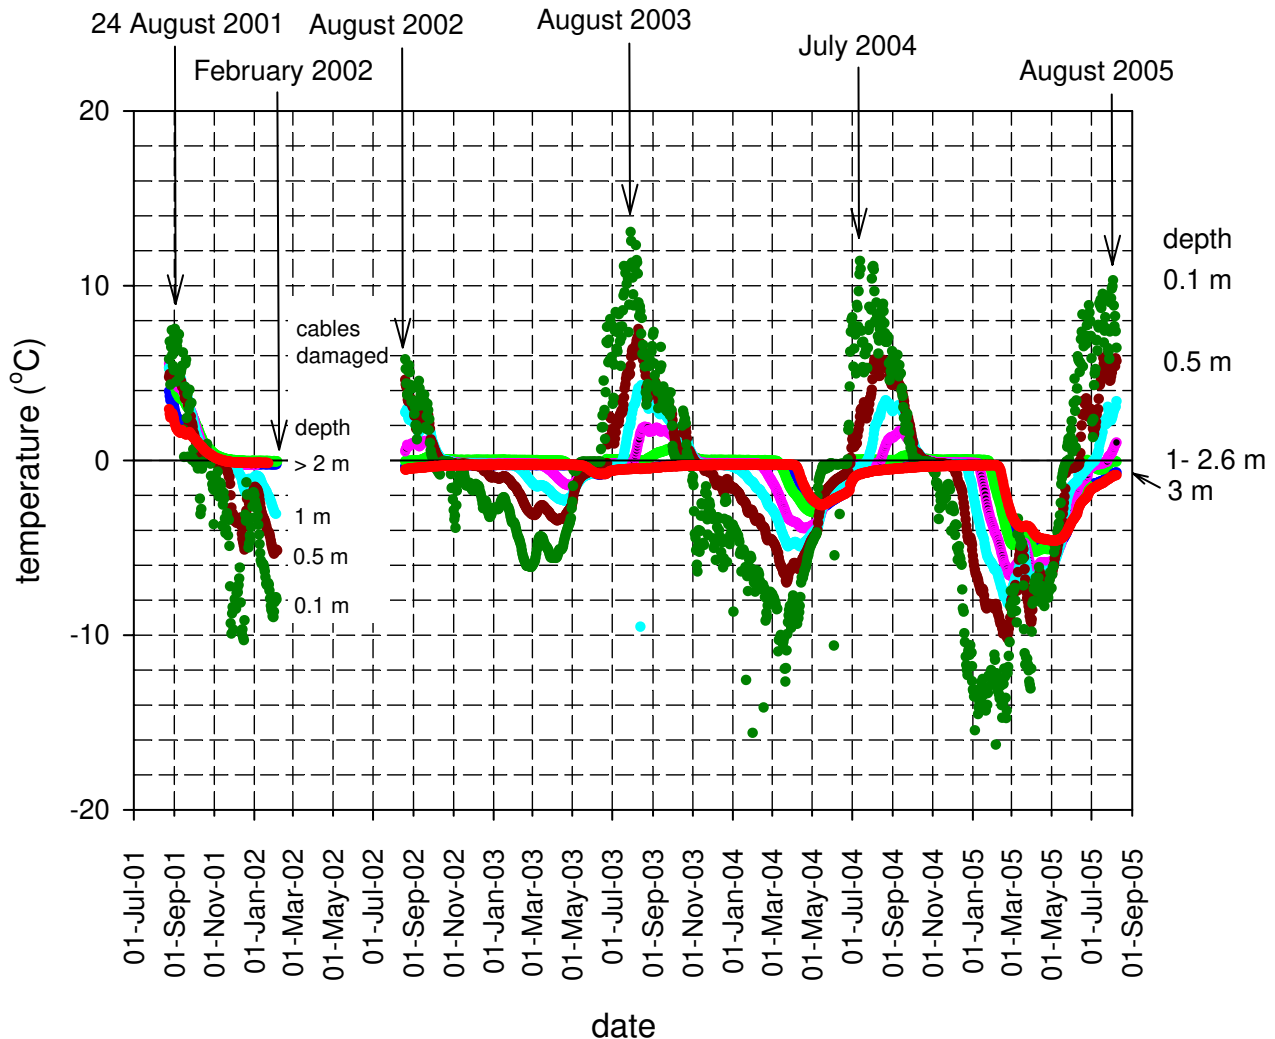
Figure 12. Example temperature-time histories from thermocouples located in Pipe 1 (upstream of barrier).

Temperature-time records from thermocouples placed in one of the instrumentation pipes immediately upstream of the barrier are shown in Figure 12. The gap in the records is due to severing of the cables by wildlife at the site in early 2002. The cables were repaired the following summer. Based on the data available, the ground temperatures at a given depth are lower in the winter of 2004-05 than the preceding winters. For monitoring points below a 2 m depth, temperatures are persistently below freezing based on the data available. This point is explored further by plotting temperature profiles from the same installation corresponding to the time of barrier installation and at selected times during the summers of 2003, 2004, and 2005 (Figure 13). The data show that freeze-back has occurred to an elevation well above the base of the original trench. The piezometers located close to the base of the barrier were frozen and hence measurement of the groundwater table behind the barrier was not recorded.

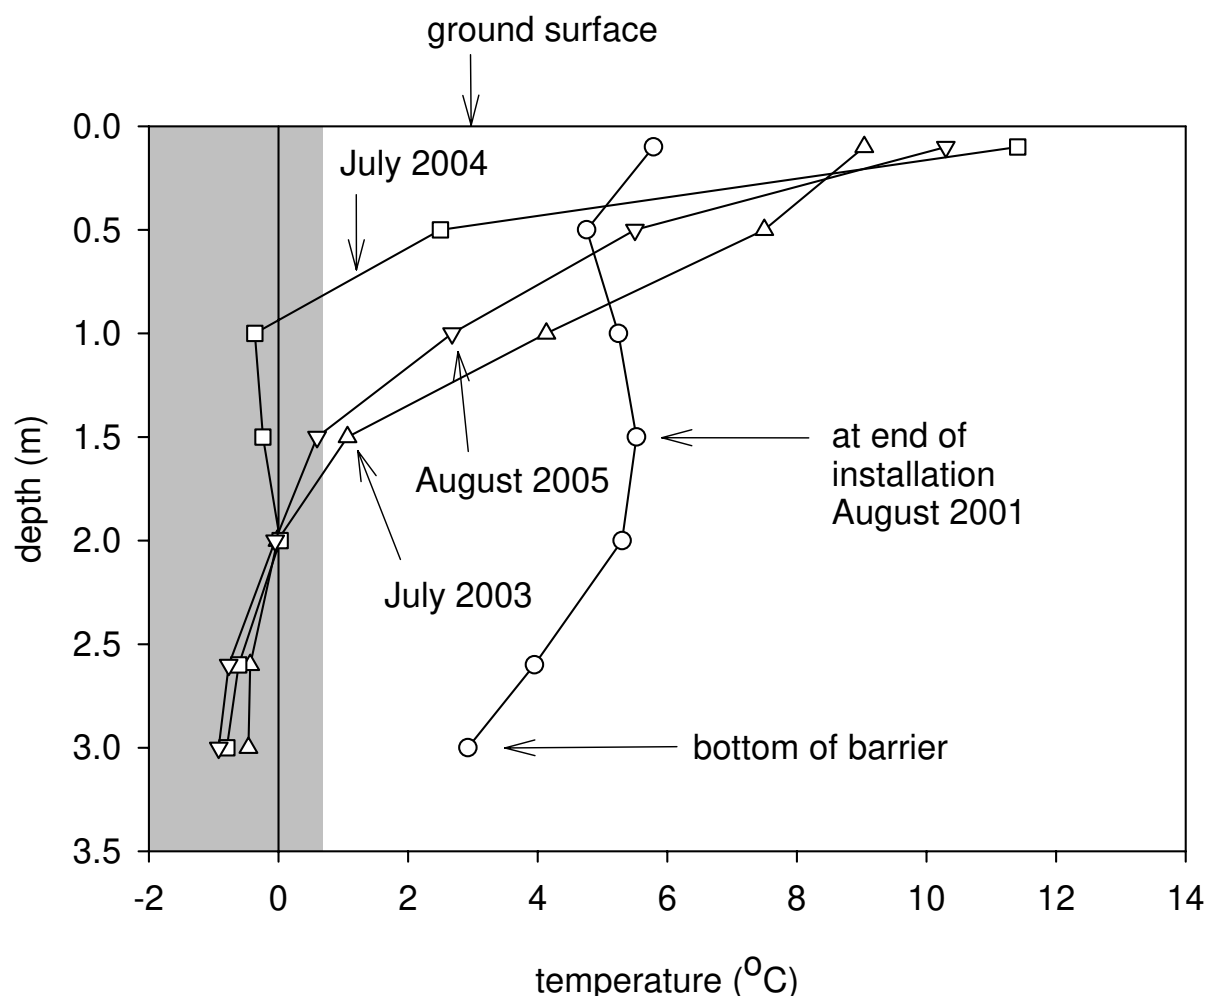
Figure 13. Temperature profiles at location of barrier system corresponding to times of maximum recorded surface temperature.

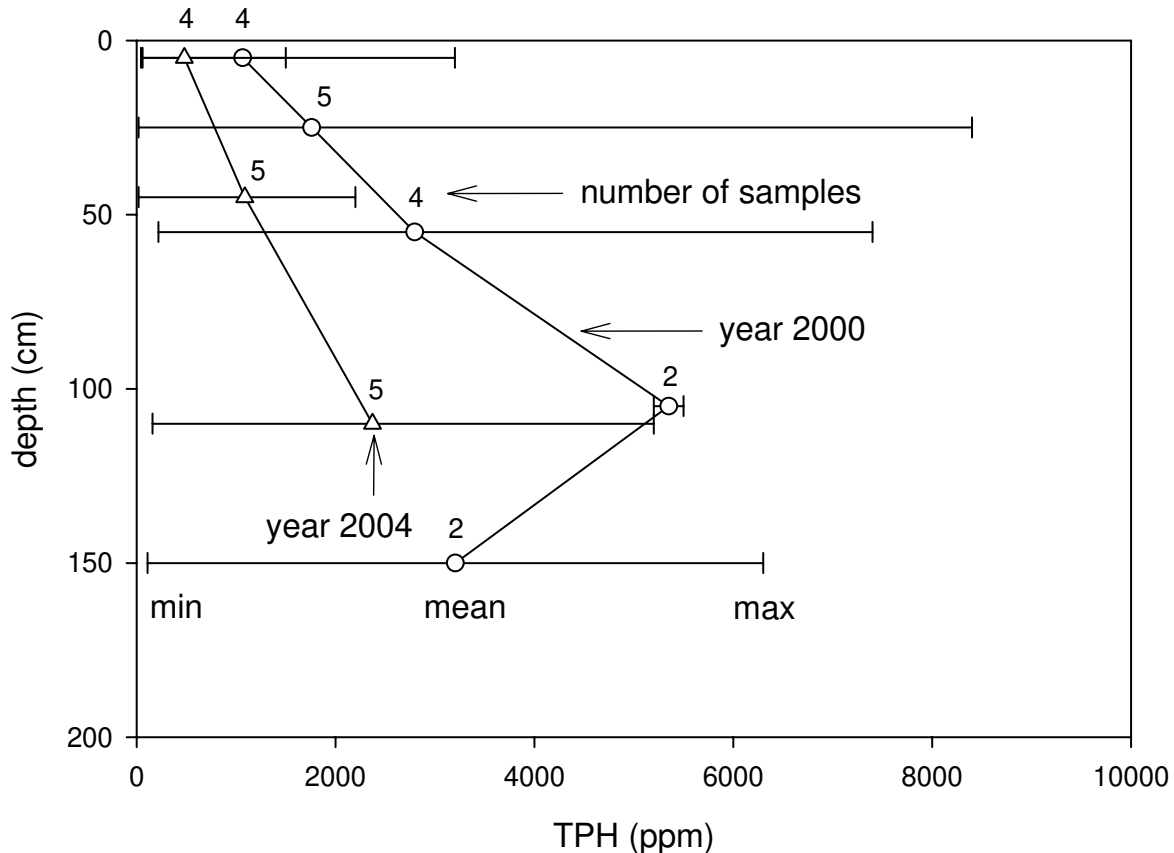
Figure 14. TPH measurements taken downstream of the barrier system before and after installation

Data from the year 2000 TPH sampling program described earlier in the paper are plotted in Figure 14 together with data gathered in the summer of 2004. The data points are for samples recovered downstream of the barrier system only. As in the initial program, the test pits used to retrieve soil samples in the summer of 2004 were put down at opportunistic locations dictated by the distribution of large boulders at and below the ground surface. The data, although subject to the expected variability, shows that the highest TPH concentrations are at a depth that likely corresponds to the location of the undisturbed permafrost level. This supports the notion that subsurface hydrocarbon migration was bounded by the permafrost table at the site. It appears that the general trend of increasing mean TPH levels with depth is preserved for both data sets. However, statistical analysis of the mean TPH concentrations indicates that the levels in 2004 are about 50% of the values determined prior to the installation of the barrier system. This decrease is probably due to a combination of volatilization, natural attenuation, and dispersal; it does, however, indicate that at least in the short term, the source has been effectively isolated.

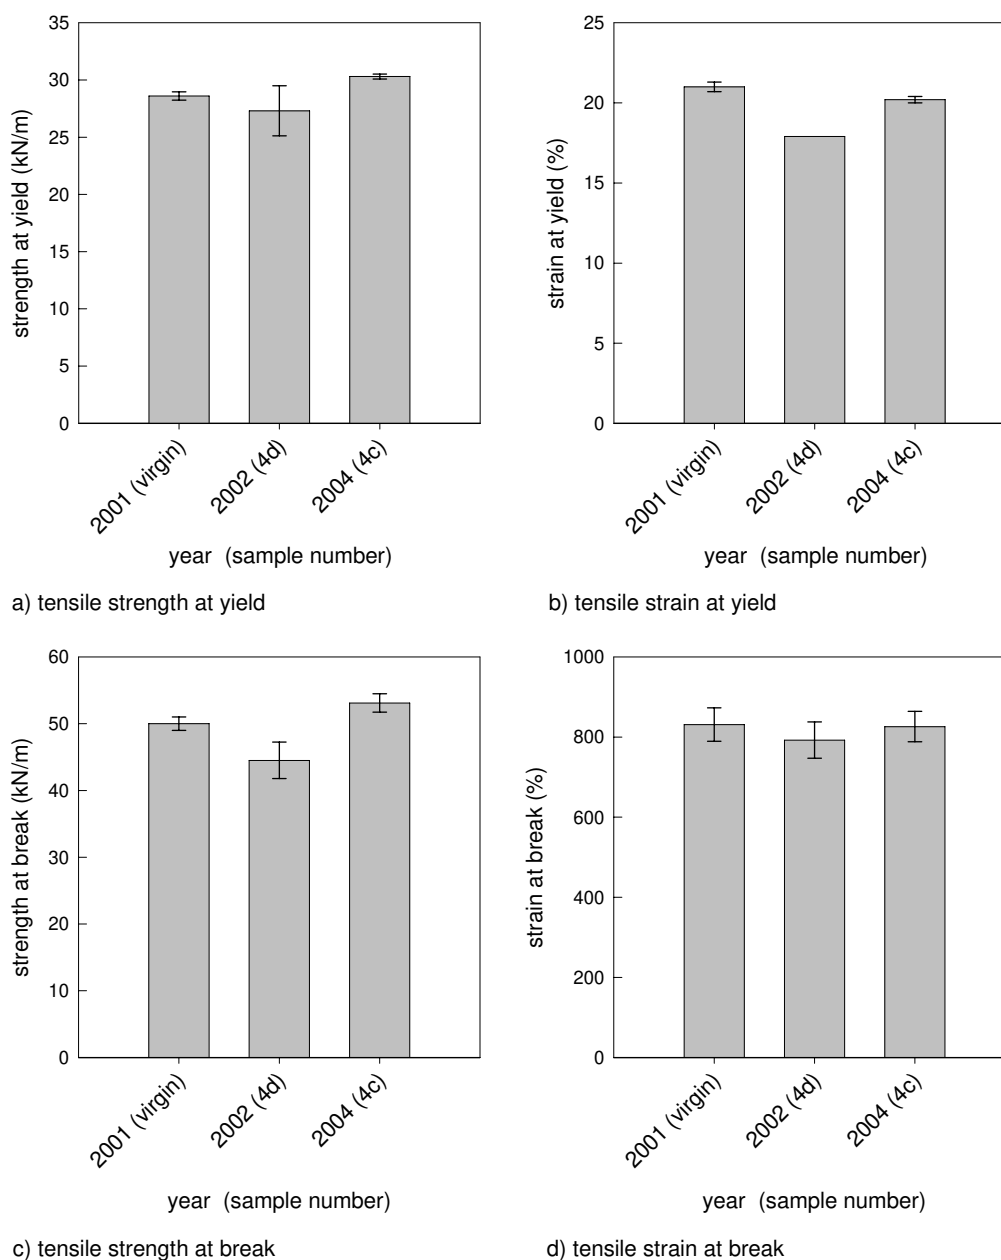
Figure 15. Mechanical load-strain properties of virgin and exhumed 1.5 mm-thick fluorinated HDPE geomembrane samples. Notes: 5 specimens per sample; error bars represent ± 1 standard deviation.

Conventional tensile tests carried out in accordance with ASTM D6693 and a displacement rate of 50 mm/min have been performed on archived and exhumed specimens of the 1.5 mm-thick fluorinated geomembrane material used at the Brevoort site. Tensile strengths at break and yield together with corresponding strain values are reproduced in Figure 15. Based on the data available there is no indication of a systematic and significant change in the index tensile properties of the f-HDPE geomembrane since installation.
